3186 Havendoklaanbrug

Change Detection

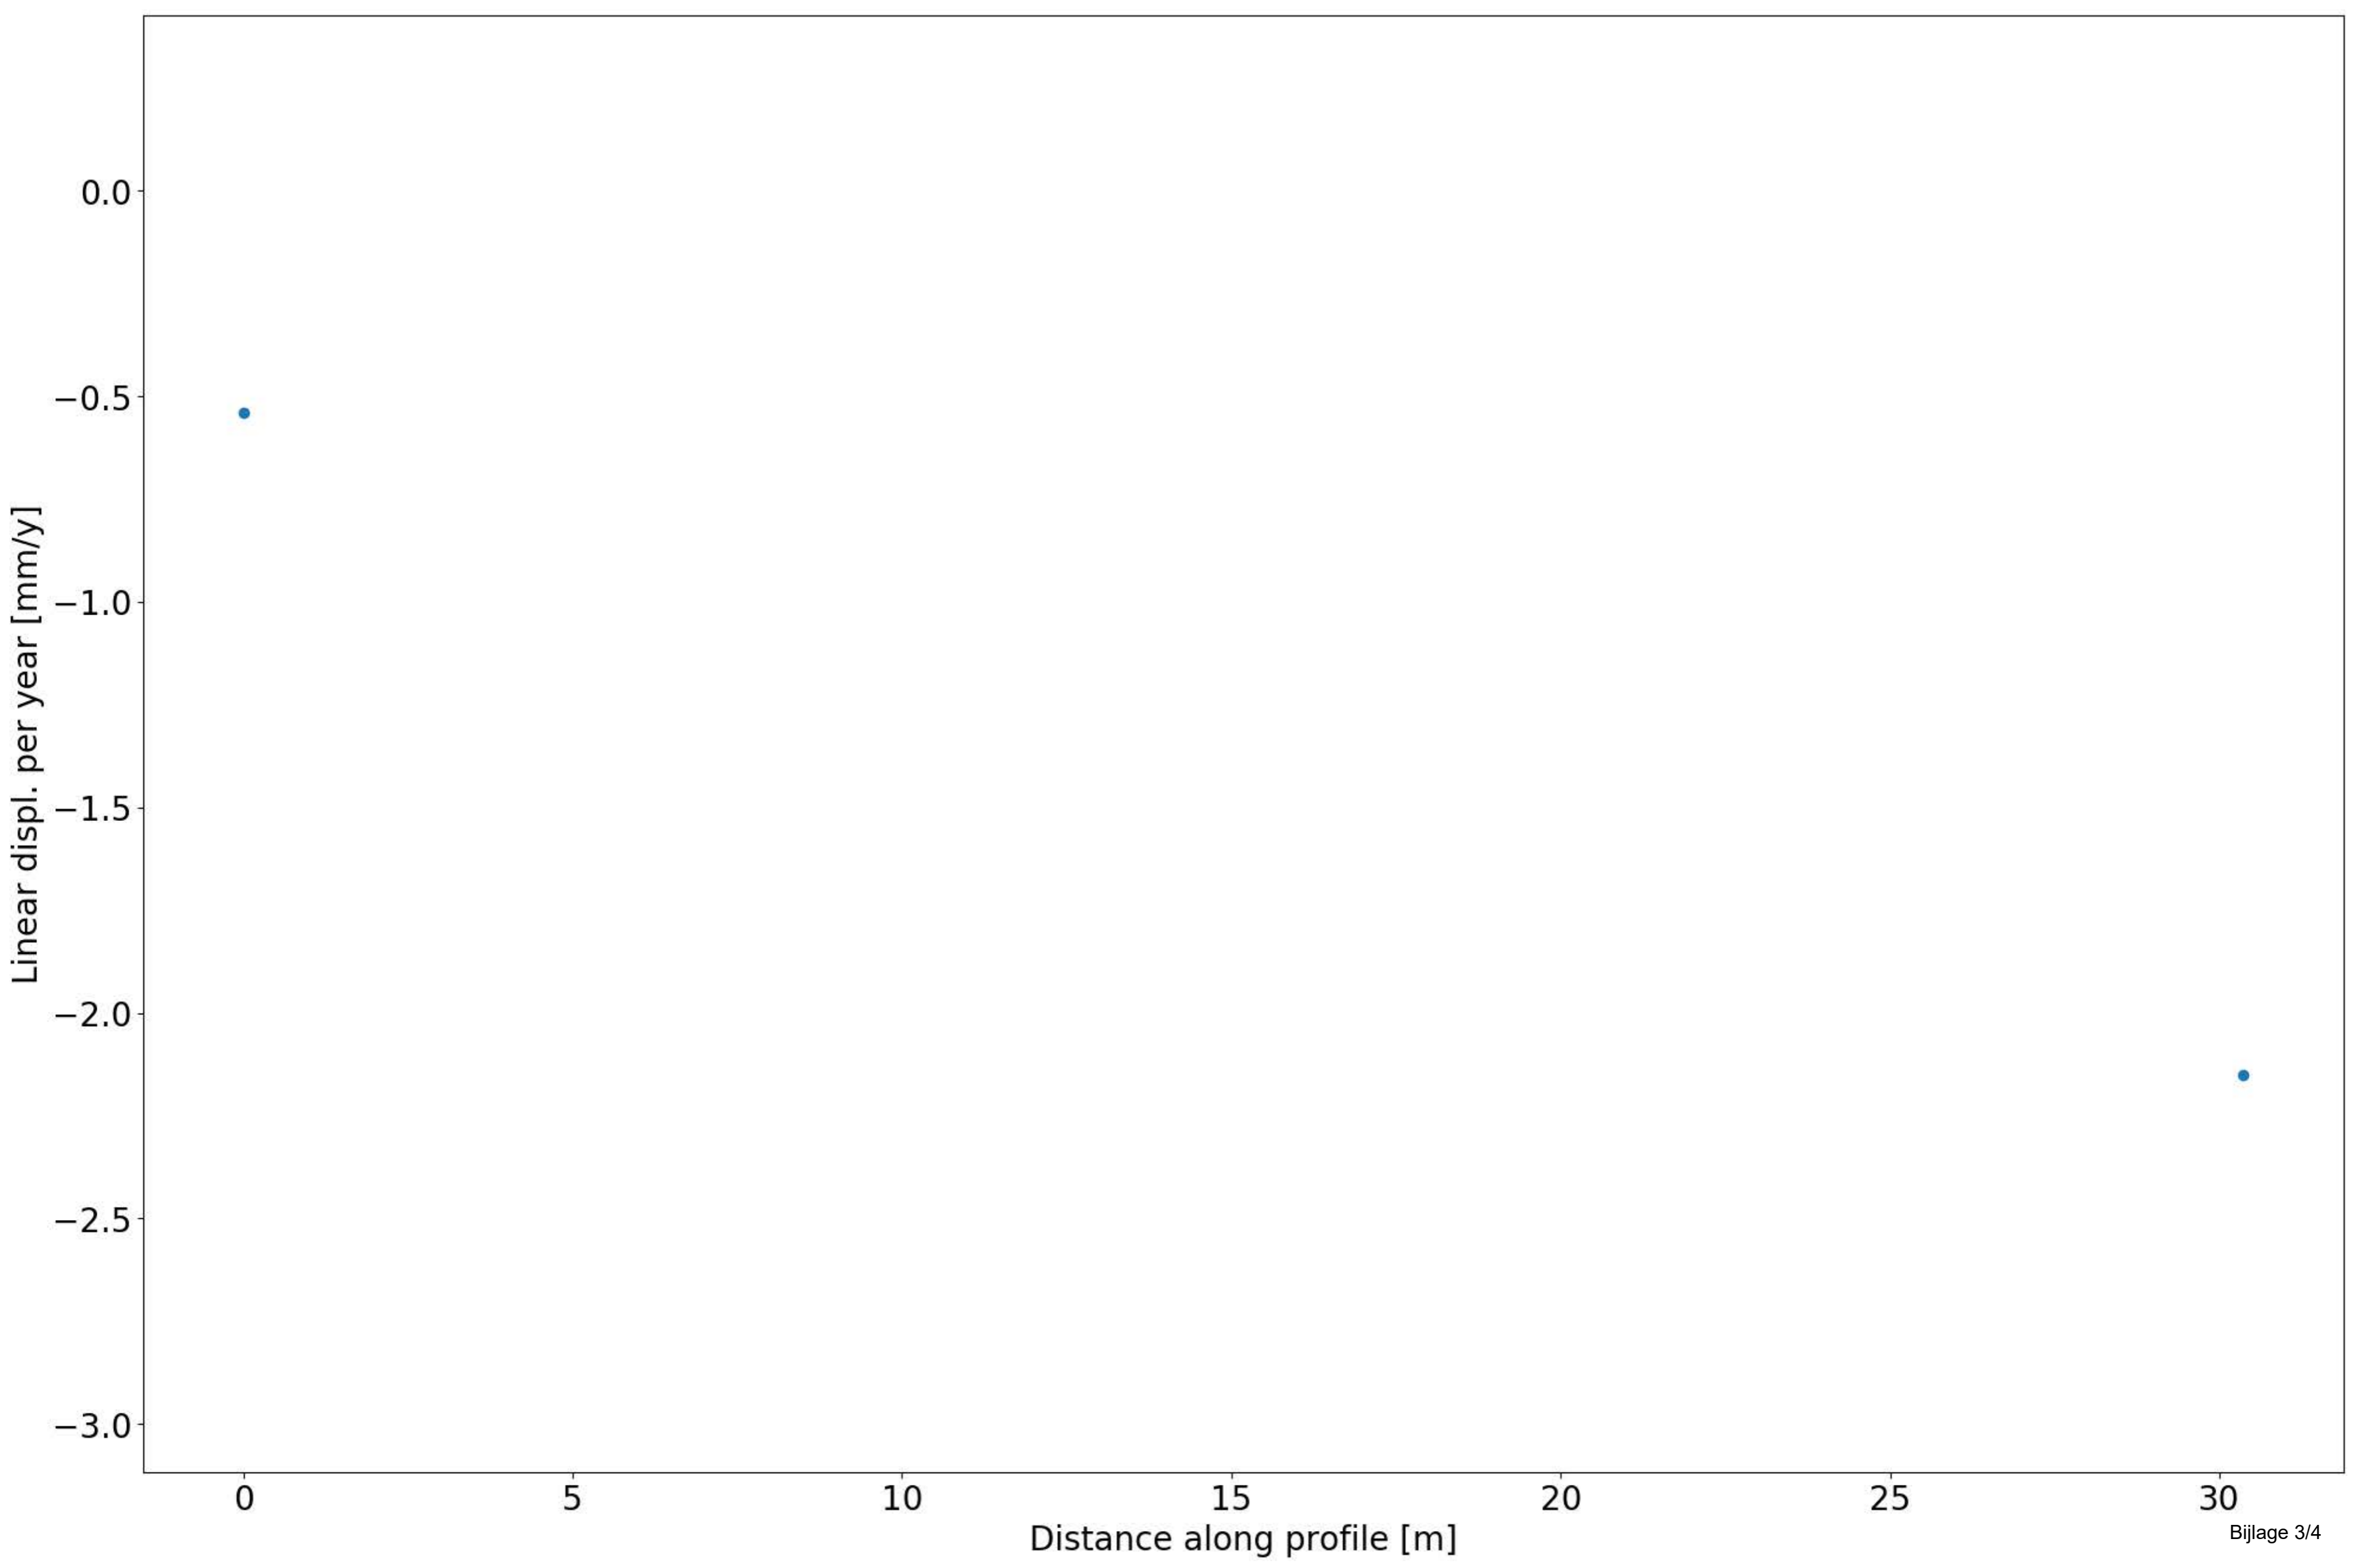
Change detection	Approx. period	Description
Change SE	April 2016	Change in displacement rate after April 2016
Change SE	April 2016	Change in amplitude after April 2016

For the TSX dataset, there are InSAR points along the full length of the bridge, no significant gaps in the data. The S1 datasets have very few points, which is likely associated with the changes detected on this bridge.

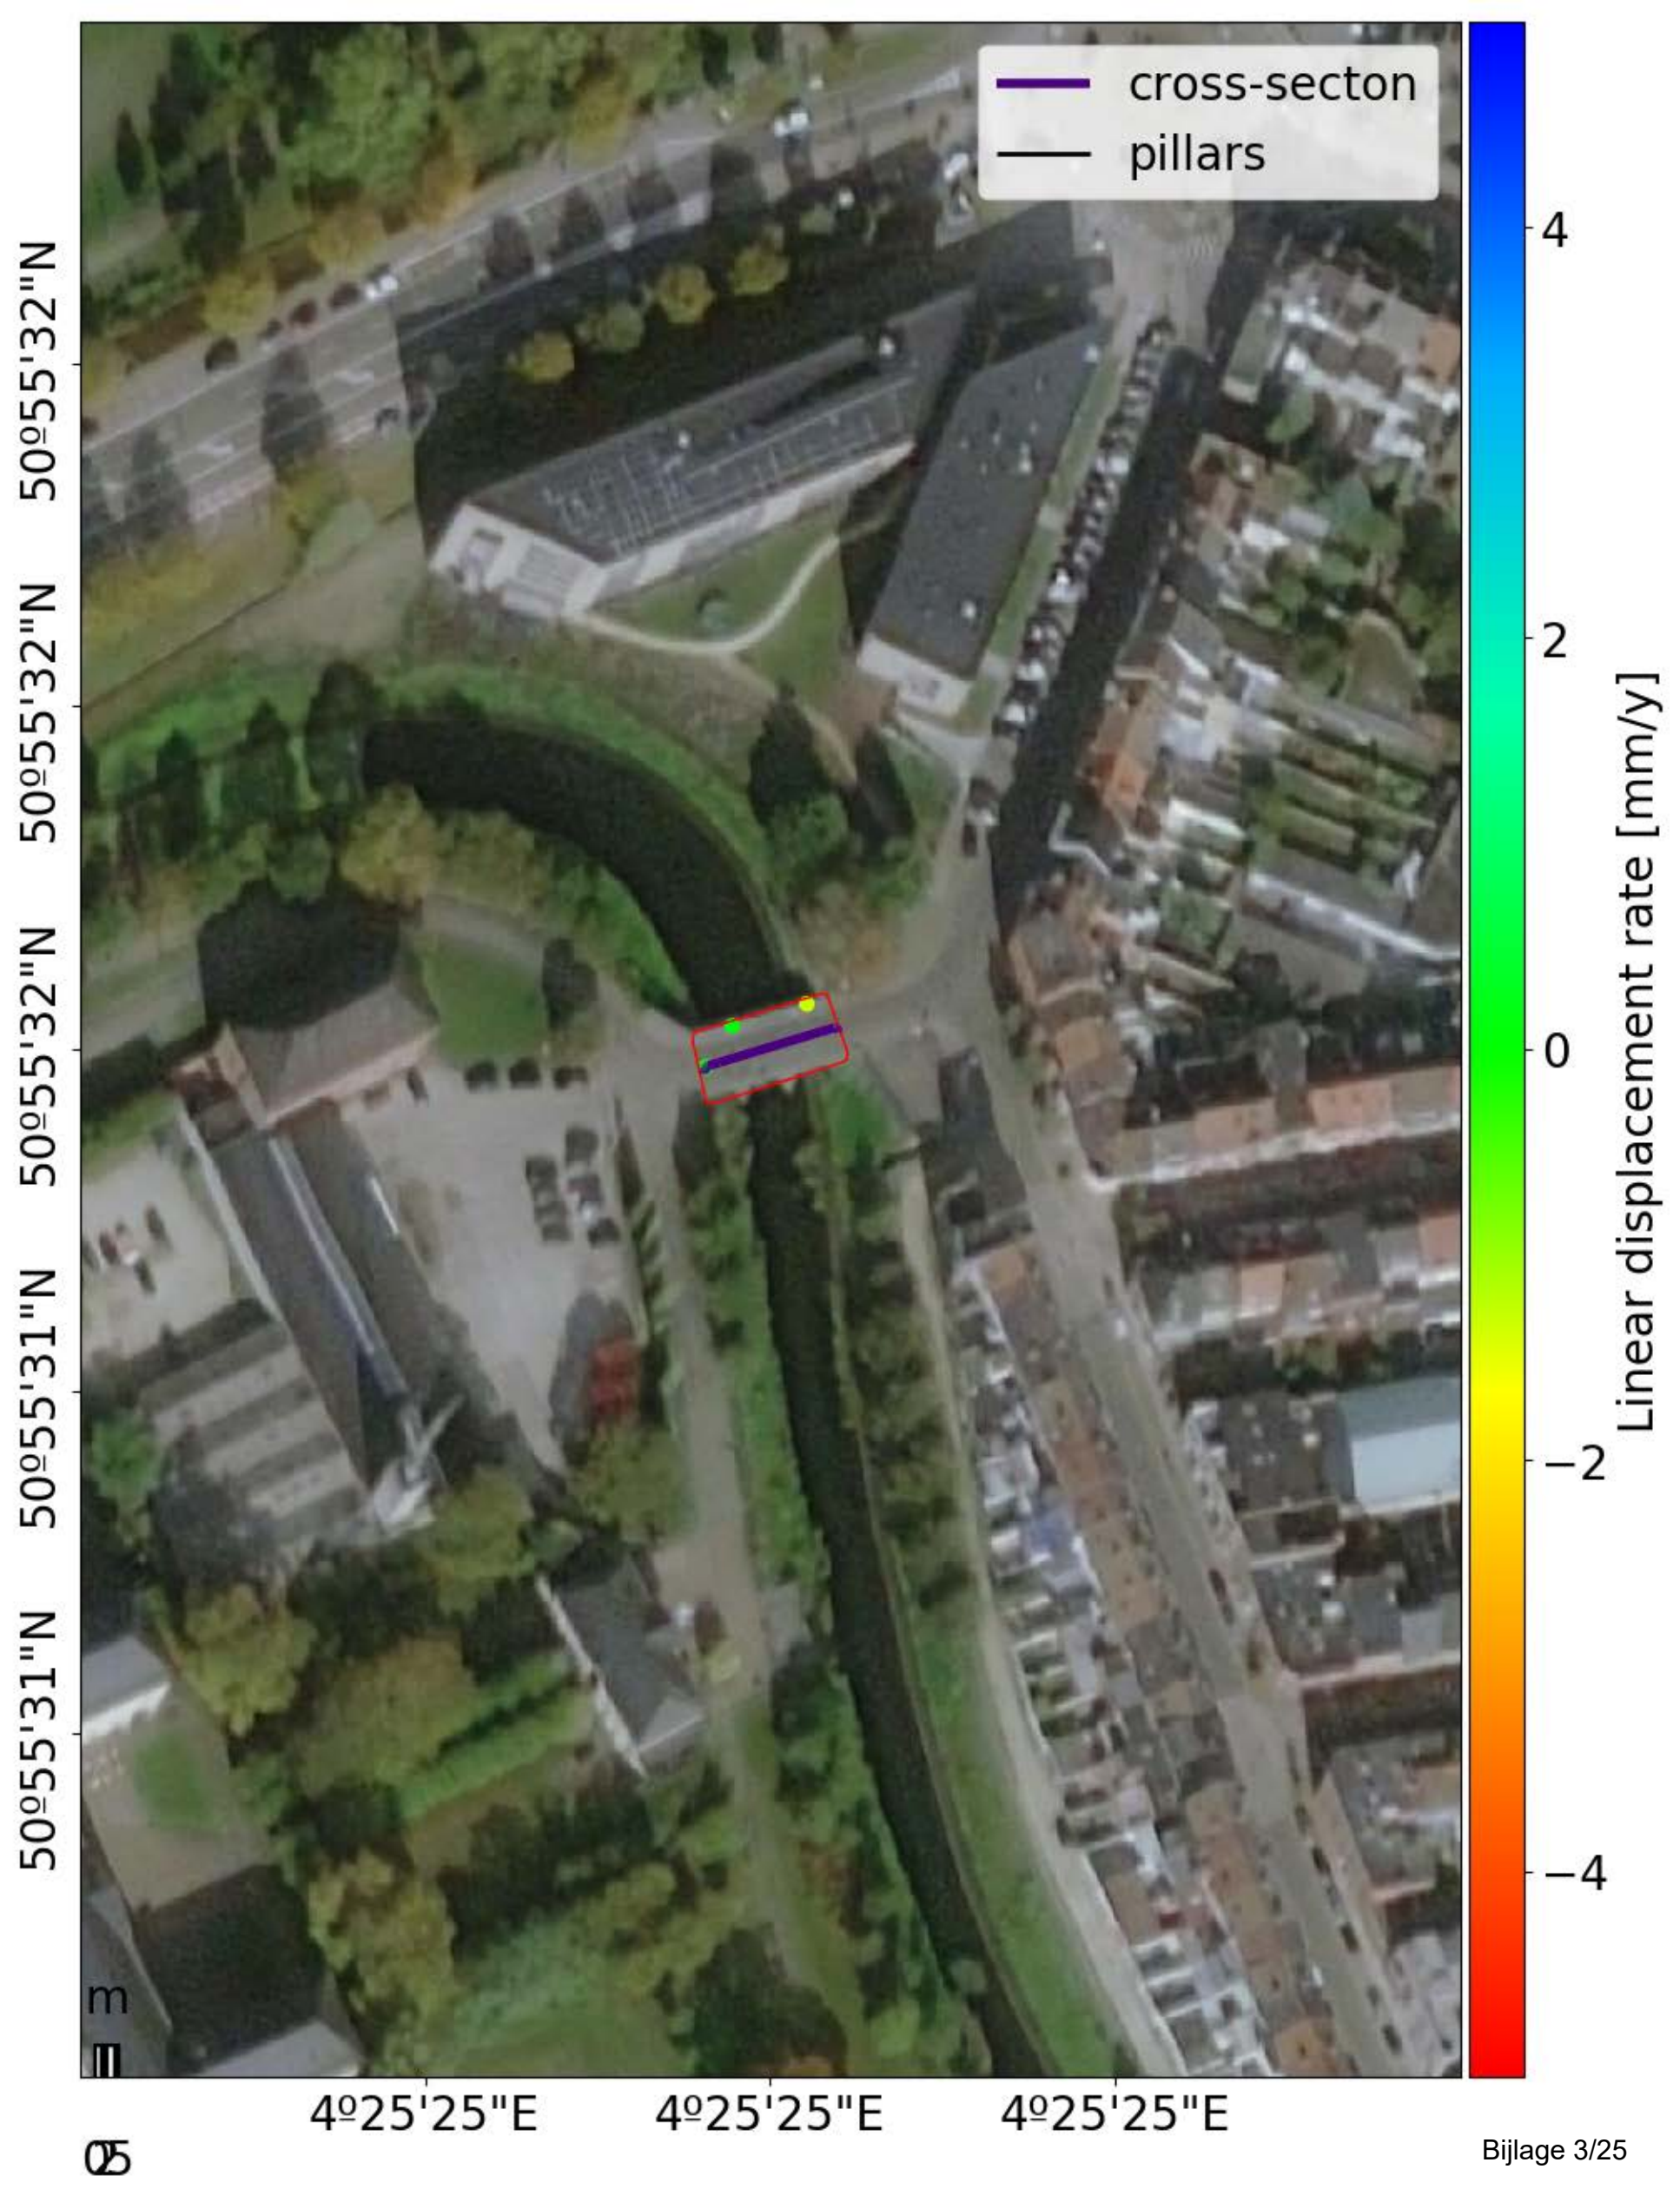
3189 Tuchthuisbrug

The TSX data has InSAR points along the full length of the bridge, no significant gaps in the data. However, the S1 datasets have just one or two points. The reason for this lack of points is currently unknown, since no maintenance works were recorded, no changes detected and it has no strong seasonal component. Further investigation would be needed to assess the causes.

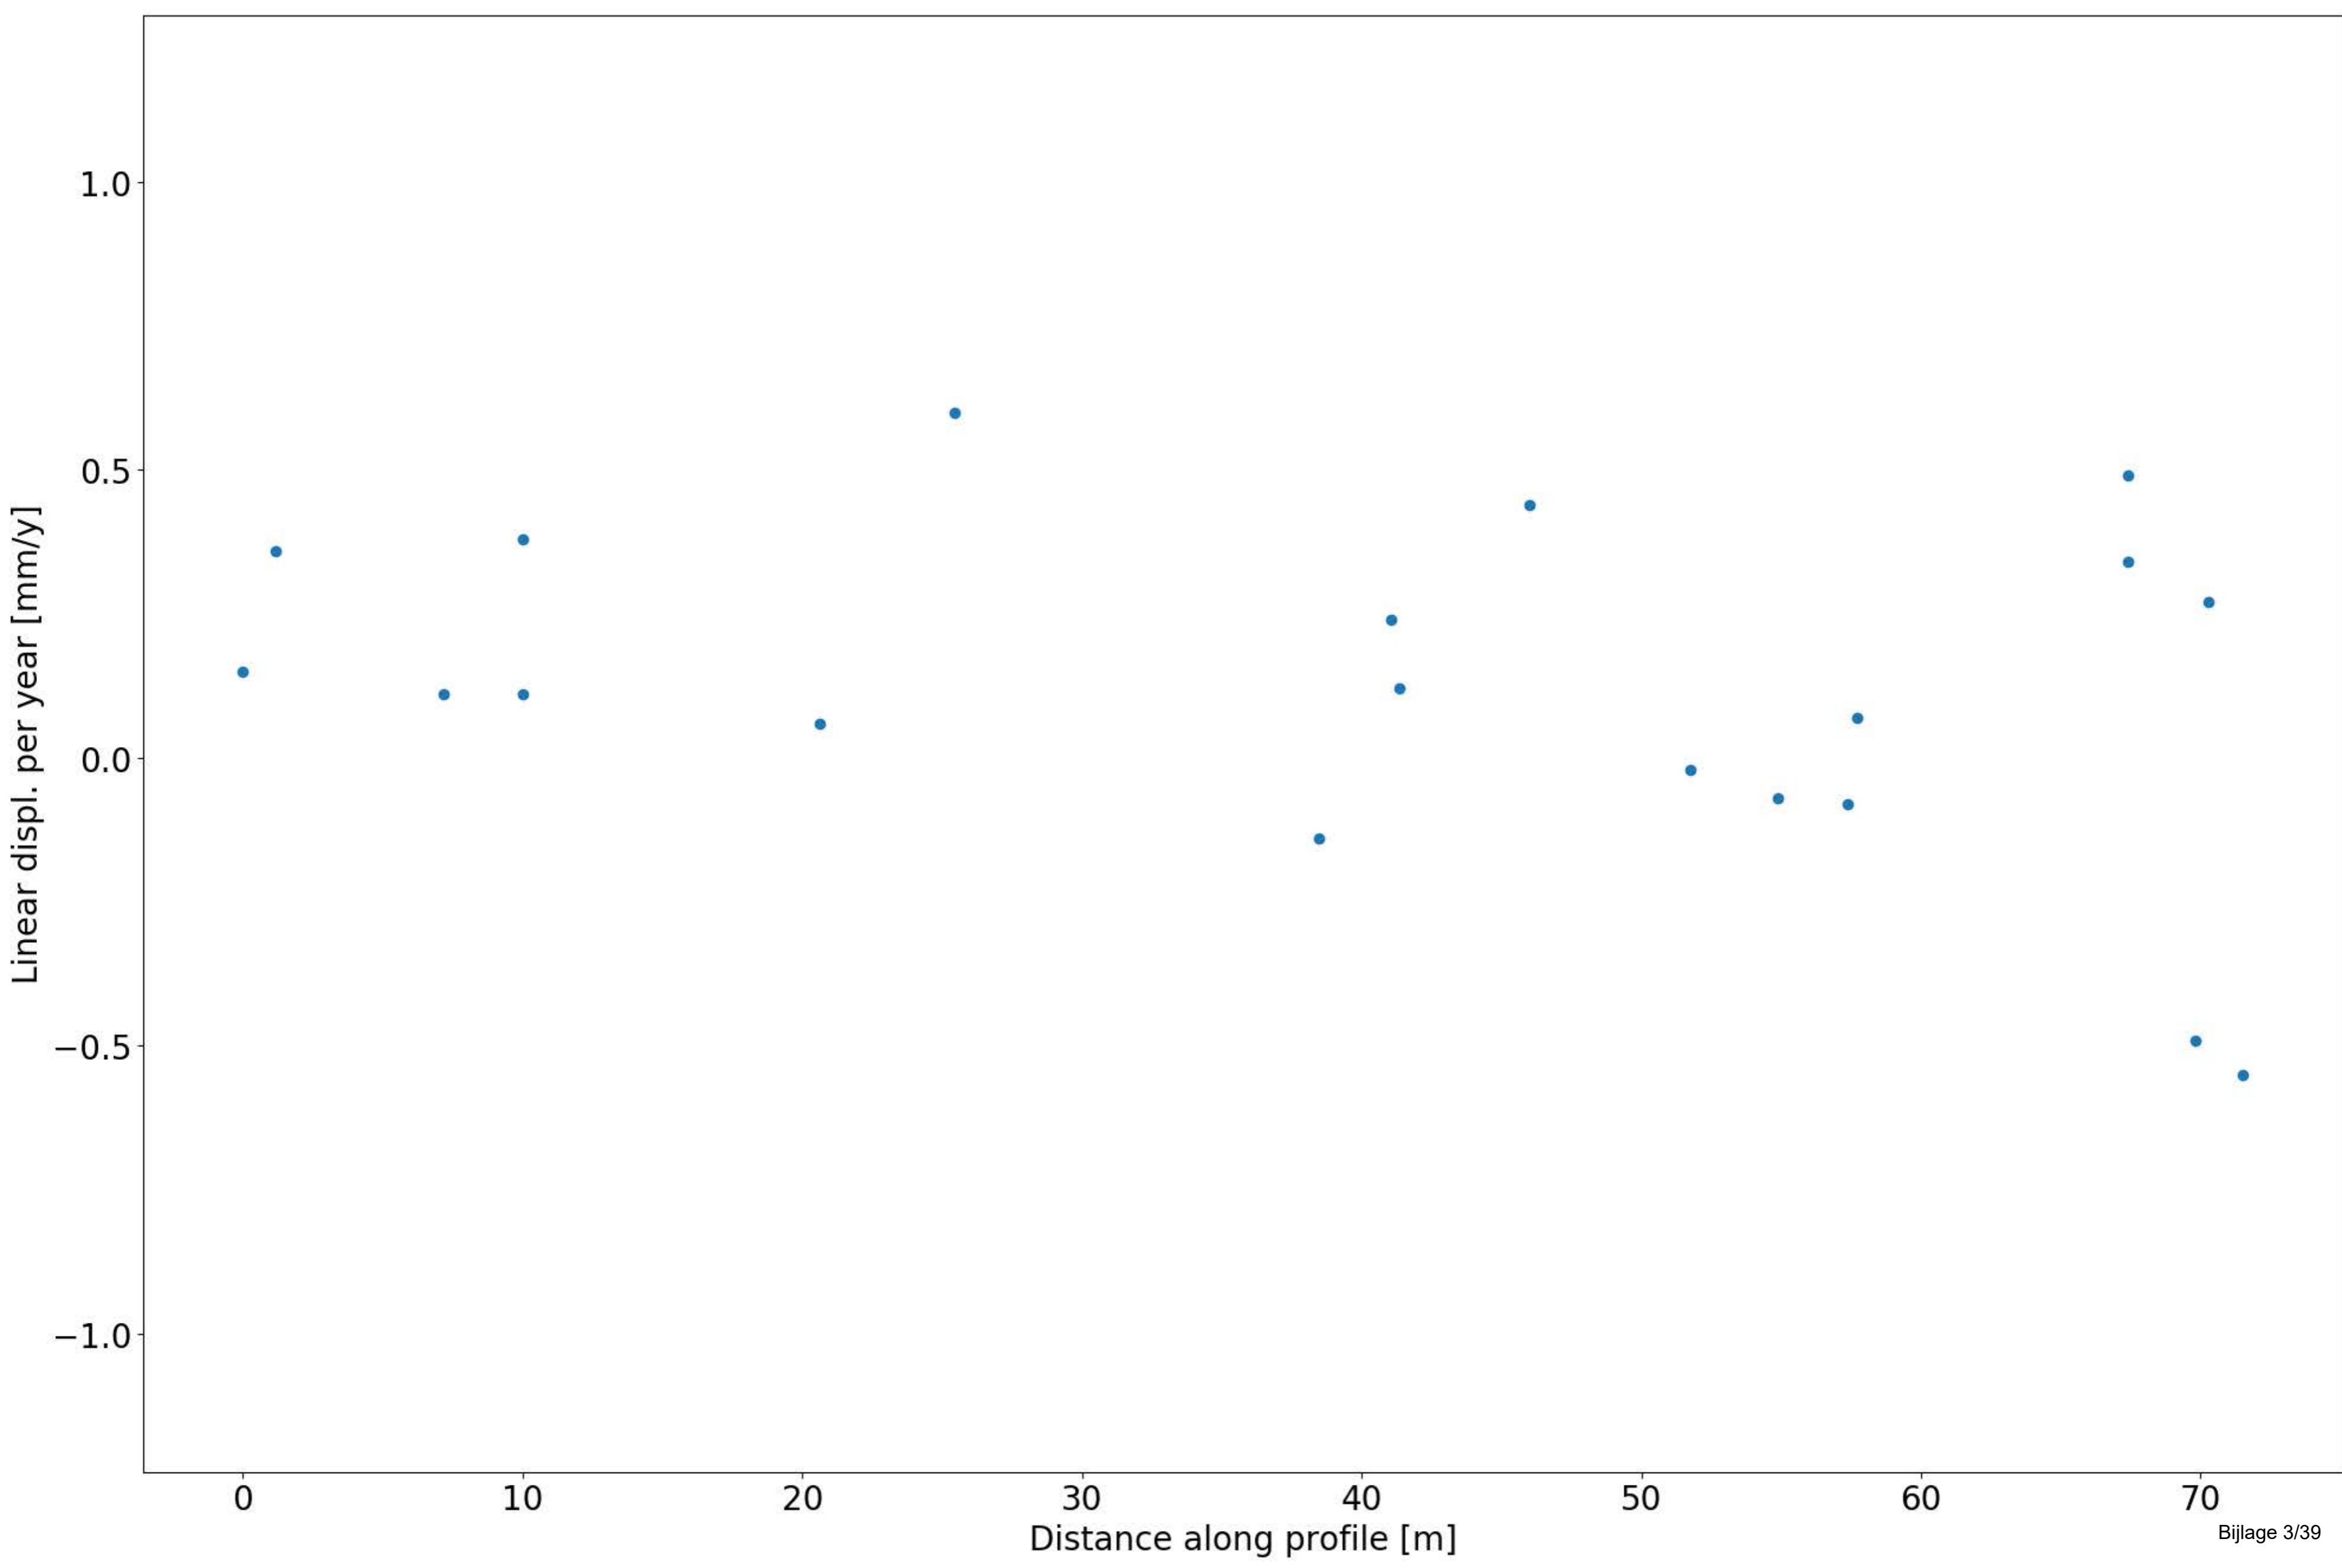
3590 Brug 1 over de J. F. Kennedylaan Grensstraat

Change detection	Approx. period	Description
Change NE	Since September 2016	Change in amplitude after September 2016

InSAR points along the length of the bridge for all 3 datasets (TSX, S1 asc and S1 dsc), no significant gaps in the data.

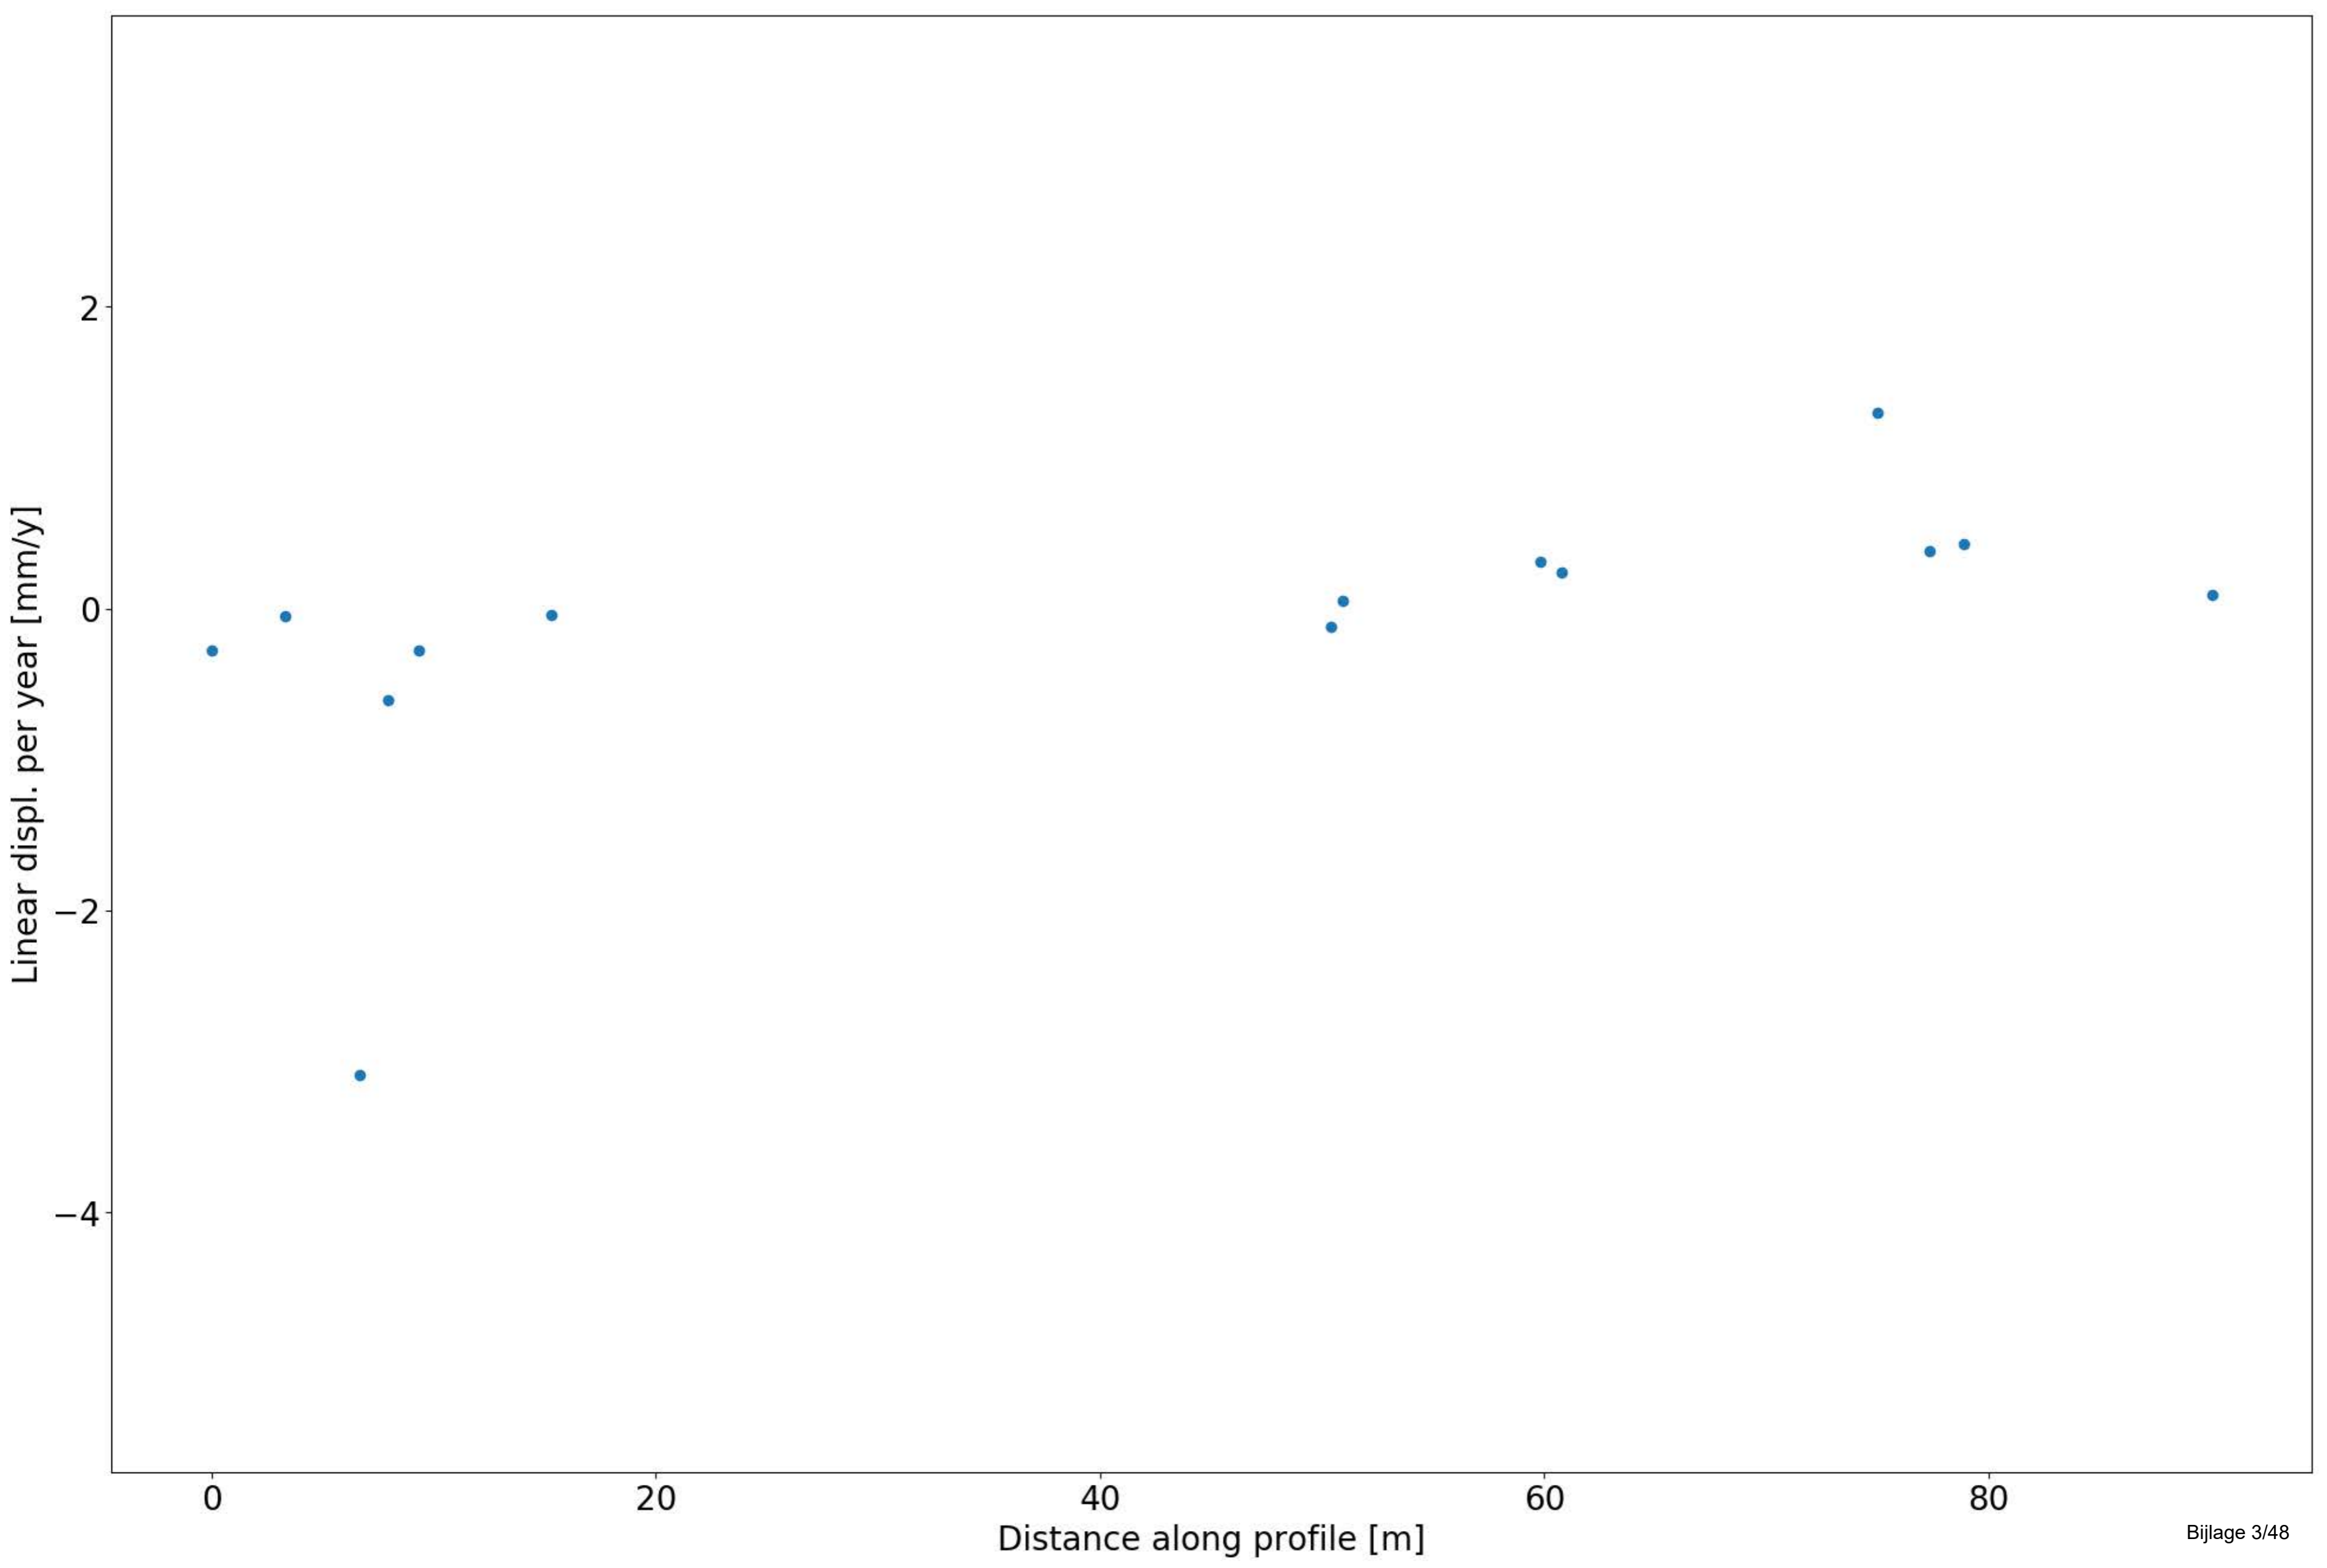
4292 Brug B14

Change detection	Approx. period	Description
Change E	February 2019	Increase in displacement rate around February 2019
Change E	October 2020	Change in amplitude after October 2020

The TSX data has InSAR points along the full length of the bridge, no significant gaps in the data. On the ramp there is a lack of points for S1 at the top of the ramp where it meets the

bridge and for S1 asc on the eastern end and S1 dsc on the western end. This could be due to the bridge geometry and would need further investigation.

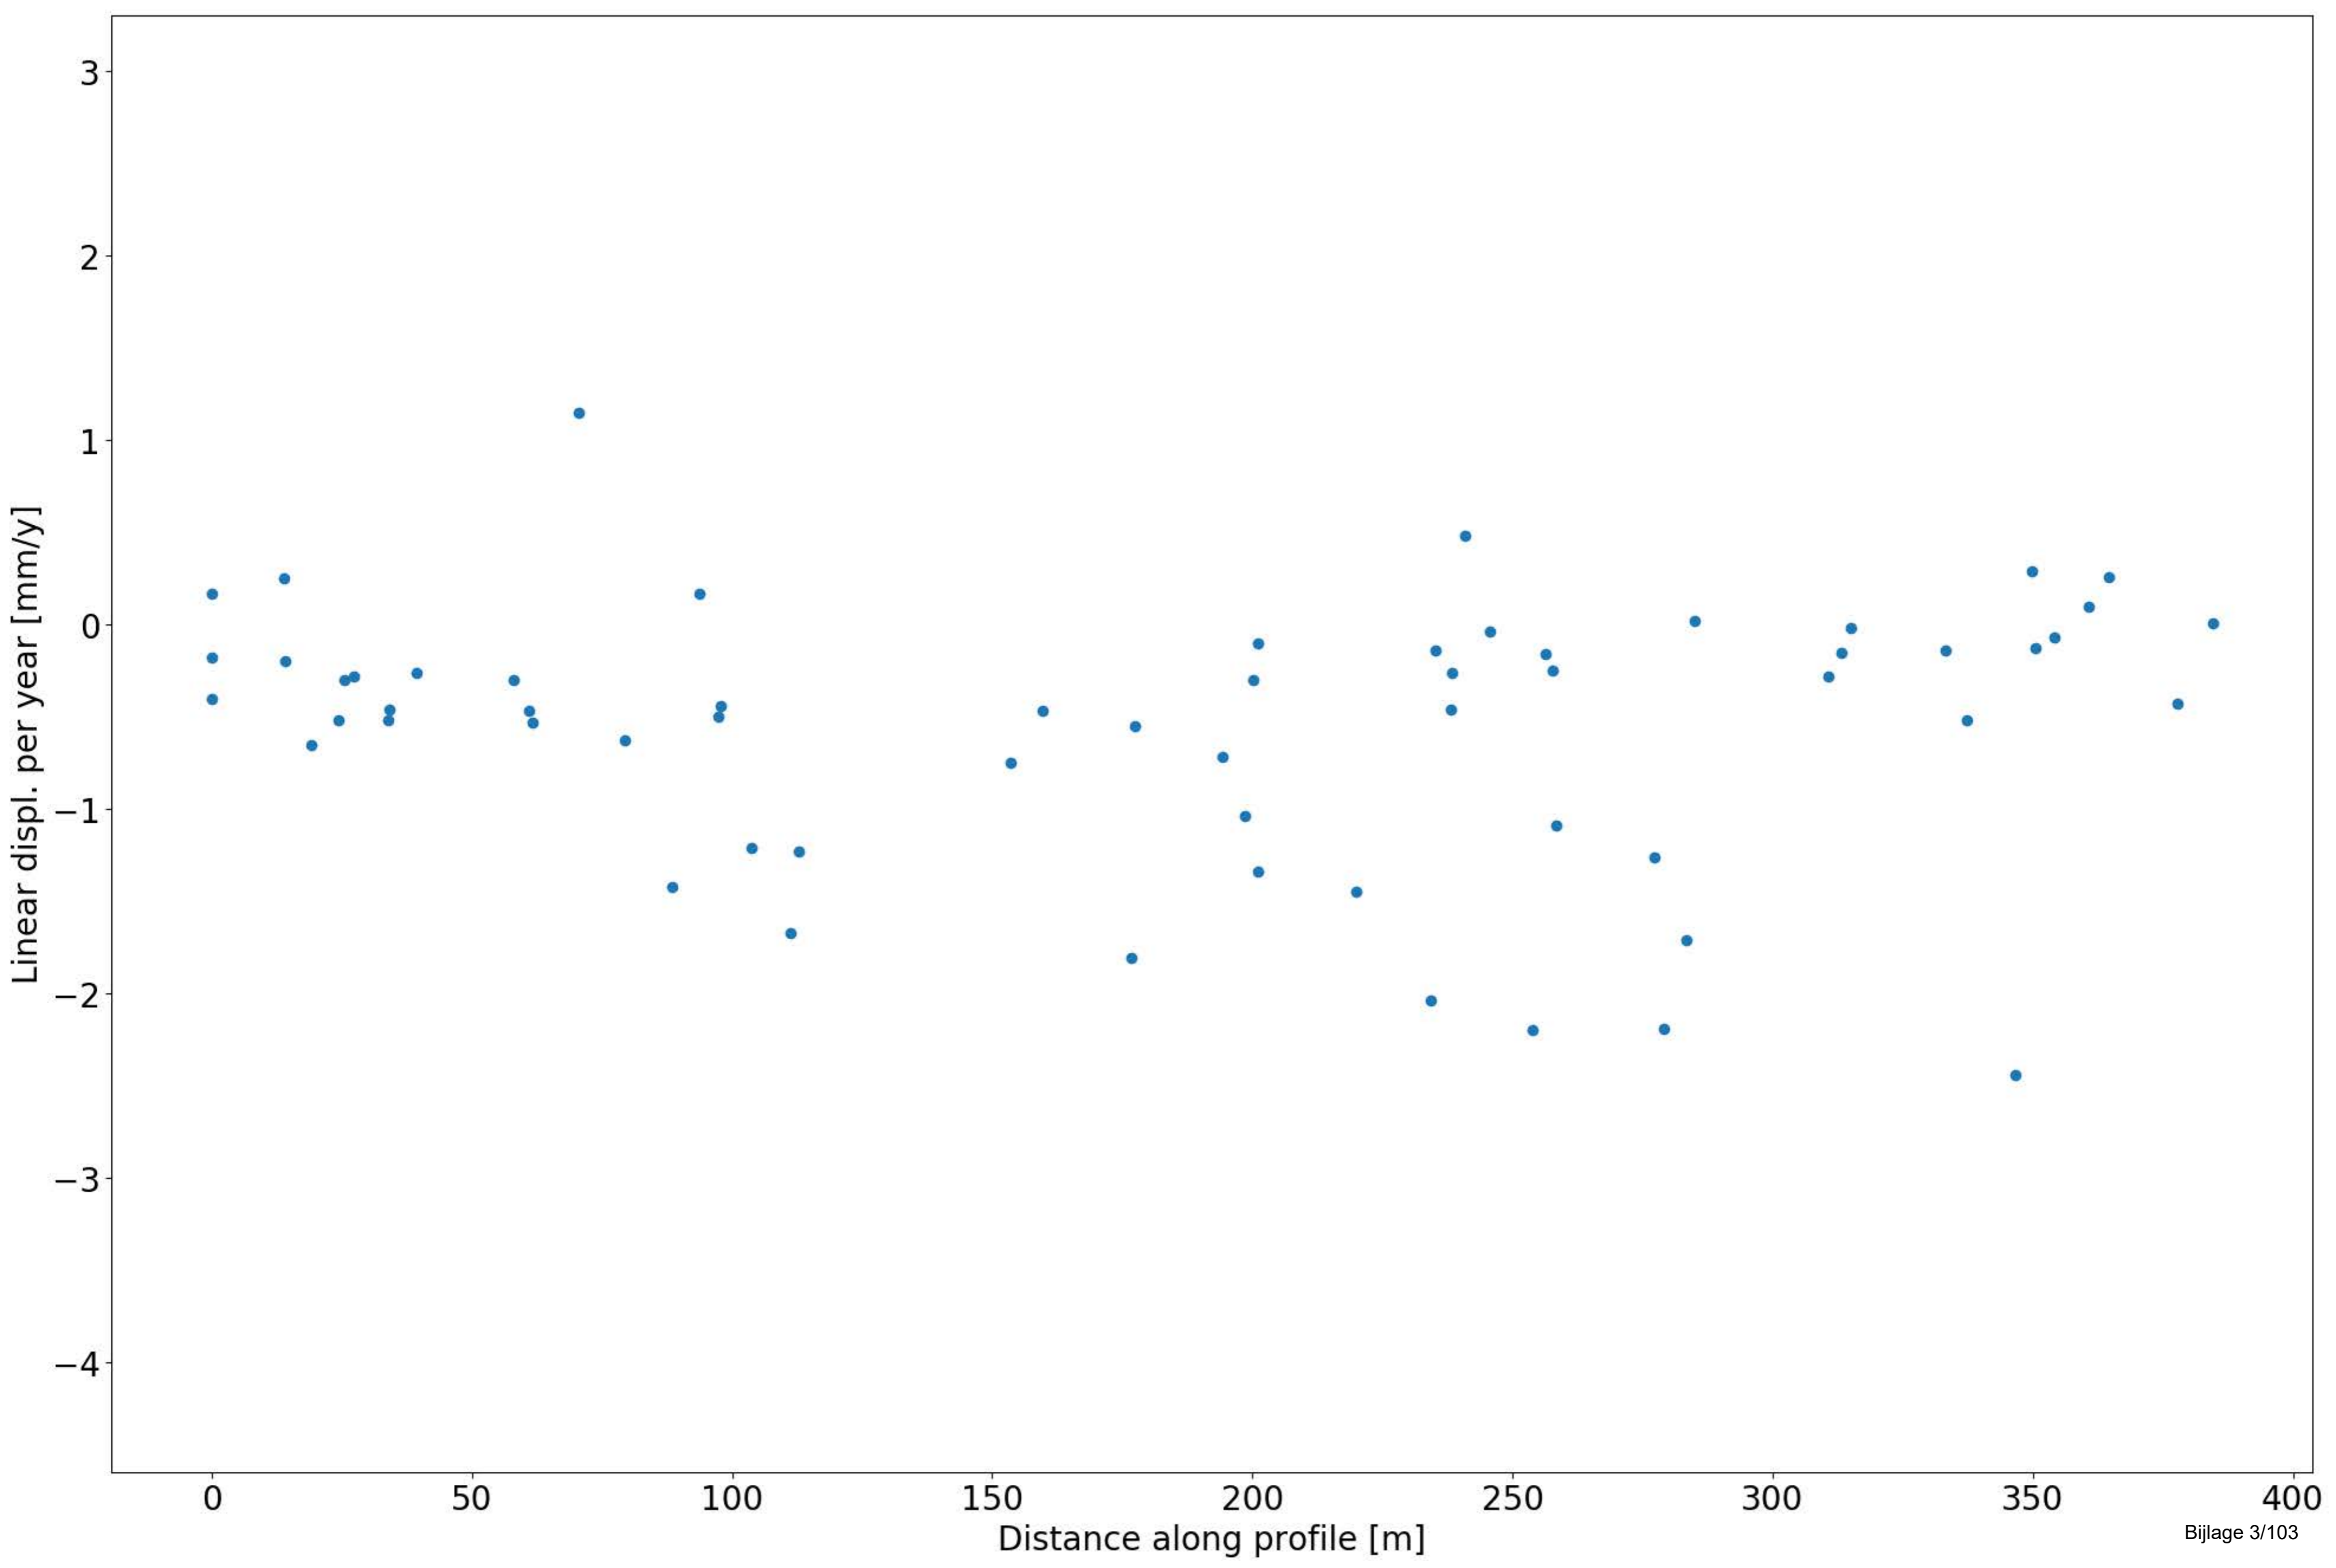
4333 Brug R18

Change detection	Approx. period	Description
Change SW	August 2017	Increase in displacement rate from August 2017
Change NE	January 2020	Slight increase in displacement rate from January 2020

InSAR points along the length of the bridge for all 3 datasets (TSX, S1 asc and S1 dsc), no significant gaps in the data.

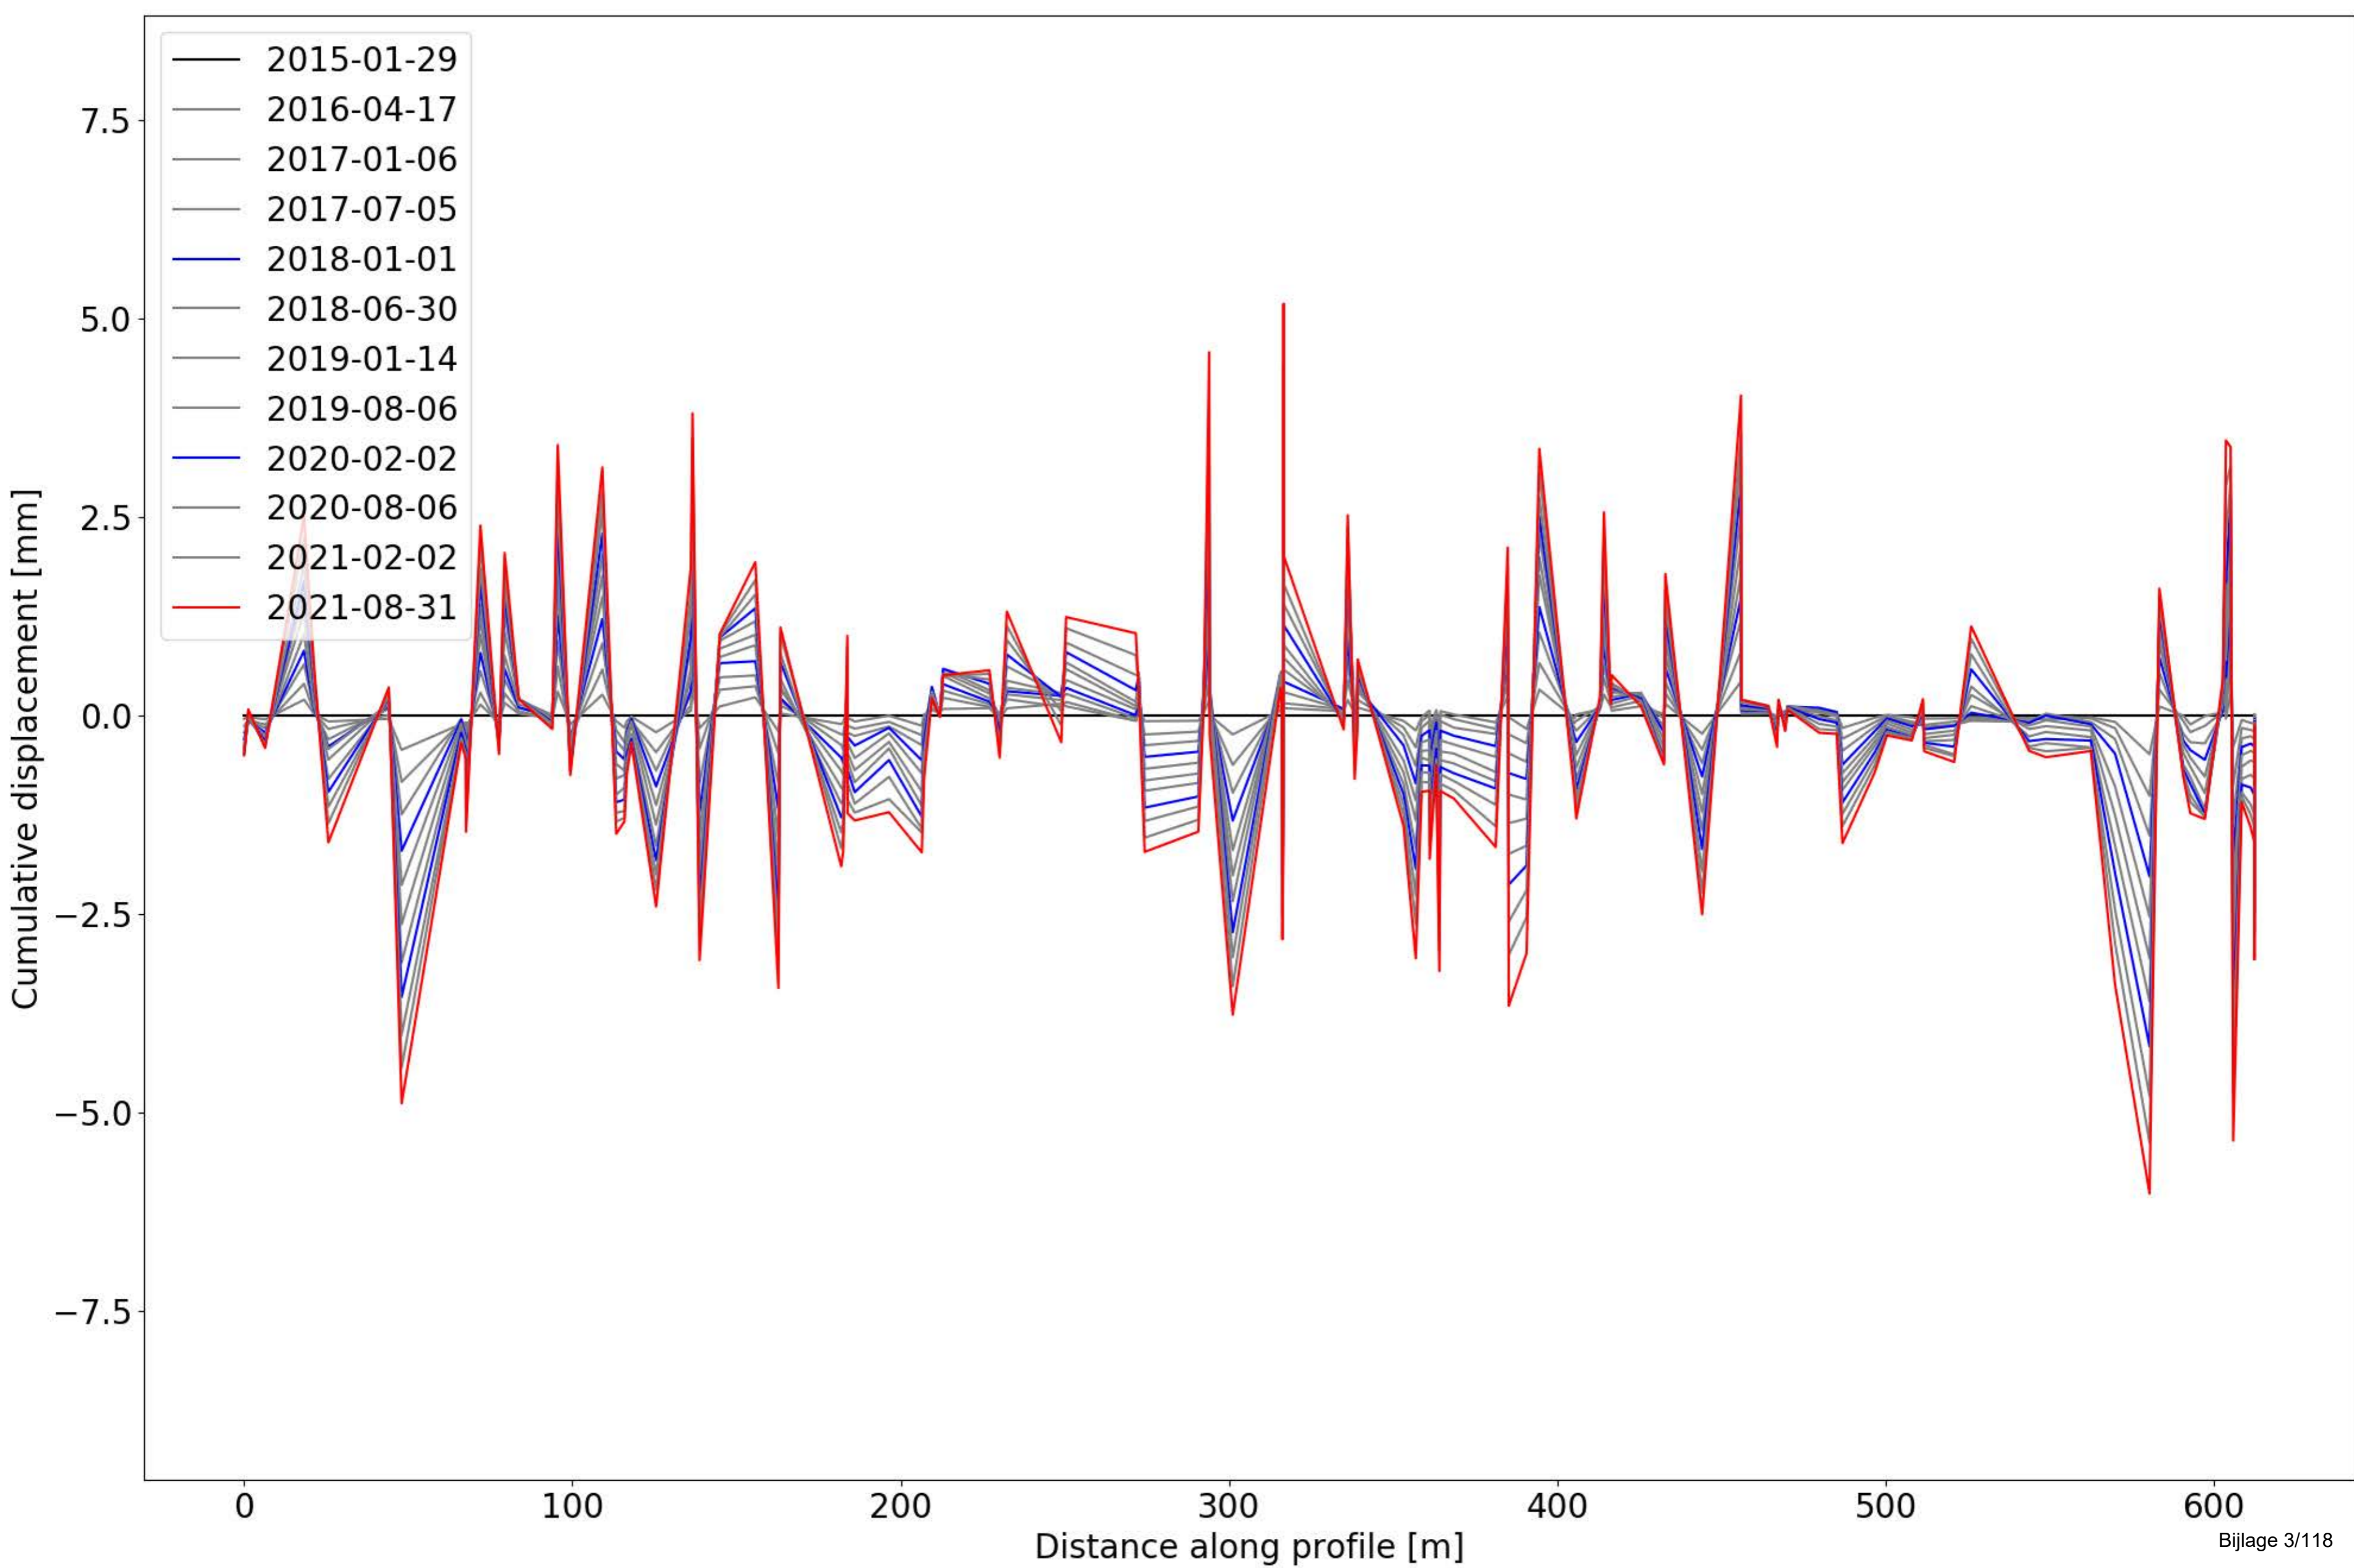
4336 Brug R21

Change detection	Approx. period	Description
Change Middle	September 2020	Increase in displacement rate from September 2020

InSAR points along the length of the bridge for all 3 datasets (TSX, S1 asc and S1 dsc), no significant gaps in the data.
