3186 Havendoklaanbrug

Change Detection

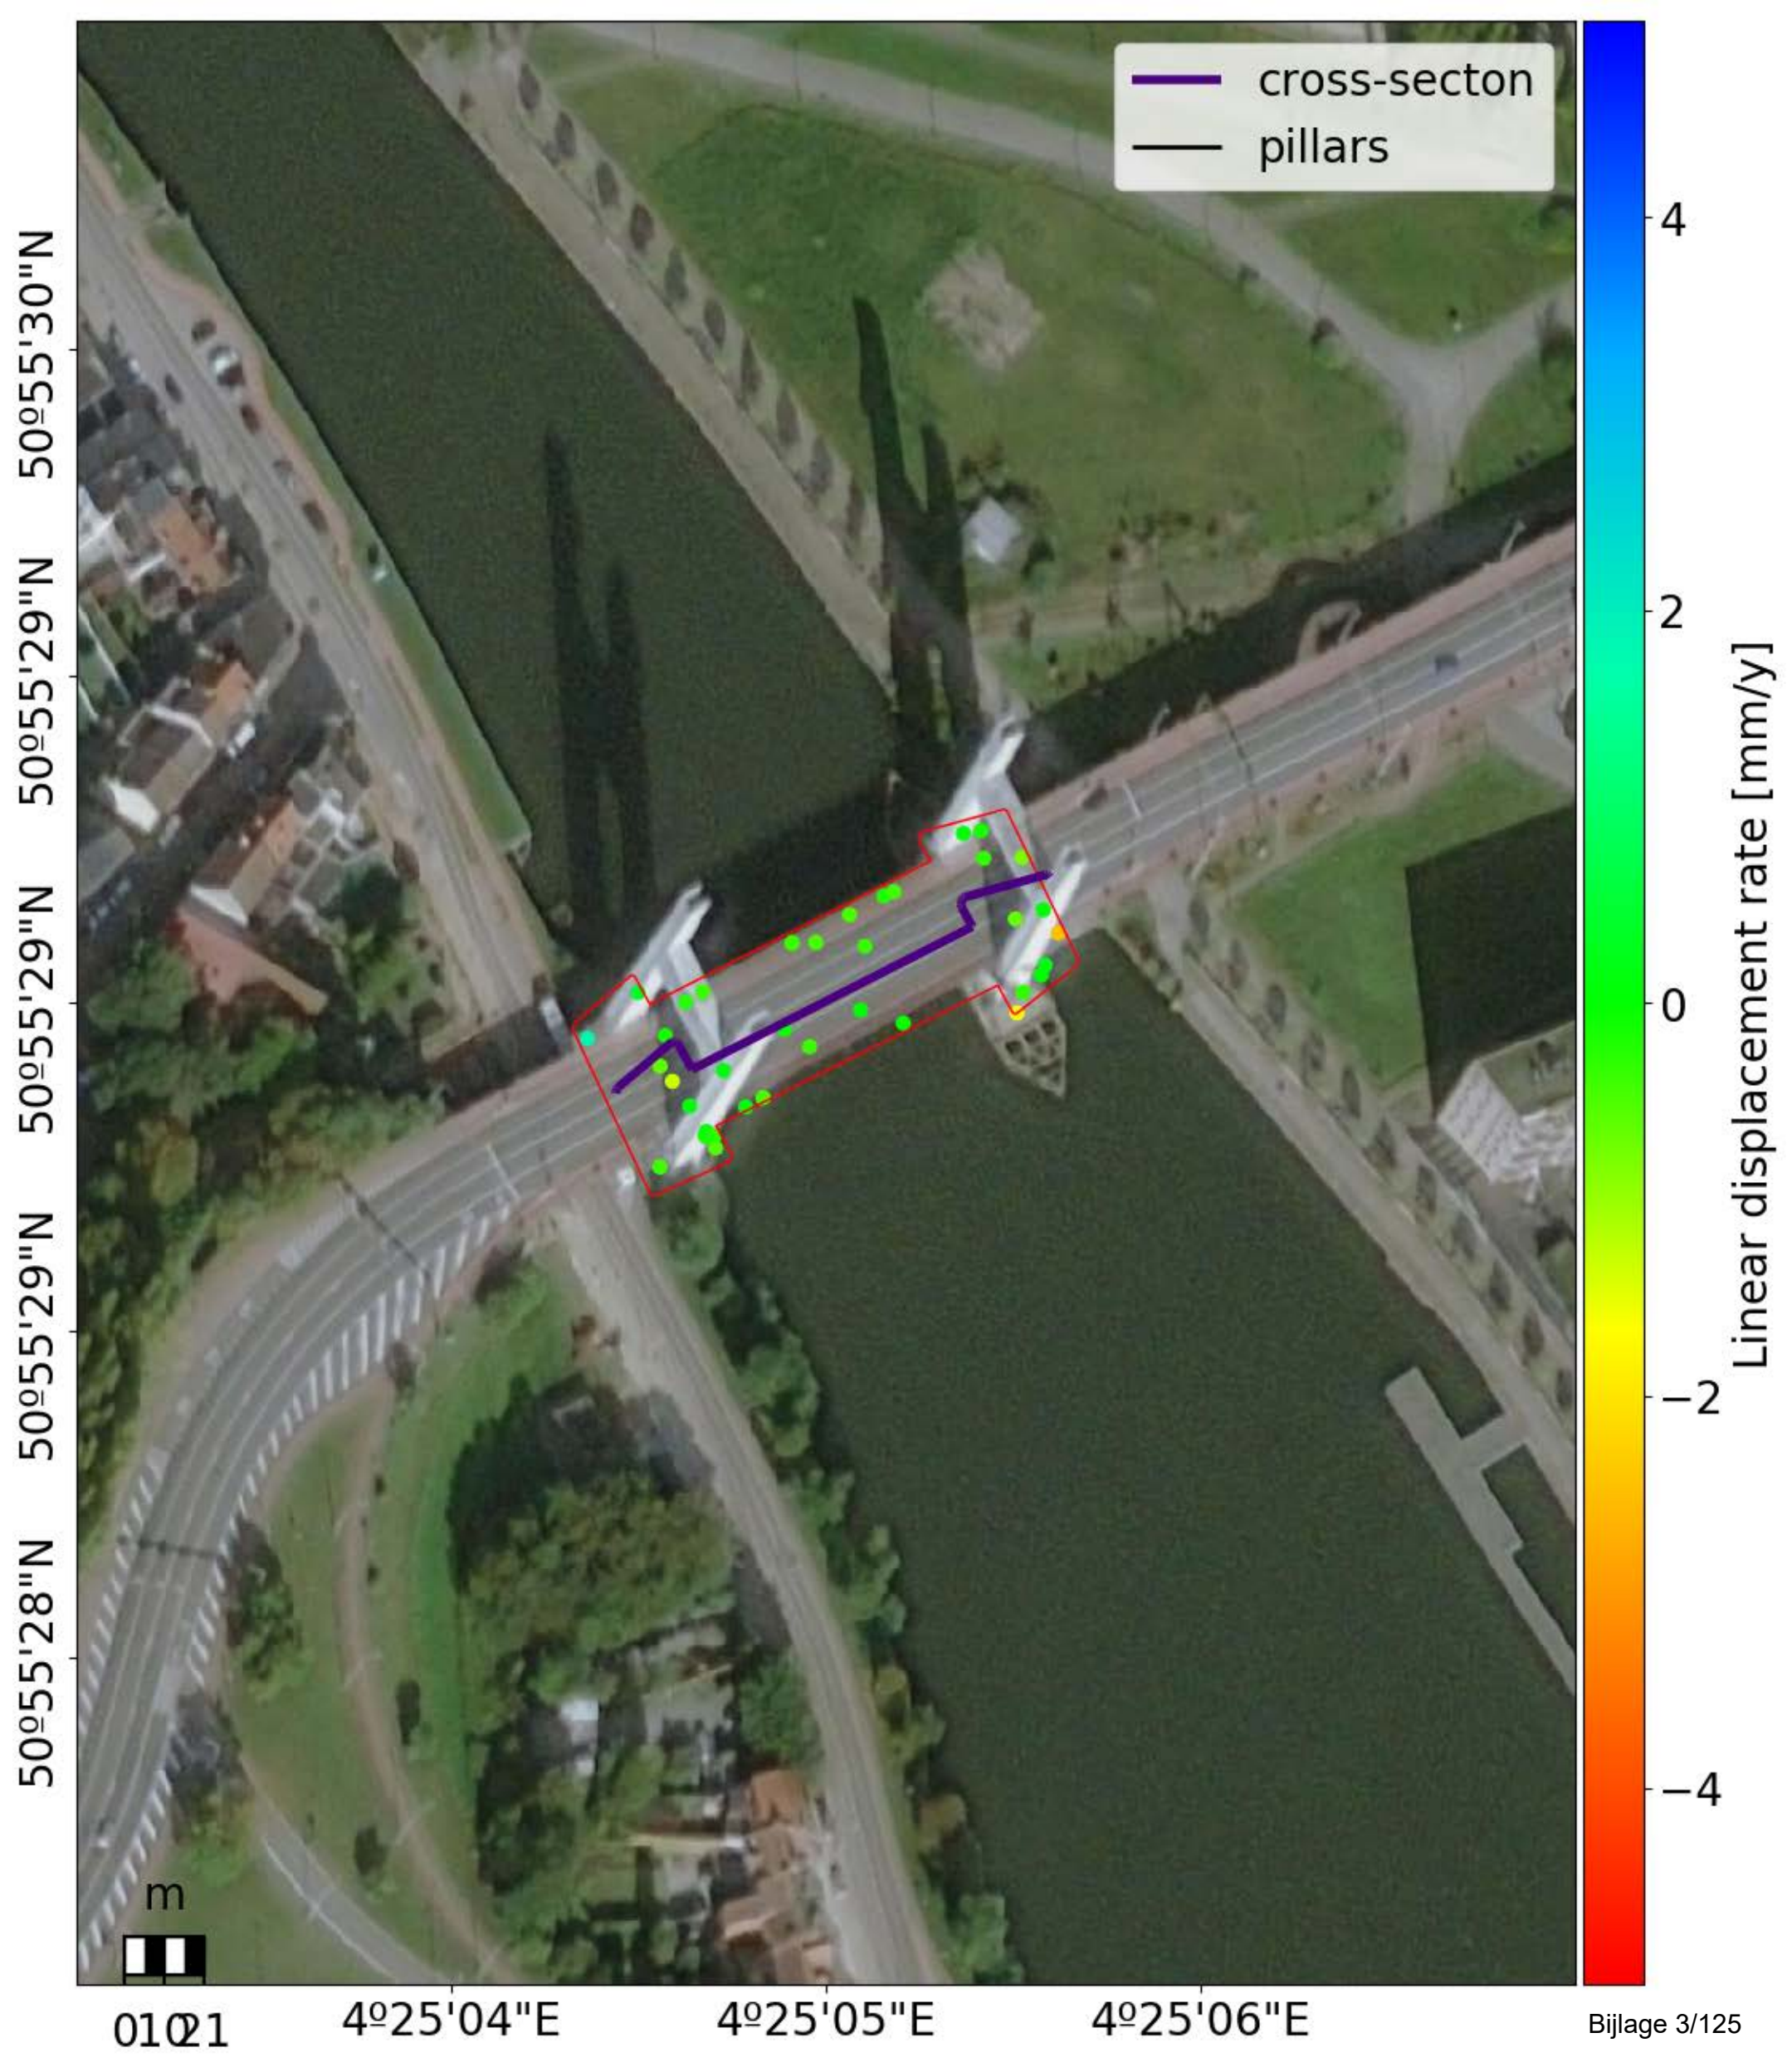
4463 Hefbrug Vilvoordebrug Vuurkruisenlaan-Rubensstraat Europabrug

Change detection	Approx. period	Description
Change Middle	December 2016	Change in amplitude after December 2016
Change Middle	August 2018	Increase in displacement rate from August 2018

All datasets have InSAR points along most of the length of the bridge, however the all datasets have a low points density/no points between the centre of the bridge and the eastern pillars. For the TSX data the gap in points can be further pinpointed to the southern lanes. This could be due to the new layer of asphalt that was completed in 2015, but it is unknown how large of an area this covered. More investigation would be required to determine the cause.

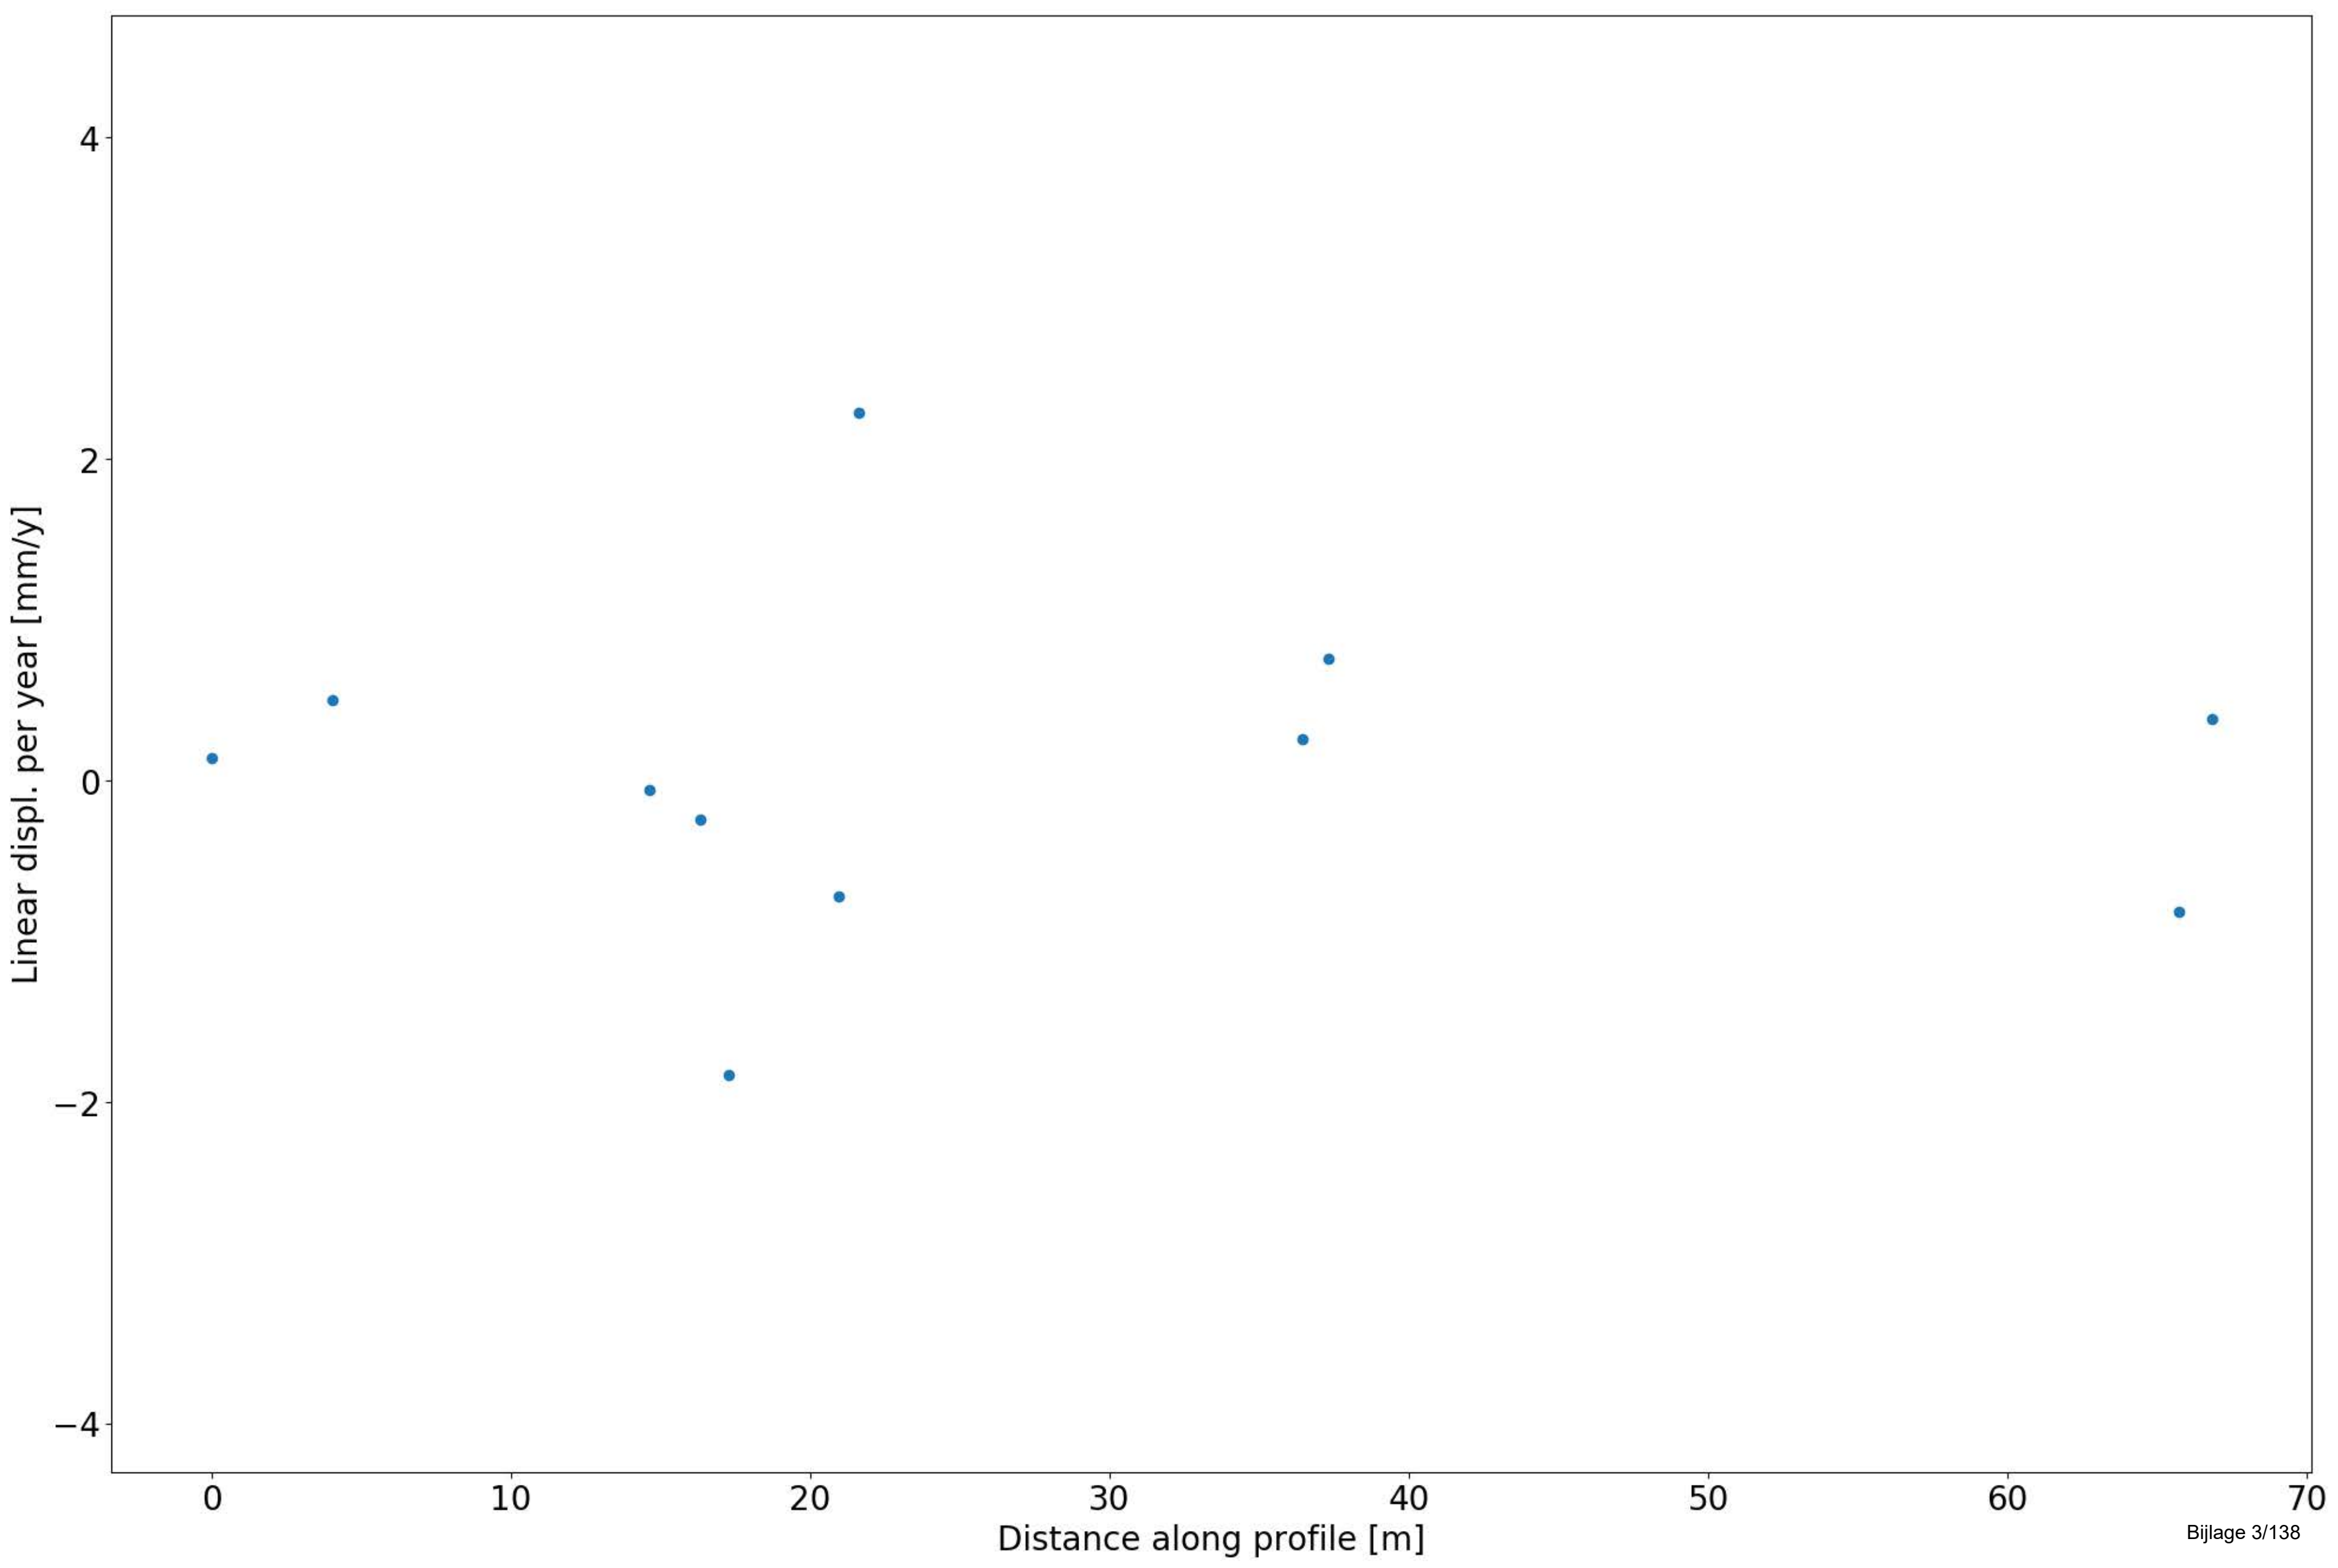
4904 Brug in N262 Parklaan over spoorweg

Change detection	Approx. period	Description
Change Middle	April 2019	Increase in displacement rate from April 2019

The middle of the eastern lane appears to have a lack of InSAR points. Points are concentrated along the safety barrier at the edges of the bridge and at the corner between the pavement curb and road. Therefore the lack of points on the eastern lane could be a geometric effect, and we would need further information on the height of the safety barriers to prove or disprove this hypothesis.

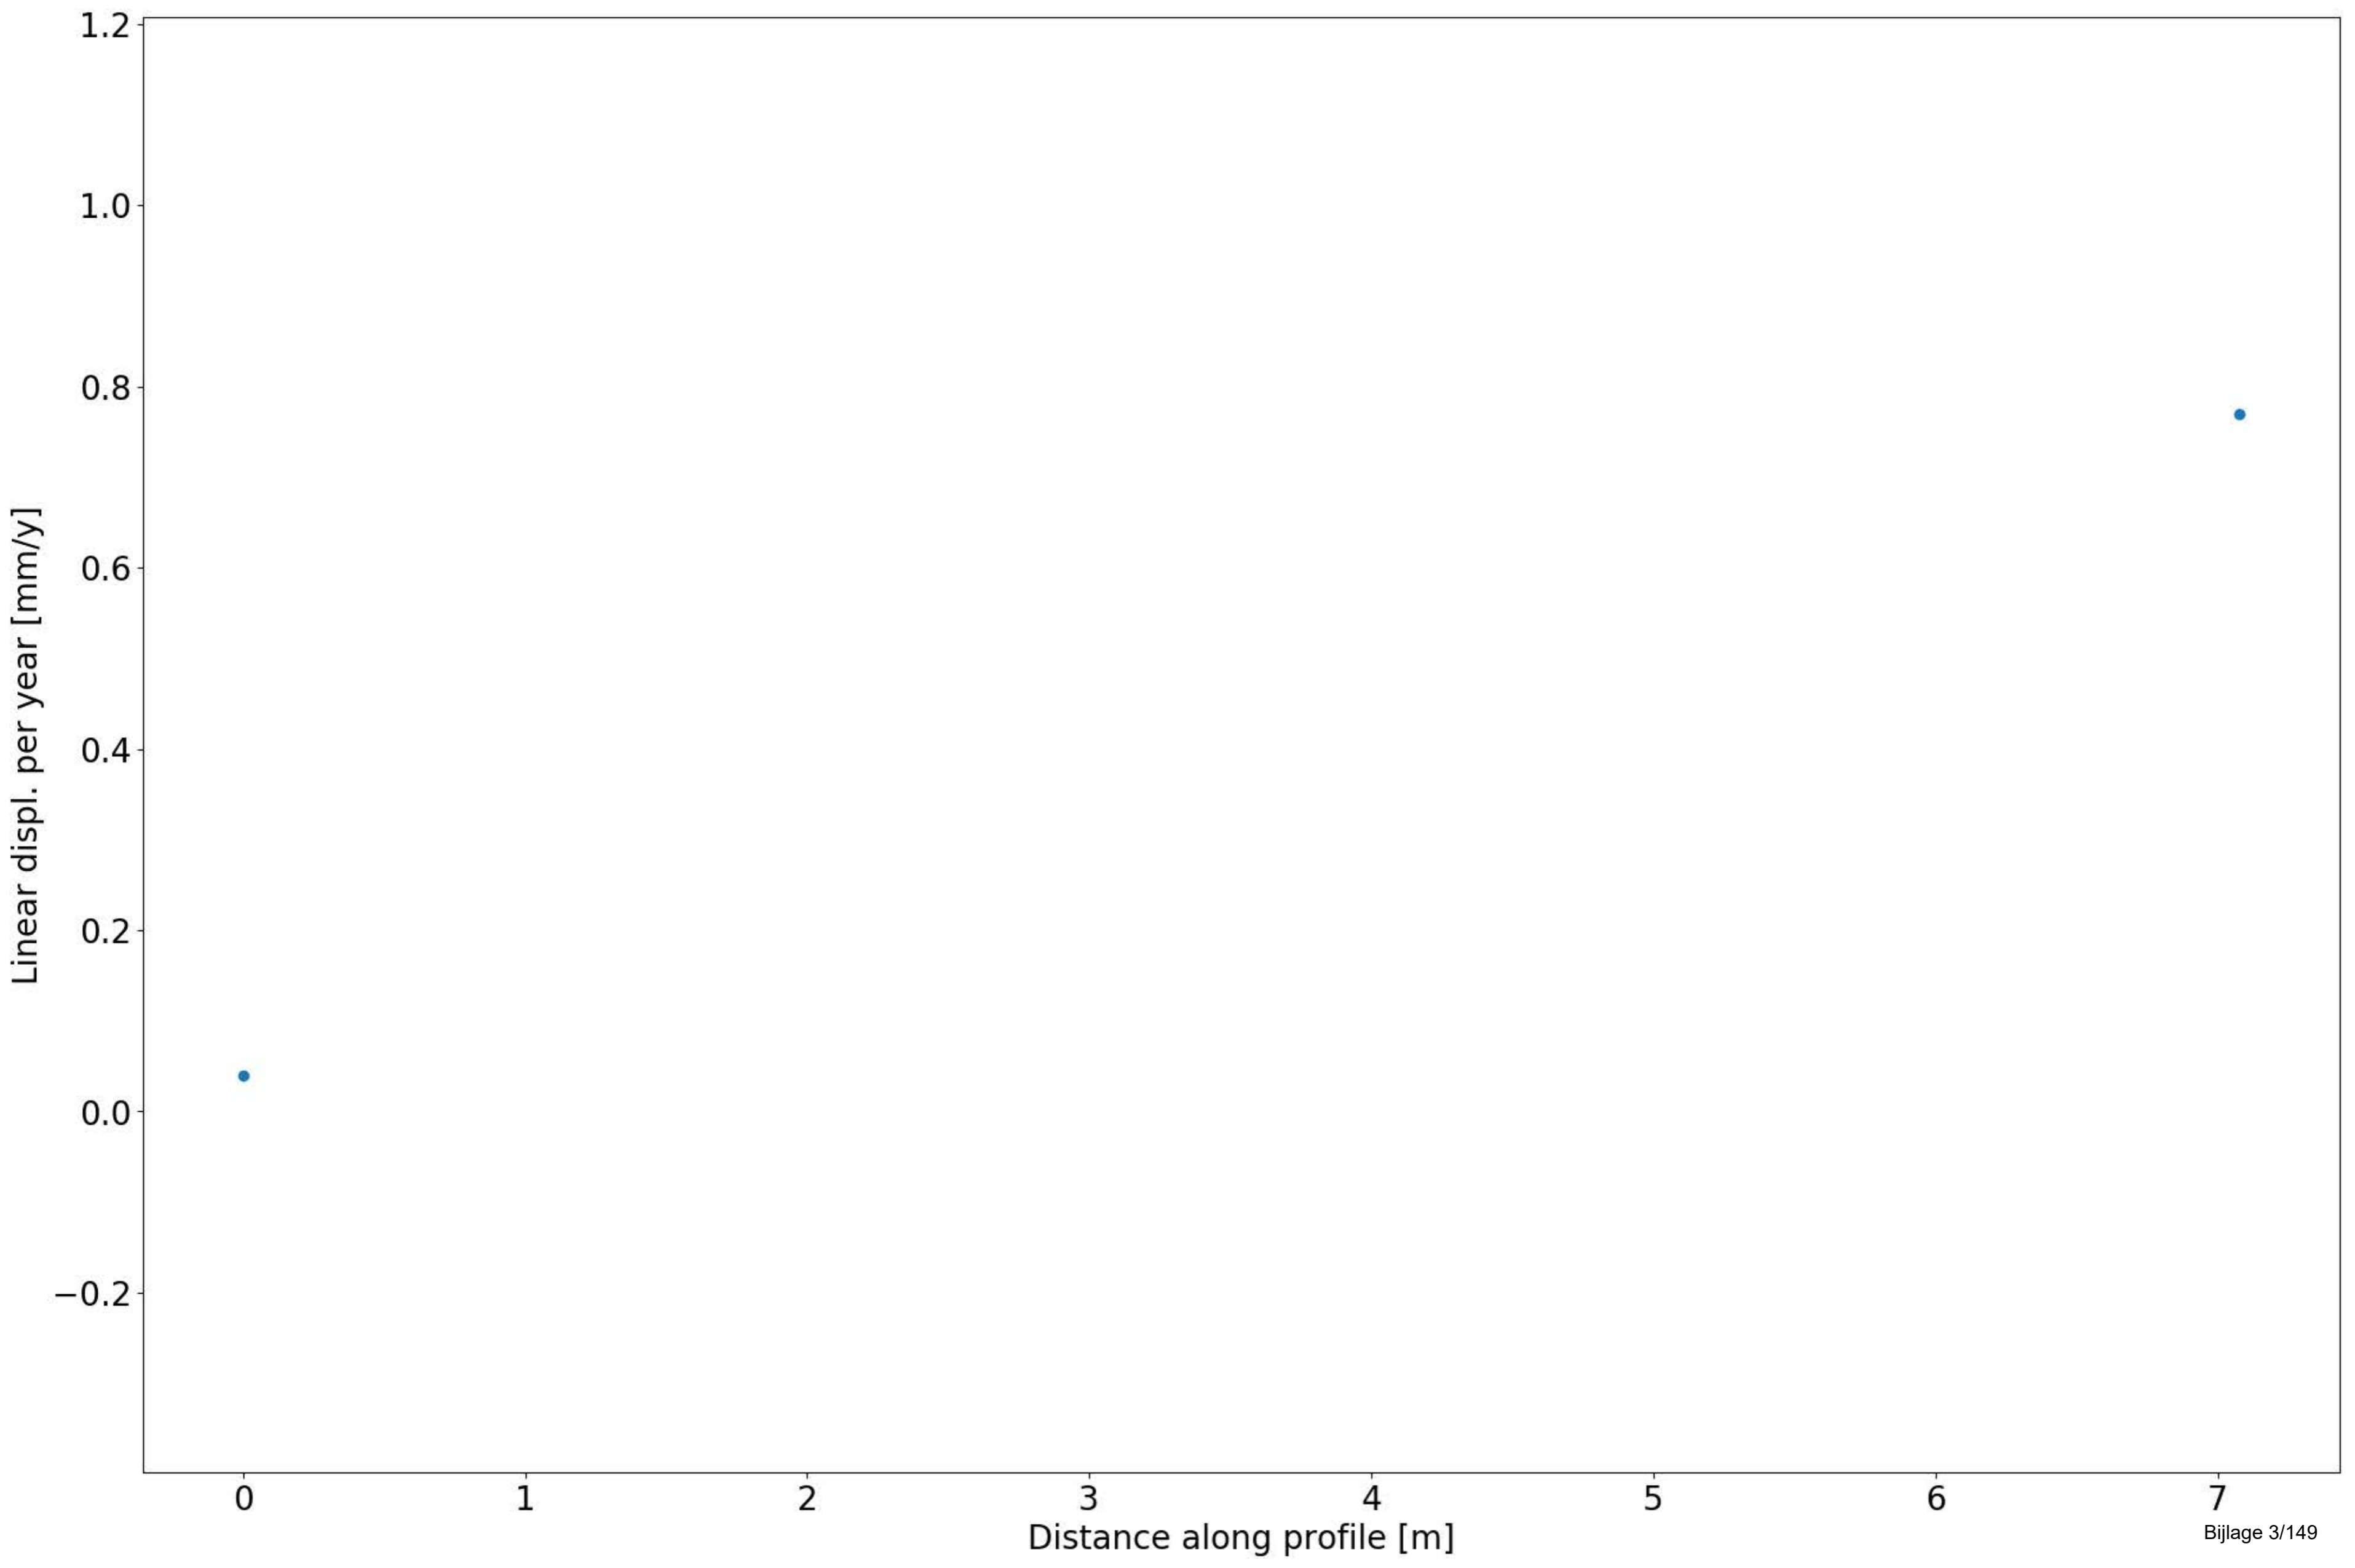
5773 Sluisstraatbrug

Change detection	Approx. period	Description
Change W	Late 2015	Increase in displacement rate from Jul 2015
Change E	spring 2017	Change in amplitude after April 2017

The TSX data has InSAR points along the full length of the bridge, no significant gaps in the data.

The S1 datasets (both ascending and descending) have very low point density (or no points) on the bridge. This is most likely due to the changes detected during the S1 time period.

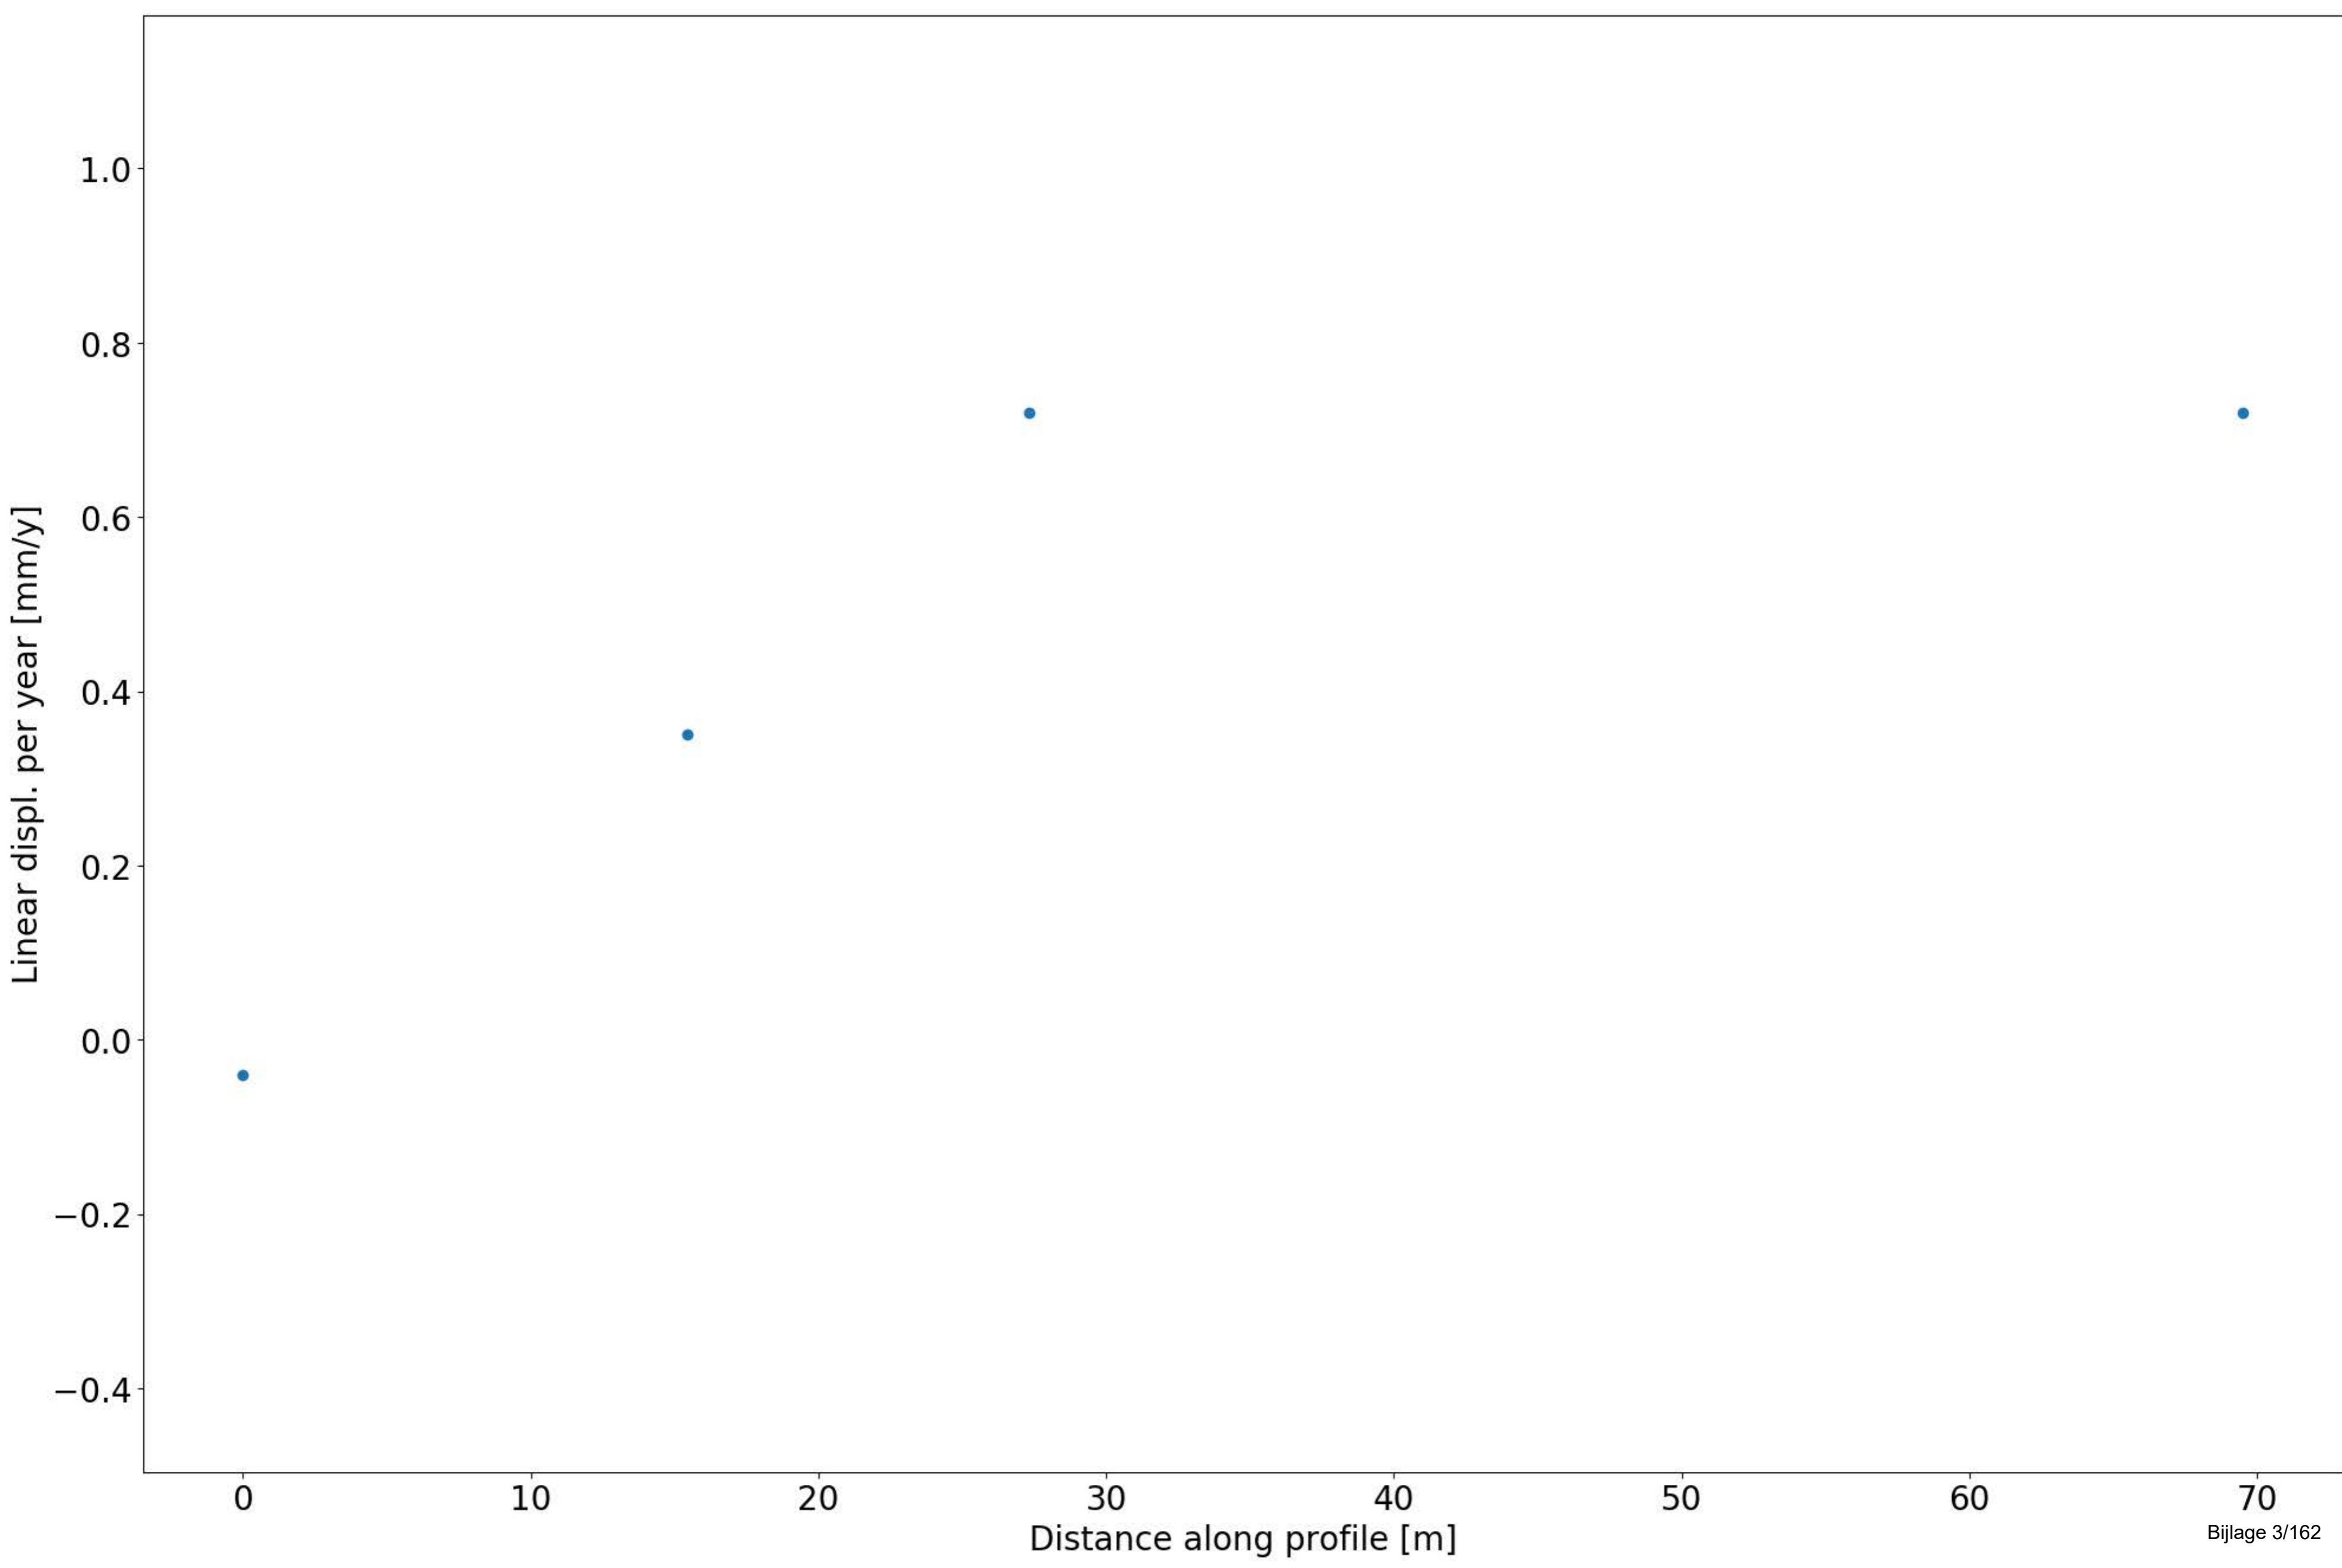
6135 Verbrande Brug

Change detection	Approx. period	Description
Change Middle	January 2020	Increase in displacement rate from January 2020
Change W	January 2020	Increase in displacement rate from January 2020

The TSX data has InSAR points along the full length of the bridge, no significant gaps in the data. The S1 ascending and descending datasets have very few points on the bridge and this is most likely related to the new top layer of asphalt which was completed in 2021,

during the time period of S1. The change to the surface results in a loss of coherence for InSAR.

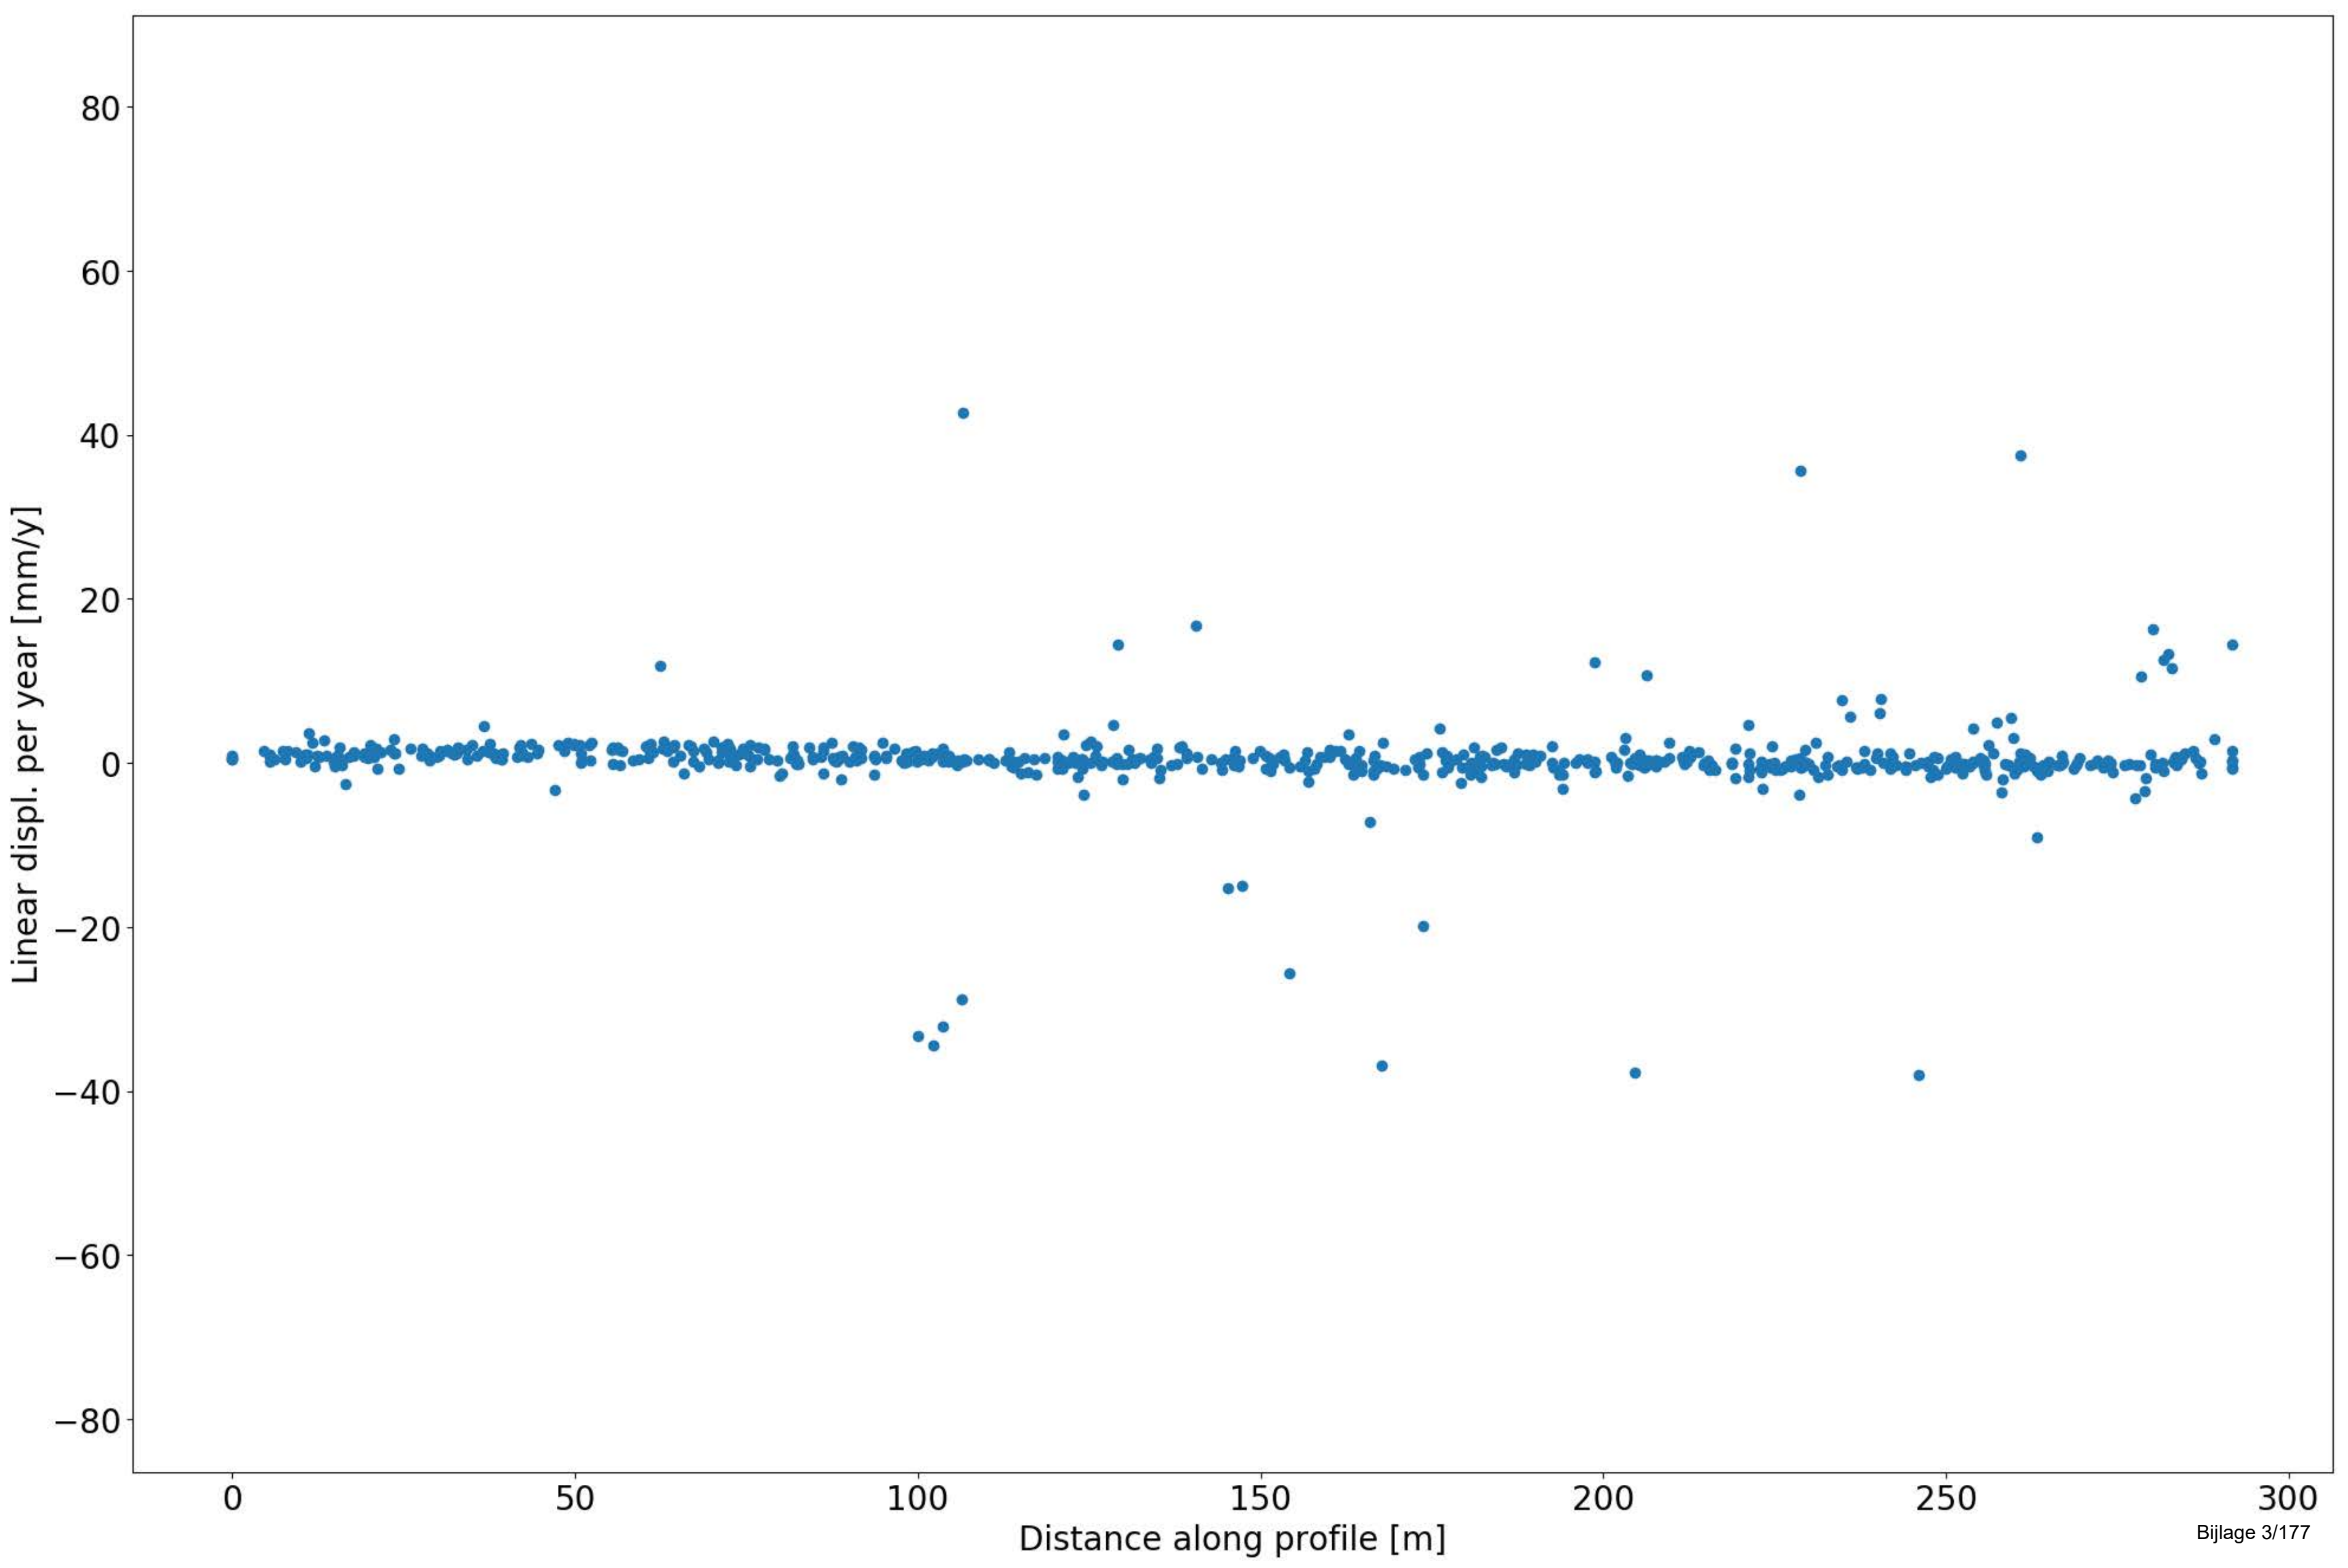
8042 Viaduct in A201 over N262

Change detection	Approx. period	Description
Change Middle	April 2018	Increase in displacement rate from April 2018
Change Middle	January 2020	Change in amplitude between April 2018 and January 2020

InSAR points along the length of the bridge for all 3 datasets (TSX, S1 asc and S1 dsc), no significant gaps in the data.

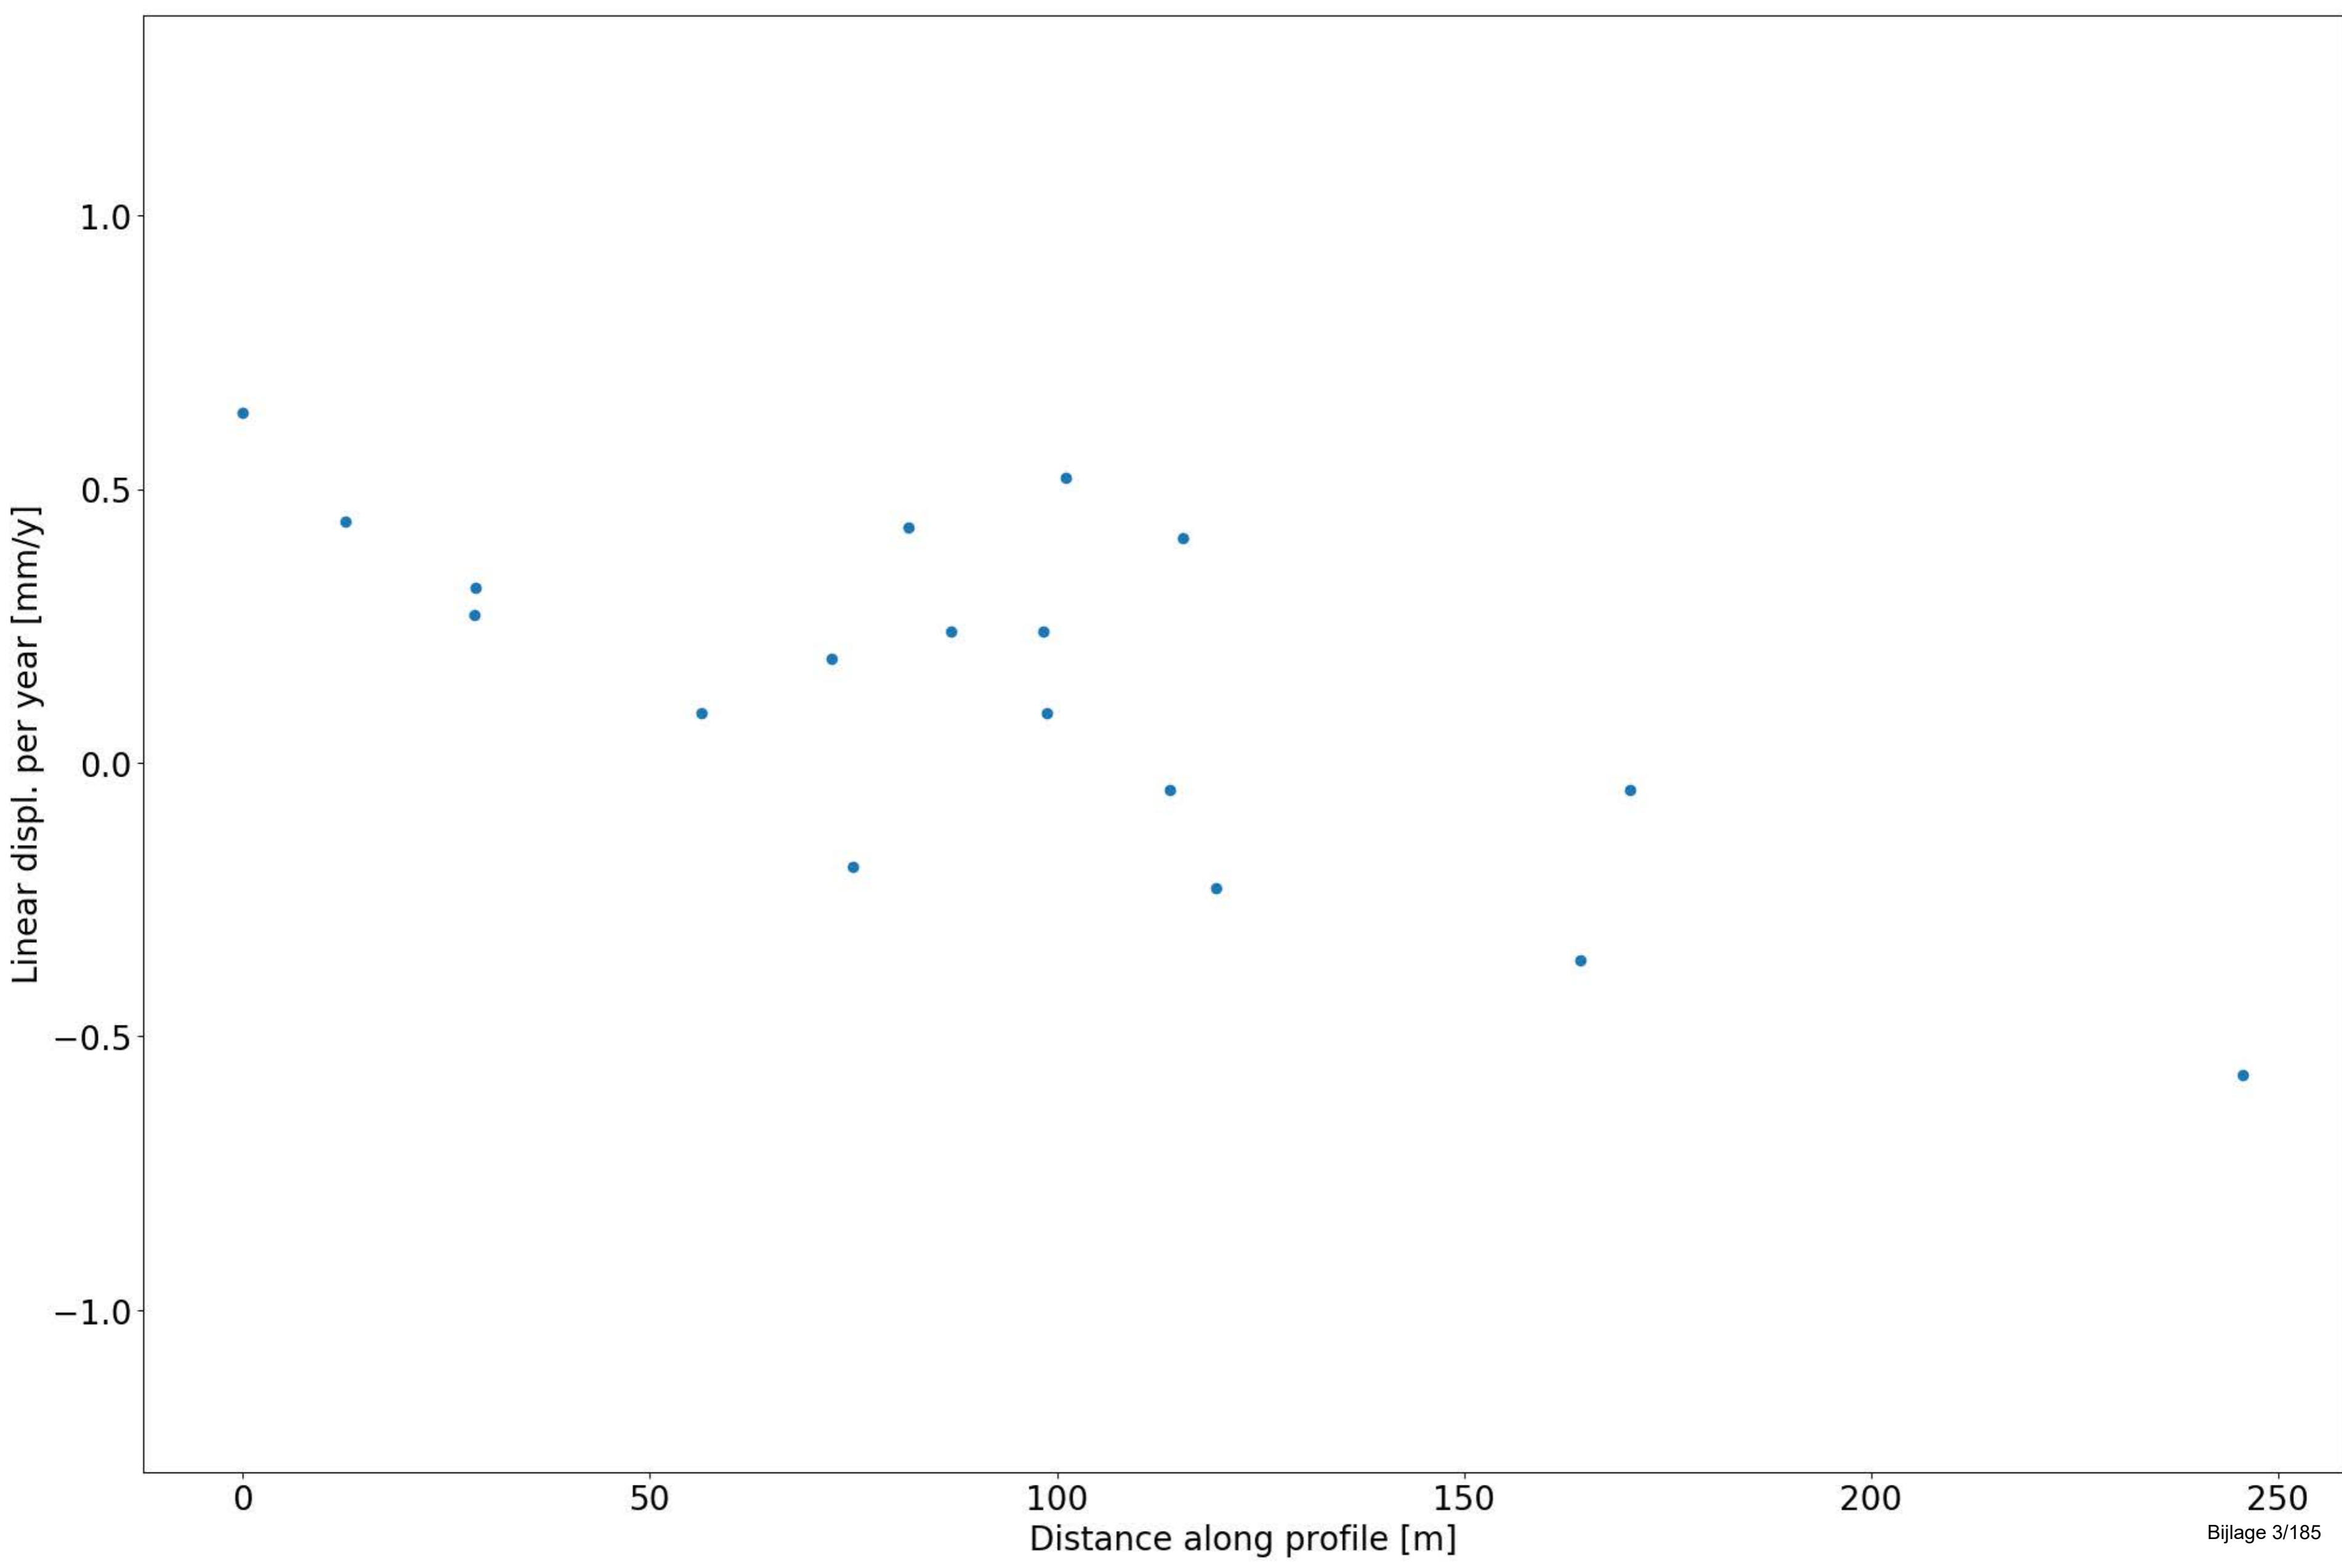
8639 Fiets- en voetbrug Schoeweever Woluwelaan

The southern end of the bridge has a lack of points in all three datasets (TSX, S1 asc and S1 dsc). This is mostly likely because it is a narrow bridge (4 m) with trees either side that S1 and TSX cannot penetrate, resulting in a loss of coherence.
