3186 Havendoklaanbrug

Change Detection

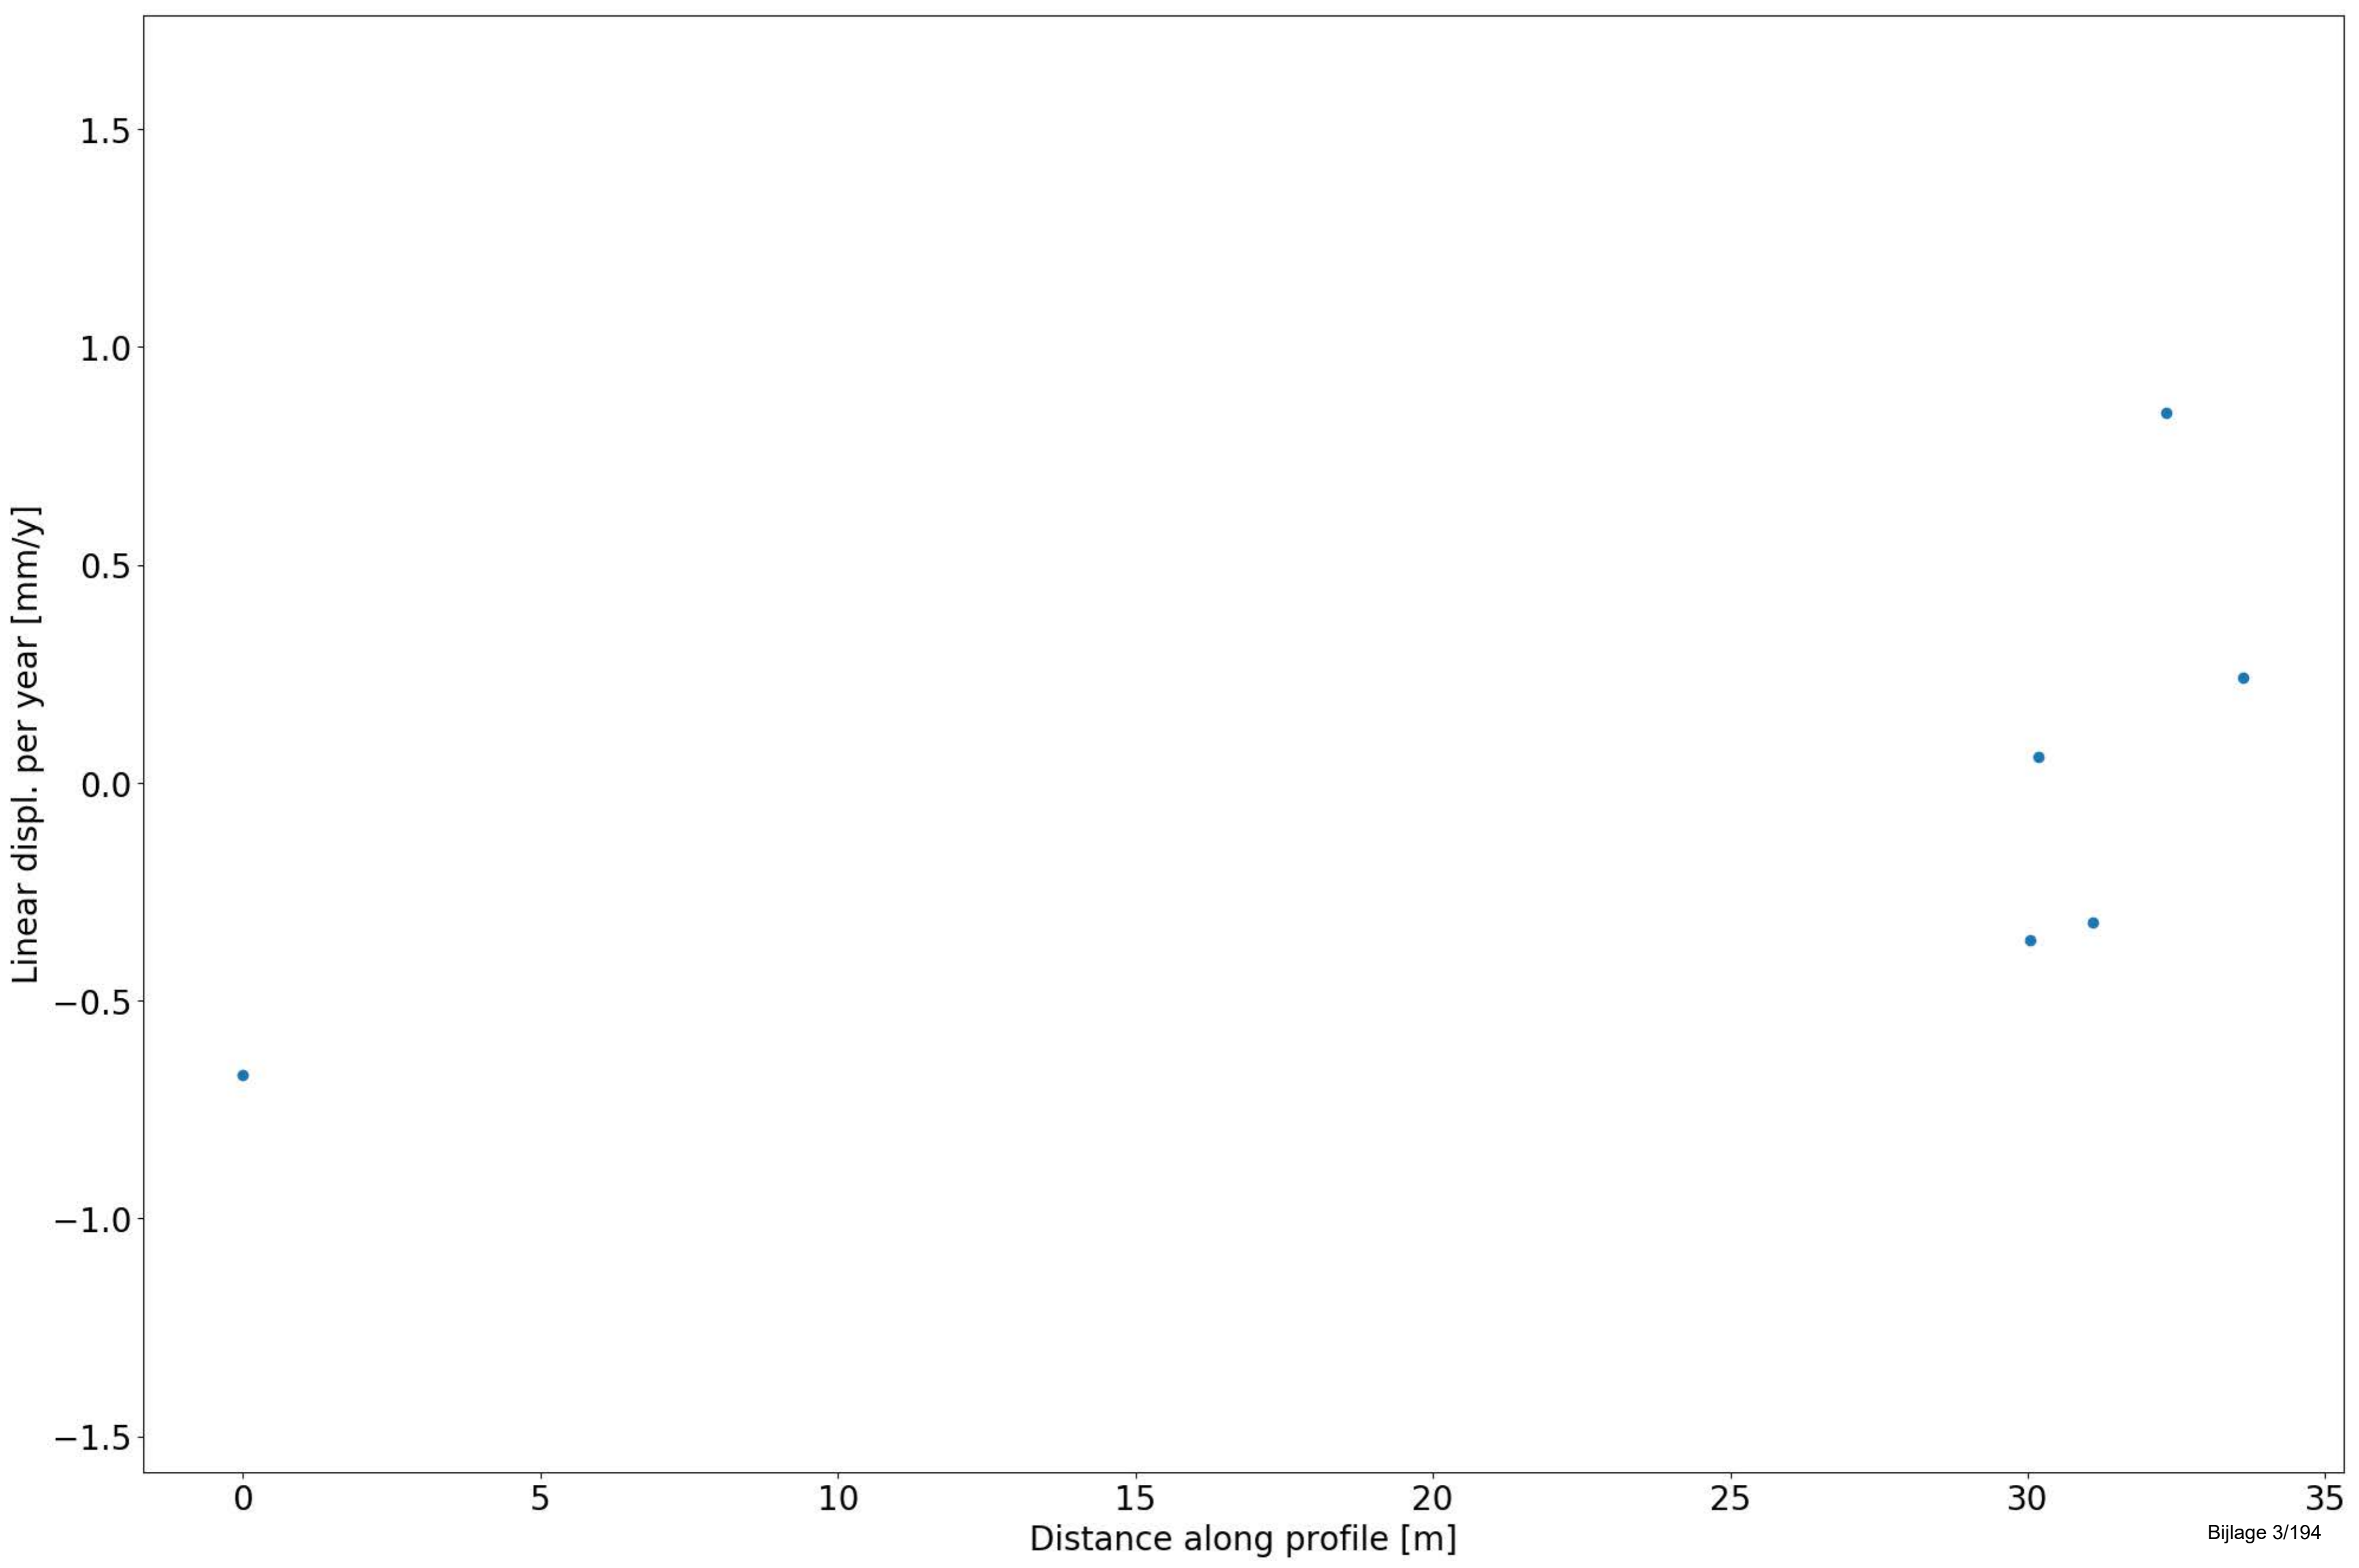
8677 Brug over de Zenne met verbindingsweg naar sluis

Change detection	Approx. period	Description
Change (all bridge)	2014 -2015	Change in amplitude during construction work (2014-2015)

Change (all bridge)	August 2018	Change in displacement rate from August 2018
---------------------	-------------	--

All three datasets have points on the abutments but not in the centre of the bridge. The bridge was built/finalised in 2014/2015 which explains the lack of data on the bridge itself, the points that are there are on the abutments/banks.

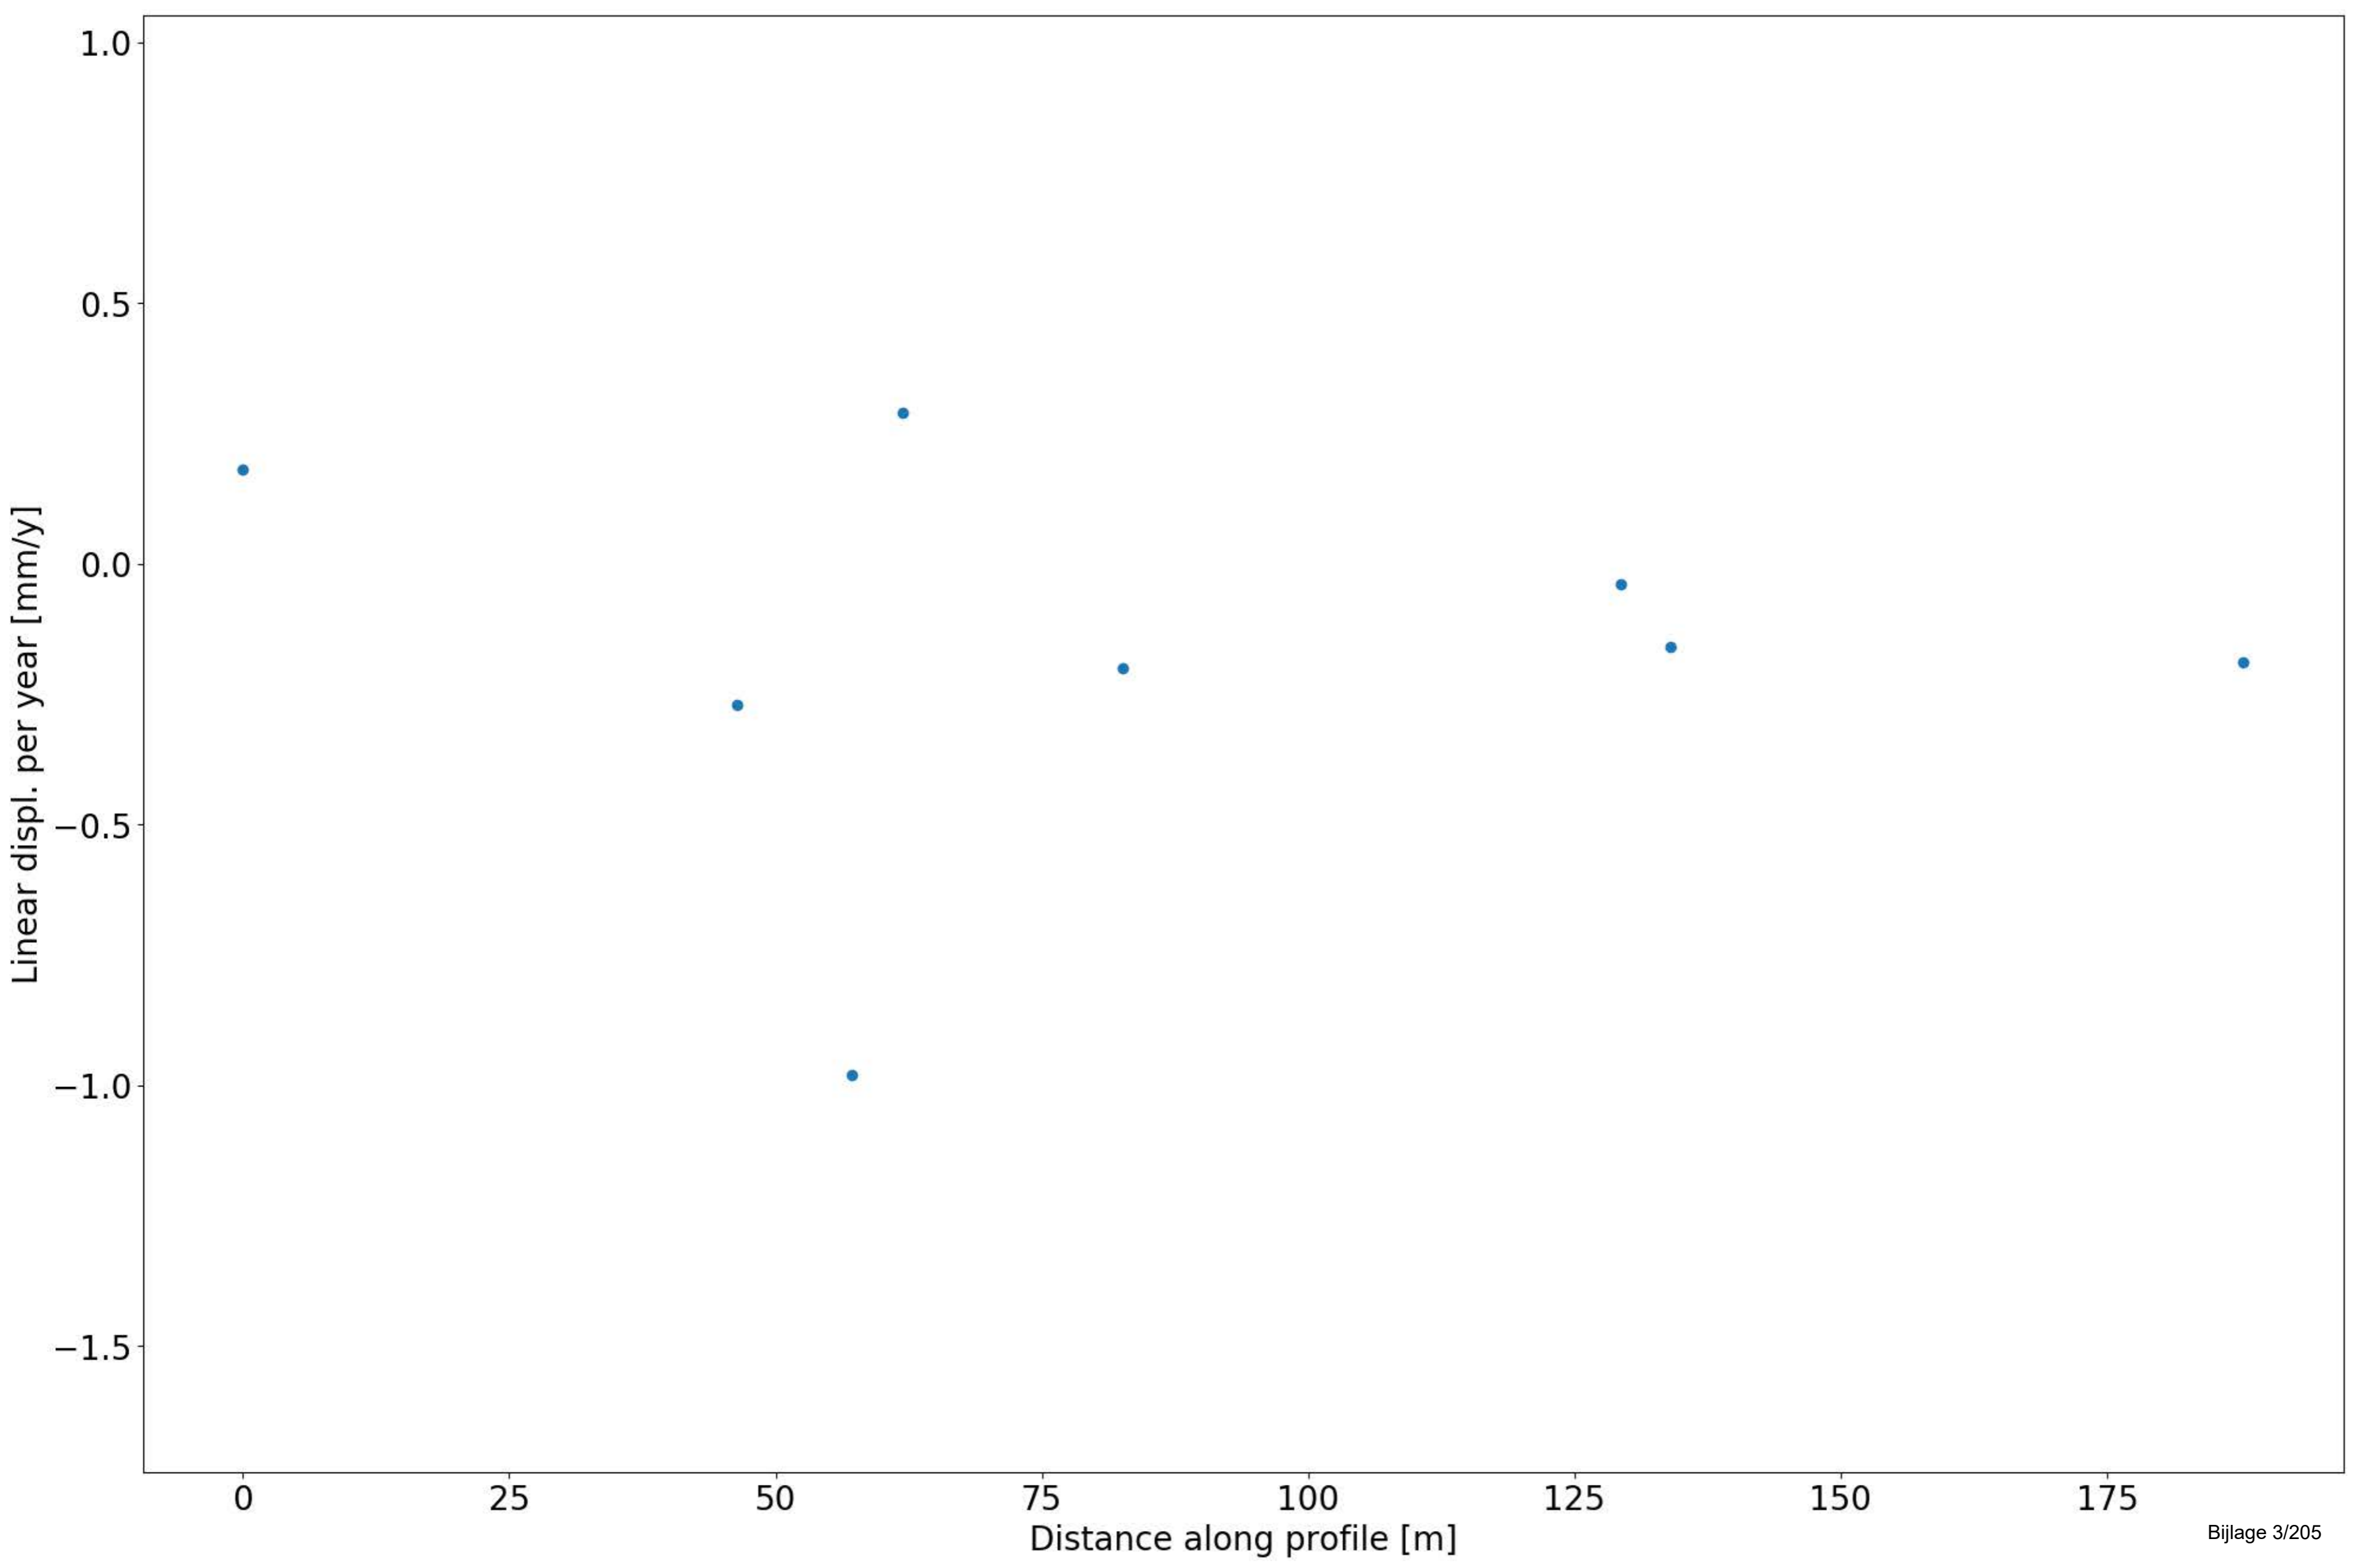
8763 Fietsbrug over E19 + Noordelijke spoorontsluiting luchthaven

Both TSX and S1 dsc have InSAR points along the length of the bridge. S1 asc has a lack of points to the western end. No changes were detected and no maintenance works recorded, so the reason for the lack of points is uncertain.

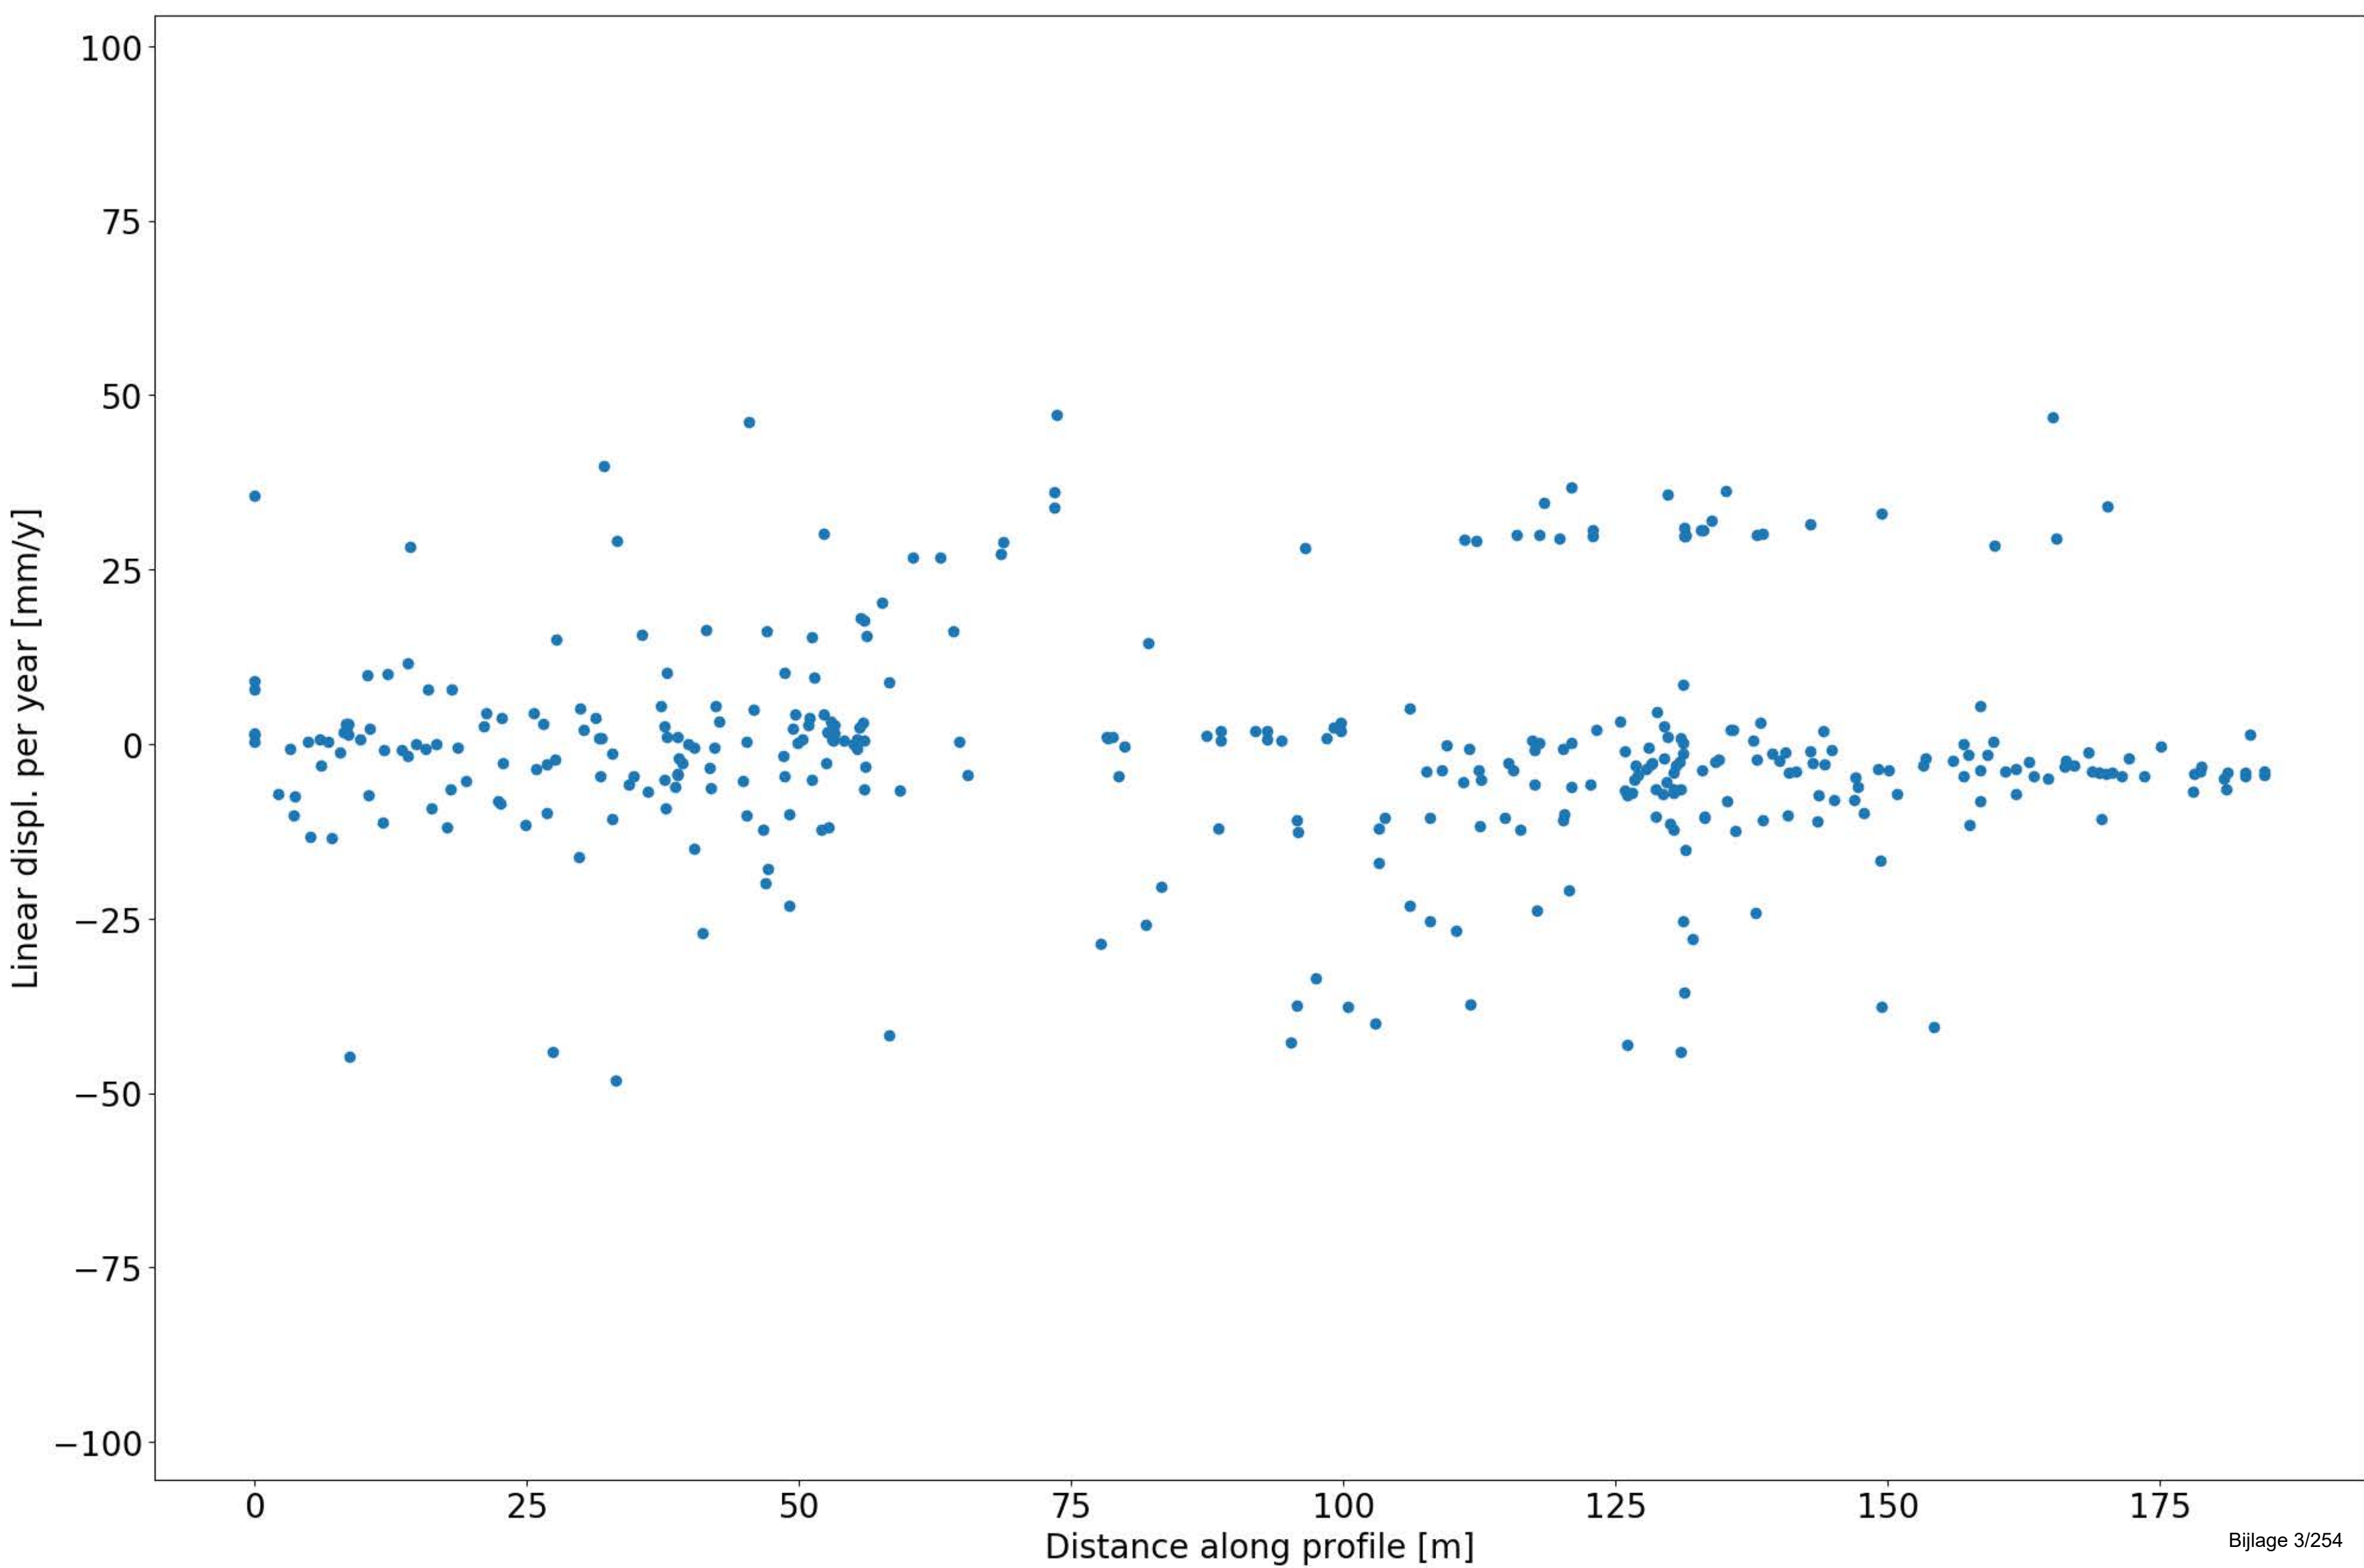
9105 Spoorwegbrug in Spoorlijn 25N over R22

Change detection	Approx. period	Description
Change	Since 2016	Differential movement in different bridge blocks

InSAR points along the length of the bridge for all three datasets (TSX, S1 asc and S1 dsc), no significant gaps in the data.
