TerraSAR-X analysis - Bridge N°18 Year of construction: 1976

2014.06.13 - 2016.03.23

Sentinel-1 analysis - Bridge N° 1 Year of construction: 1948

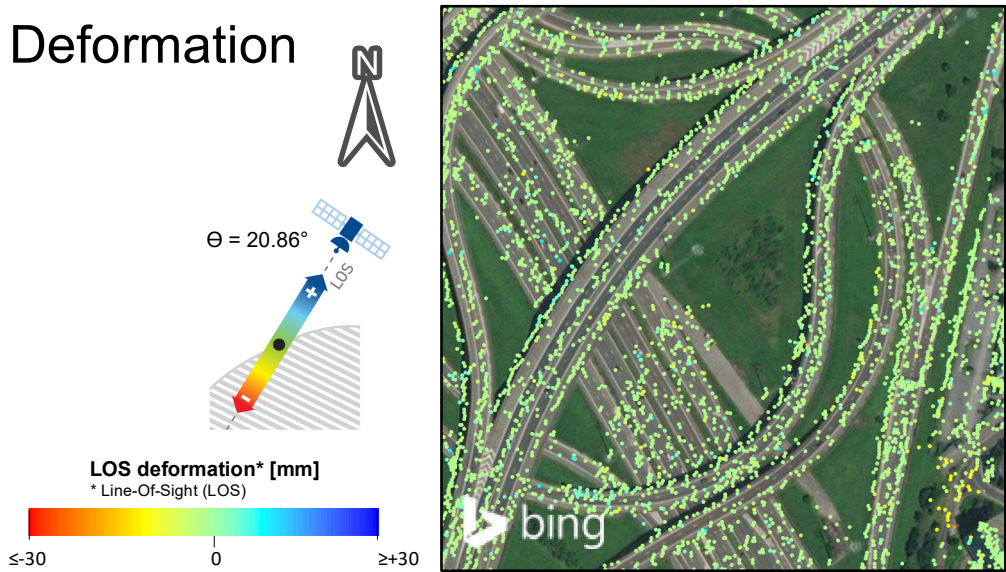
Deformation

MP count 402	Avg_displ 0,52 mm	Avg_stdef 1,69 mm
PS count 315	Min_displ -15,1 mm	Min_stdef 0,4 mm
DS count 87	Max_displ 9,3 mm	Max_stdef 3,7 mm
	Std_displ 3,21 mm	
Avg_vel -0,08 mm/yr	Avg_seas 1,04 mm	
Min_vel -5,9 mm/yr	Min_seas 0,04 mm	
Max_vel 5 mm/yr	Max_seas 8,47 mm	
Vel_std 1,17 mm/yr	Std_seas 0,81 mm

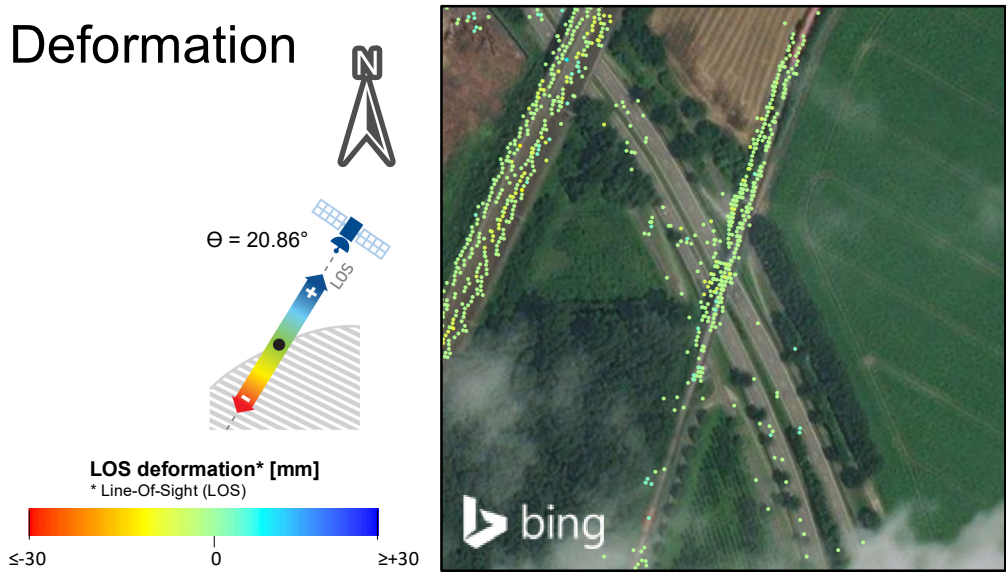
Deformation

MP count	167	Avg_displ	0,02 mm	Avg_stdef	1,4 mm
PS count	152	Min_displ	-9,8 mm	Min_stdef	0,6 mm
DS count	15	Max_displ	7,3 mm	Max_stdef	3,1 mm
		Std_displ	2,64 mm		
Avg_vel	-0,29 mm/yr	Avg_seas	0,88 mm		
Min_vel	-2,9 mm/yr	Min_seas	0,05 mm		
Max_vel	2,2 mm/yr	Max_seas	4,16 mm		
Vel_std	0,66 mm/yr	Std_seas	0,53 mm

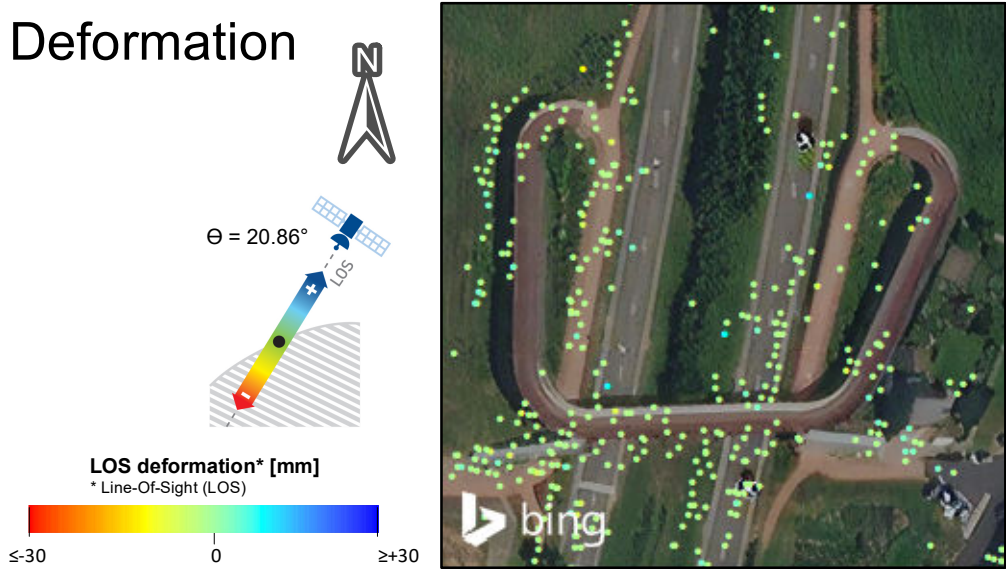
Deformation

MP count	73	Avg_displ	0,21 mm	Avg_stdef	1,84 mm
PS count	70	Min_displ	-9,9 mm	Min_stdef	0,7 mm
DS count	3	Max_displ	8,4 mm	Max_stdef	3 mm
		Std_displ	2,95 mm		
Avg_vel	-0,11 mm/yr	Avg_seas	1,08 mm		
Min_vel	-3,7 mm/yr	Min_seas	0,23 mm		
Max_vel	2,2 mm/yr	Max_seas	3,57 mm		
Vel_std	0,93 mm/yr	Std_seas	0,75 mm

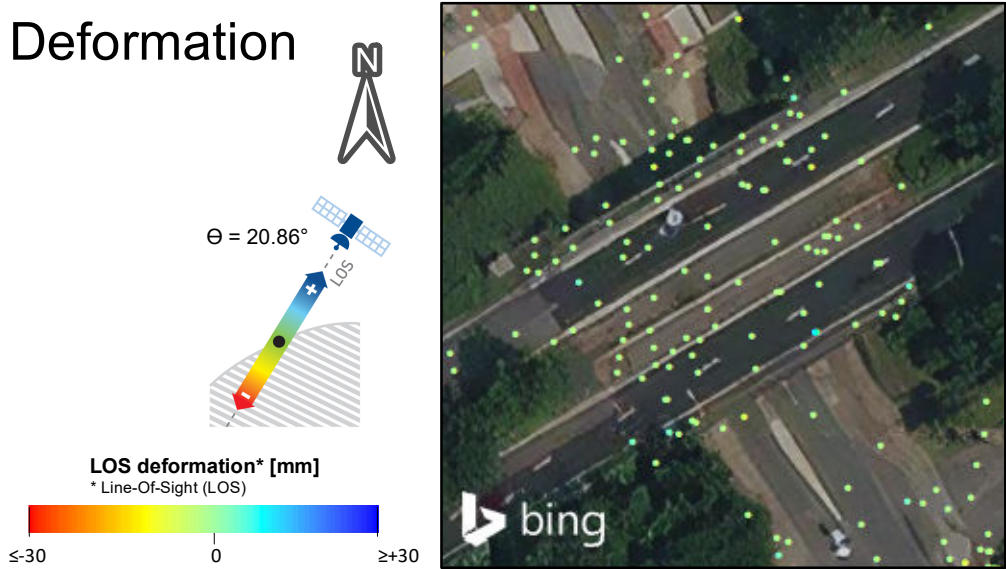
Deformation

MP count	97	Avg_displ	1,54 mm	Avg_stdef	1,57 mm
PS count	47	Min_displ	-6,4 mm	Min_stdef	0,7 mm
DS count	50	Max_displ	10,9 mm	Max_stdef	3,2 mm
		Std_displ	2,43 mm		
Avg_vel	-0,08 mm/yr	Avg_seas	0,69 mm		
Min_vel	-2 mm/yr	Min_seas	0,11 mm		
Max_vel	1,8 mm/yr	Max_seas	2,28 mm		
Vel_std	0,64 mm/yr	Std_seas	0,45 mm

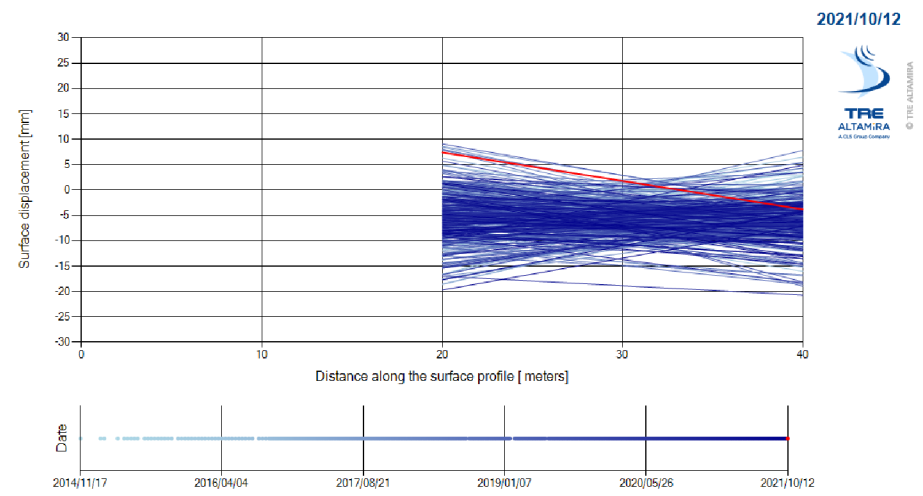
Deformation Profile*

MP count	2	Avg_displ	1,8 mm	Avg_stdef	4,75 mm
PS count	2	Min_displ	-3,8 mm	Min_stdef	4,3 mm
DS count	0	Max_displ	7,4 mm	Max_stdef	5,2 mm
		Std_displ	5,6 mm		
Avg_vel	-0,2 mm/yr	Avg_seas	0,25 mm		
Min_vel	-0,5 mm/yr	Min_seas	0,07 mm		
Max_vel	0,1 mm/yr	Max_seas	0,43 mm		
Vel_std	0,3 mm/yr	Std_seas	0,18 mm

* From west to east or/and south to north

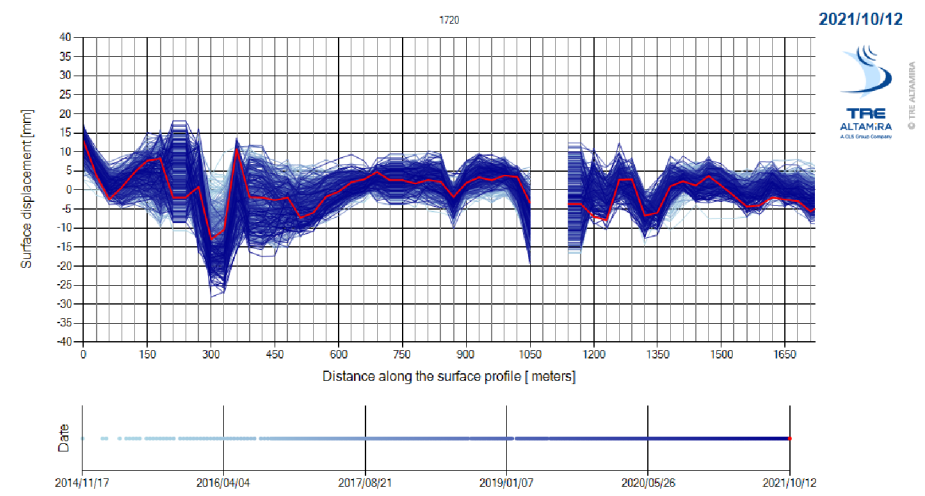
Deformation Profile*

MP count 302	Avg_displ 0,3 mm	Avg_stdef 5,01 mm
PS count 298	Min_displ -28,7 mm	Min_stdef 1,4 mm
DS count 4	Max_displ 25,3 mm	Max_stdef 7,2 mm
	Std_displ 8,11 mm	
Avg_vel -0,05 mm/yr	Avg_seas 2,07 mm	
Min_vel -4,6 mm/yr	Min_seas 0,08 mm	
Max_vel 2 mm/yr	Max_seas 6,65 mm	
Vel_std 0,85 mm/yr	Std_seas 1,35 mm

* From west to east or/and south to north
