3186 Havendoklaanbrug

Change Detection

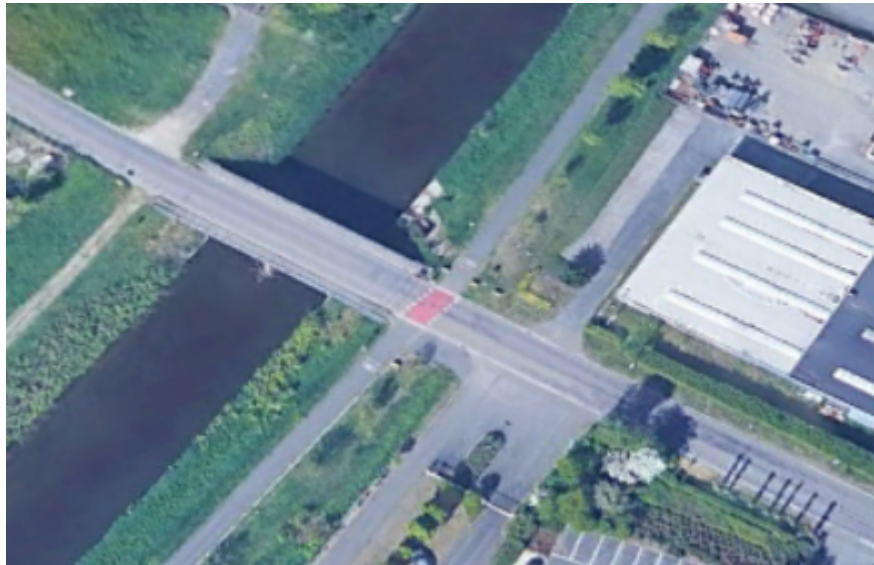
Change detection	Approx. period	Description
Change SE	April 2016	Change in displacement rate after April 2016
Change SE	April 2016	Change in amplitude after April 2016

For the TSX dataset, there are InSAR points along the full length of the bridge, no significant gaps in the data. The S1 datasets have very few points, which is likely associated with the changes detected on this bridge.

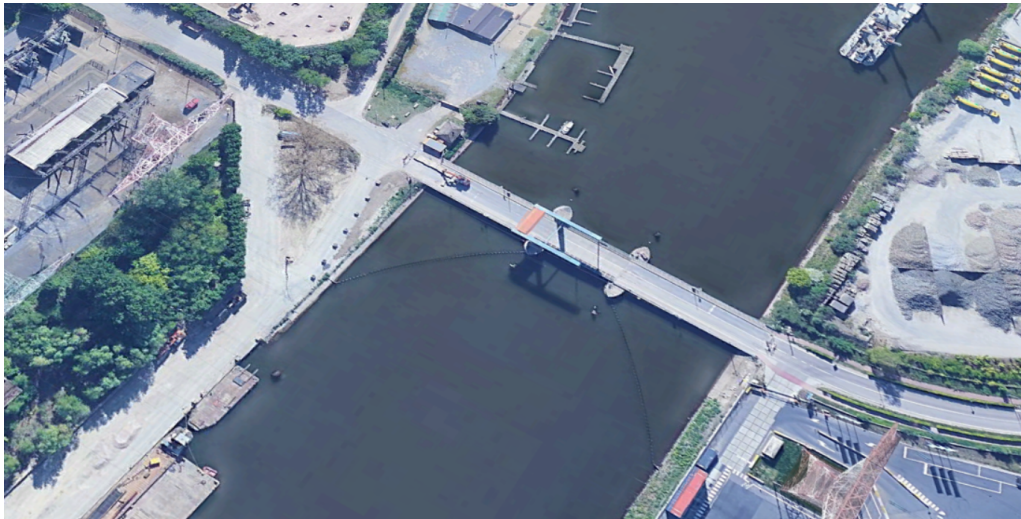
3187 Willemsbrug

No change was detected for this bridge.

All datasets have InSAR points along the full length of the bridge, no significant gaps in the data.

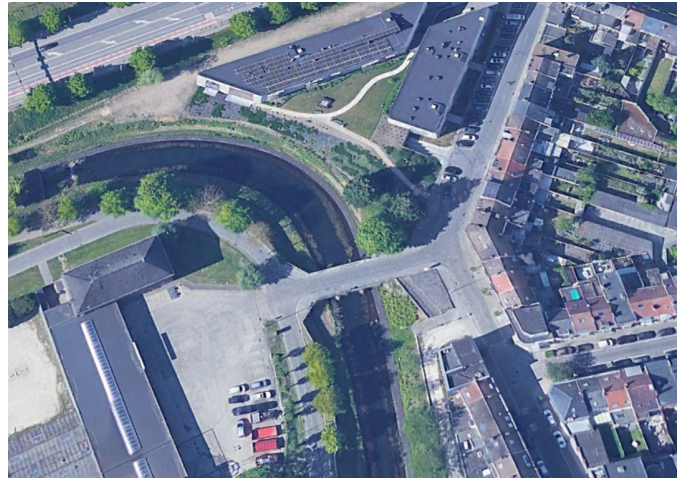
3189 Tuchthuisbrug

No change was detected.

The TSX data has InSAR points along the full length of the bridge, no significant gaps in the data. However, the S1 datasets have just one or two points. The reason for this lack of points is currently unknown, since no maintenance works were recorded, no changes detected and it has no strong seasonal component. Further investigation would be needed to assess the causes.

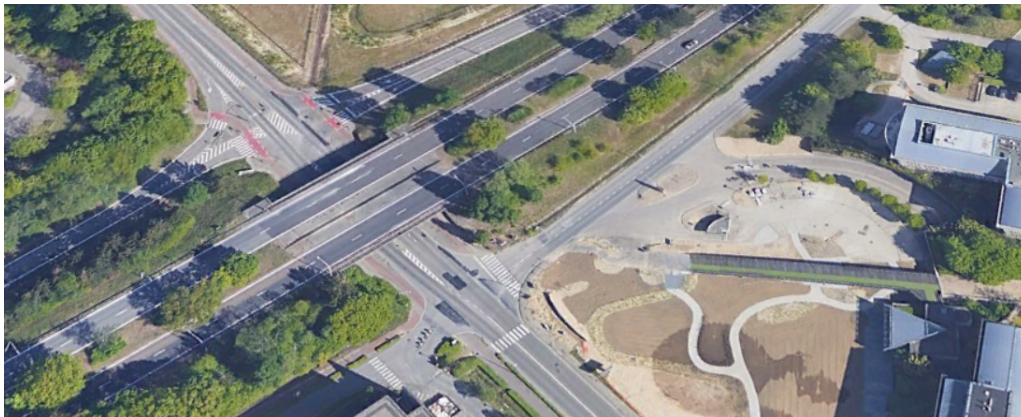
3590 Brug 1 over de J. F. Kennedylaan Grensstraat

Change detection	Approx. period	Description
Change NE	Since September 2016	Change in amplitude after September 2016

InSAR points along the length of the bridge for all 3 datasets (TSX, S1 asc and S1 dsc), no significant gaps in the data.

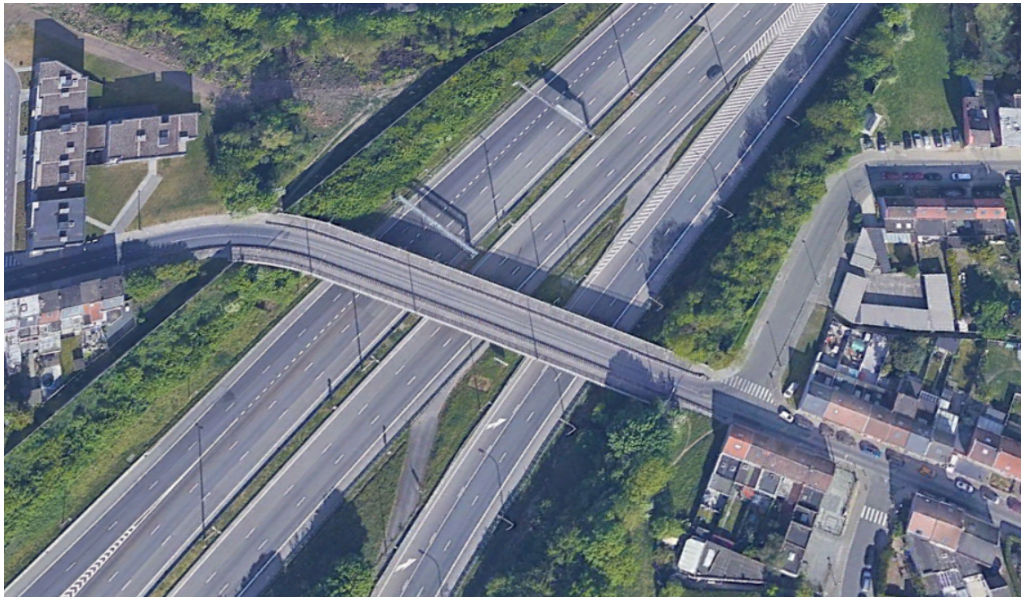
4318 Brug R8 P. Schoonstraat Oudstrijdersstraat

No changes were detected.

InSAR points along the full length of the bridge, no significant gaps in the data.

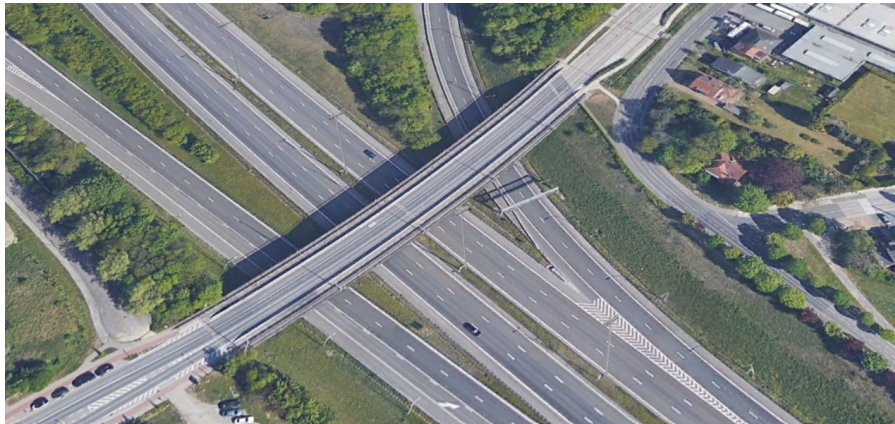
4323 Brug R15

No changes were detected.

InSAR points along the full length of the bridge, no significant gaps in the data.

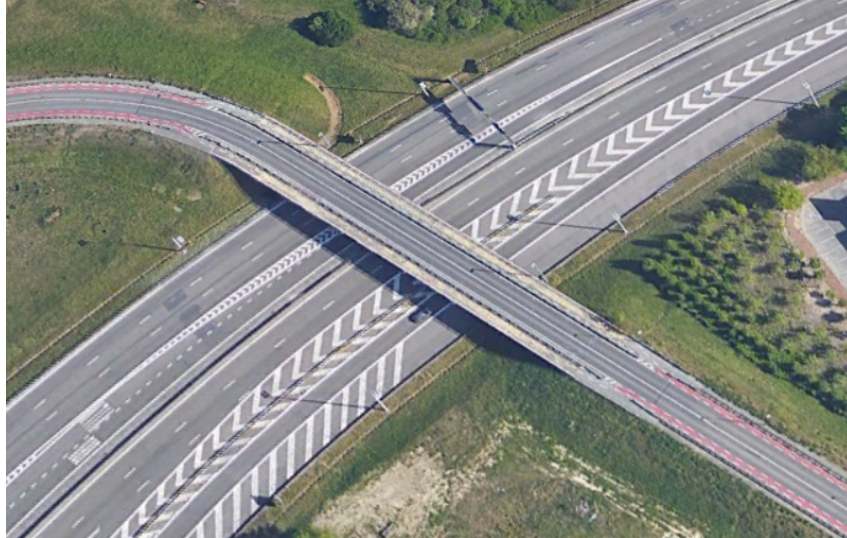
4332 Brug D5 Steenweg op Zaventem

No changes were detected.

InSAR points along the length of the bridge for all 3 datasets (TSX, S1 asc and S1 dsc), no significant gaps in the data.

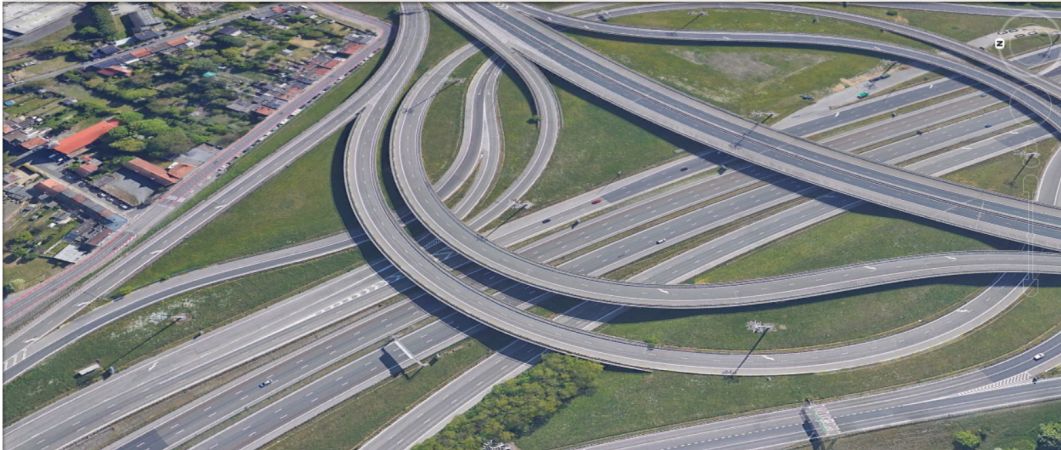
4333 Brug R18

Change detection	Approx. period	Description
Change SW	August 2017	Increase in displacement rate from August 2017
Change NE	January 2020	Slight increase in displacement rate from January 2020

InSAR points along the length of the bridge for all 3 datasets (TSX, S1 asc and S1 dsc), no significant gaps in the data.

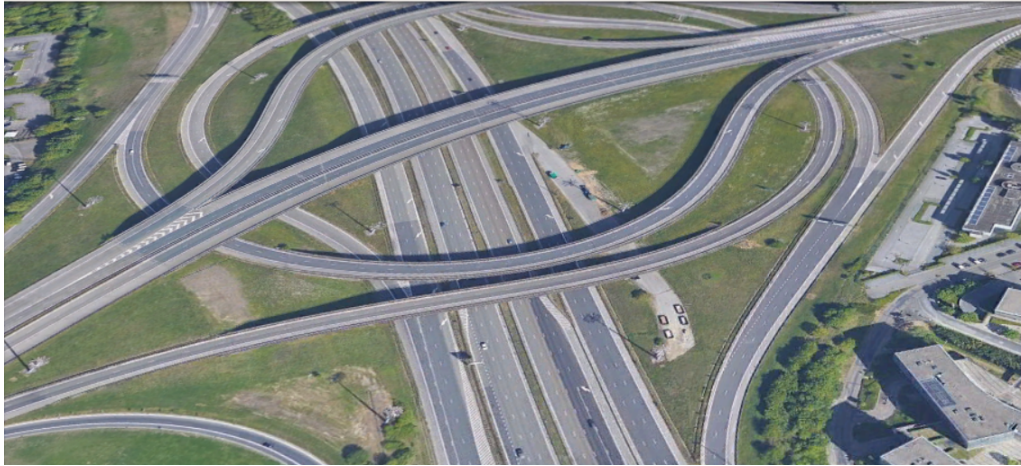
4336 Brug R21

Change detection	Approx. period	Description
Change Middle	September 2020	Increase in displacement rate from September 2020

InSAR points along the length of the bridge for all 3 datasets (TSX, S1 asc and S1 dsc), no significant gaps in the data.

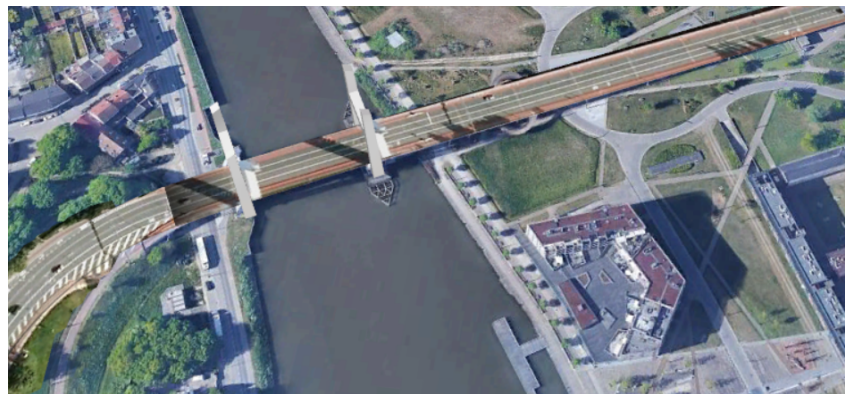
4463 Hefbrug Vilvoordebrug Vuurkruisenlaan-Rubensstraat Europabrug

Change detection	Approx. period	Description
Change Middle	December 2016	Change in amplitude after December 2016
Change Middle	August 2018	Increase in displacement rate from August 2018

All datasets have InSAR points along most of the length of the bridge, however the all datasets have a low points density/no points between the centre of the bridge and the eastern pillars. For the TSX data the gap in points can be further pinpointed to the southern lanes. This could be due to the new layer of asphalt that was completed in 2015, but it is unknown how large of an area this covered. More investigation would be required to determine the cause.

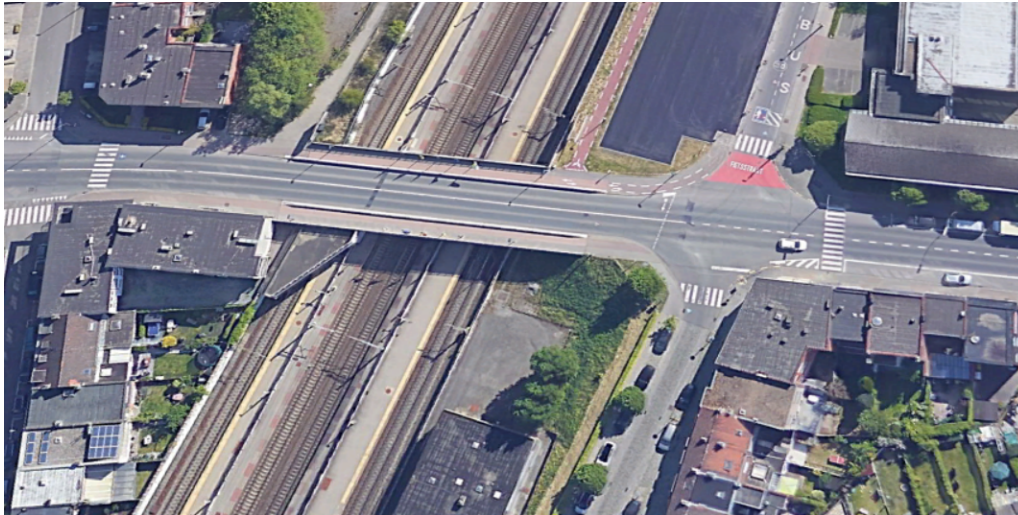
4904 Brug in N262 Parklaan over spoorweg

Change detection	Approx. period	Description
Change Middle	April 2019	Increase in displacement rate from April 2019

The middle of the eastern lane appears to have a lack of InSAR points. Points are concentrated along the safety barrier at the edges of the bridge and at the corner between the pavement curb and road. Therefore the lack of points on the eastern lane could be a geometric effect, and we would need further information on the height of the safety barriers to prove or disprove this hypothesis.

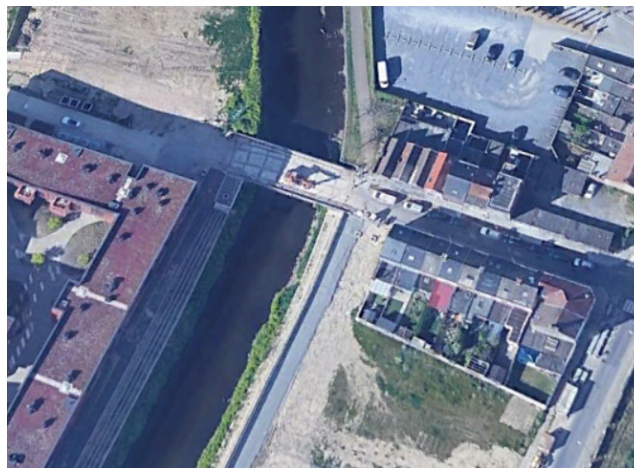
5773 Sluisstraatbrug

Change detection	Approx. period	Description
Change W	Late 2015	Increase in displacement rate from Jul 2015
Change E	spring 2017	Change in amplitude after April 2017

The TSX data has InSAR points along the full length of the bridge, no significant gaps in the data.

The S1 datasets (both ascending and descending) have very low point density (or no points) on the bridge. This is most likely due to the changes detected during the S1 time period.

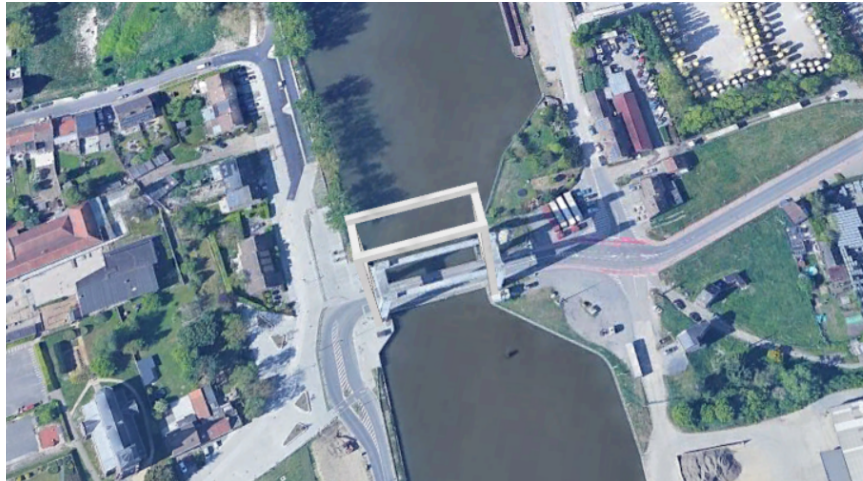
6135 Verbrande Brug

Change detection	Approx. period	Description
Change Middle	January 2020	Increase in displacement rate from January 2020
Change W	January 2020	Increase in displacement rate from January 2020

The TSX data has InSAR points along the full length of the bridge, no significant gaps in the data. The S1 ascending and descending datasets have very few points on the bridge and this is most likely related to the new top layer of asphalt which was completed in 2021,

during the time period of S1. The change to the surface results in a loss of coherence for InSAR.

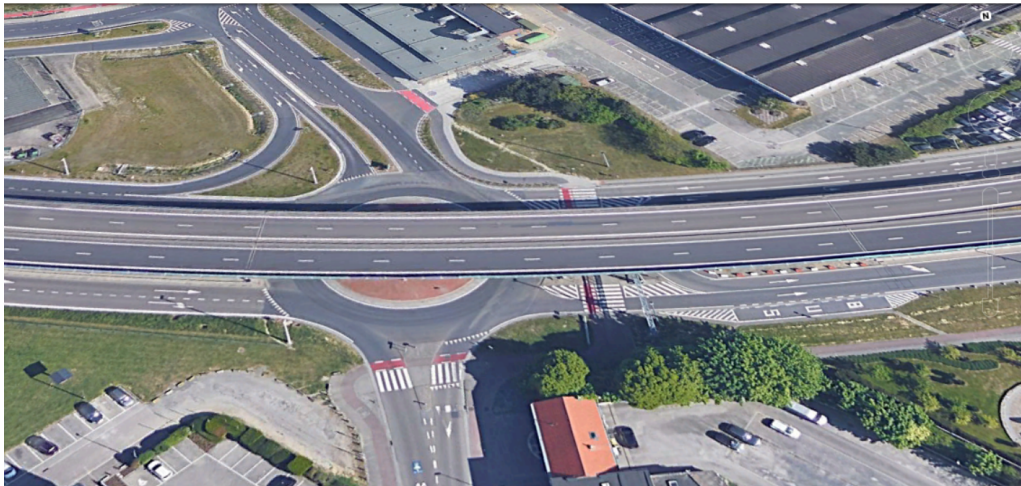
8042 Viaduct in A201 over N262

Change detection	Approx. period	Description
Change Middle	April 2018	Increase in displacement rate from April 2018
Change Middle	January 2020	Change in amplitude between April 2018 and January 2020

InSAR points along the length of the bridge for all 3 datasets (TSX, S1 asc and S1 dsc), no significant gaps in the data.

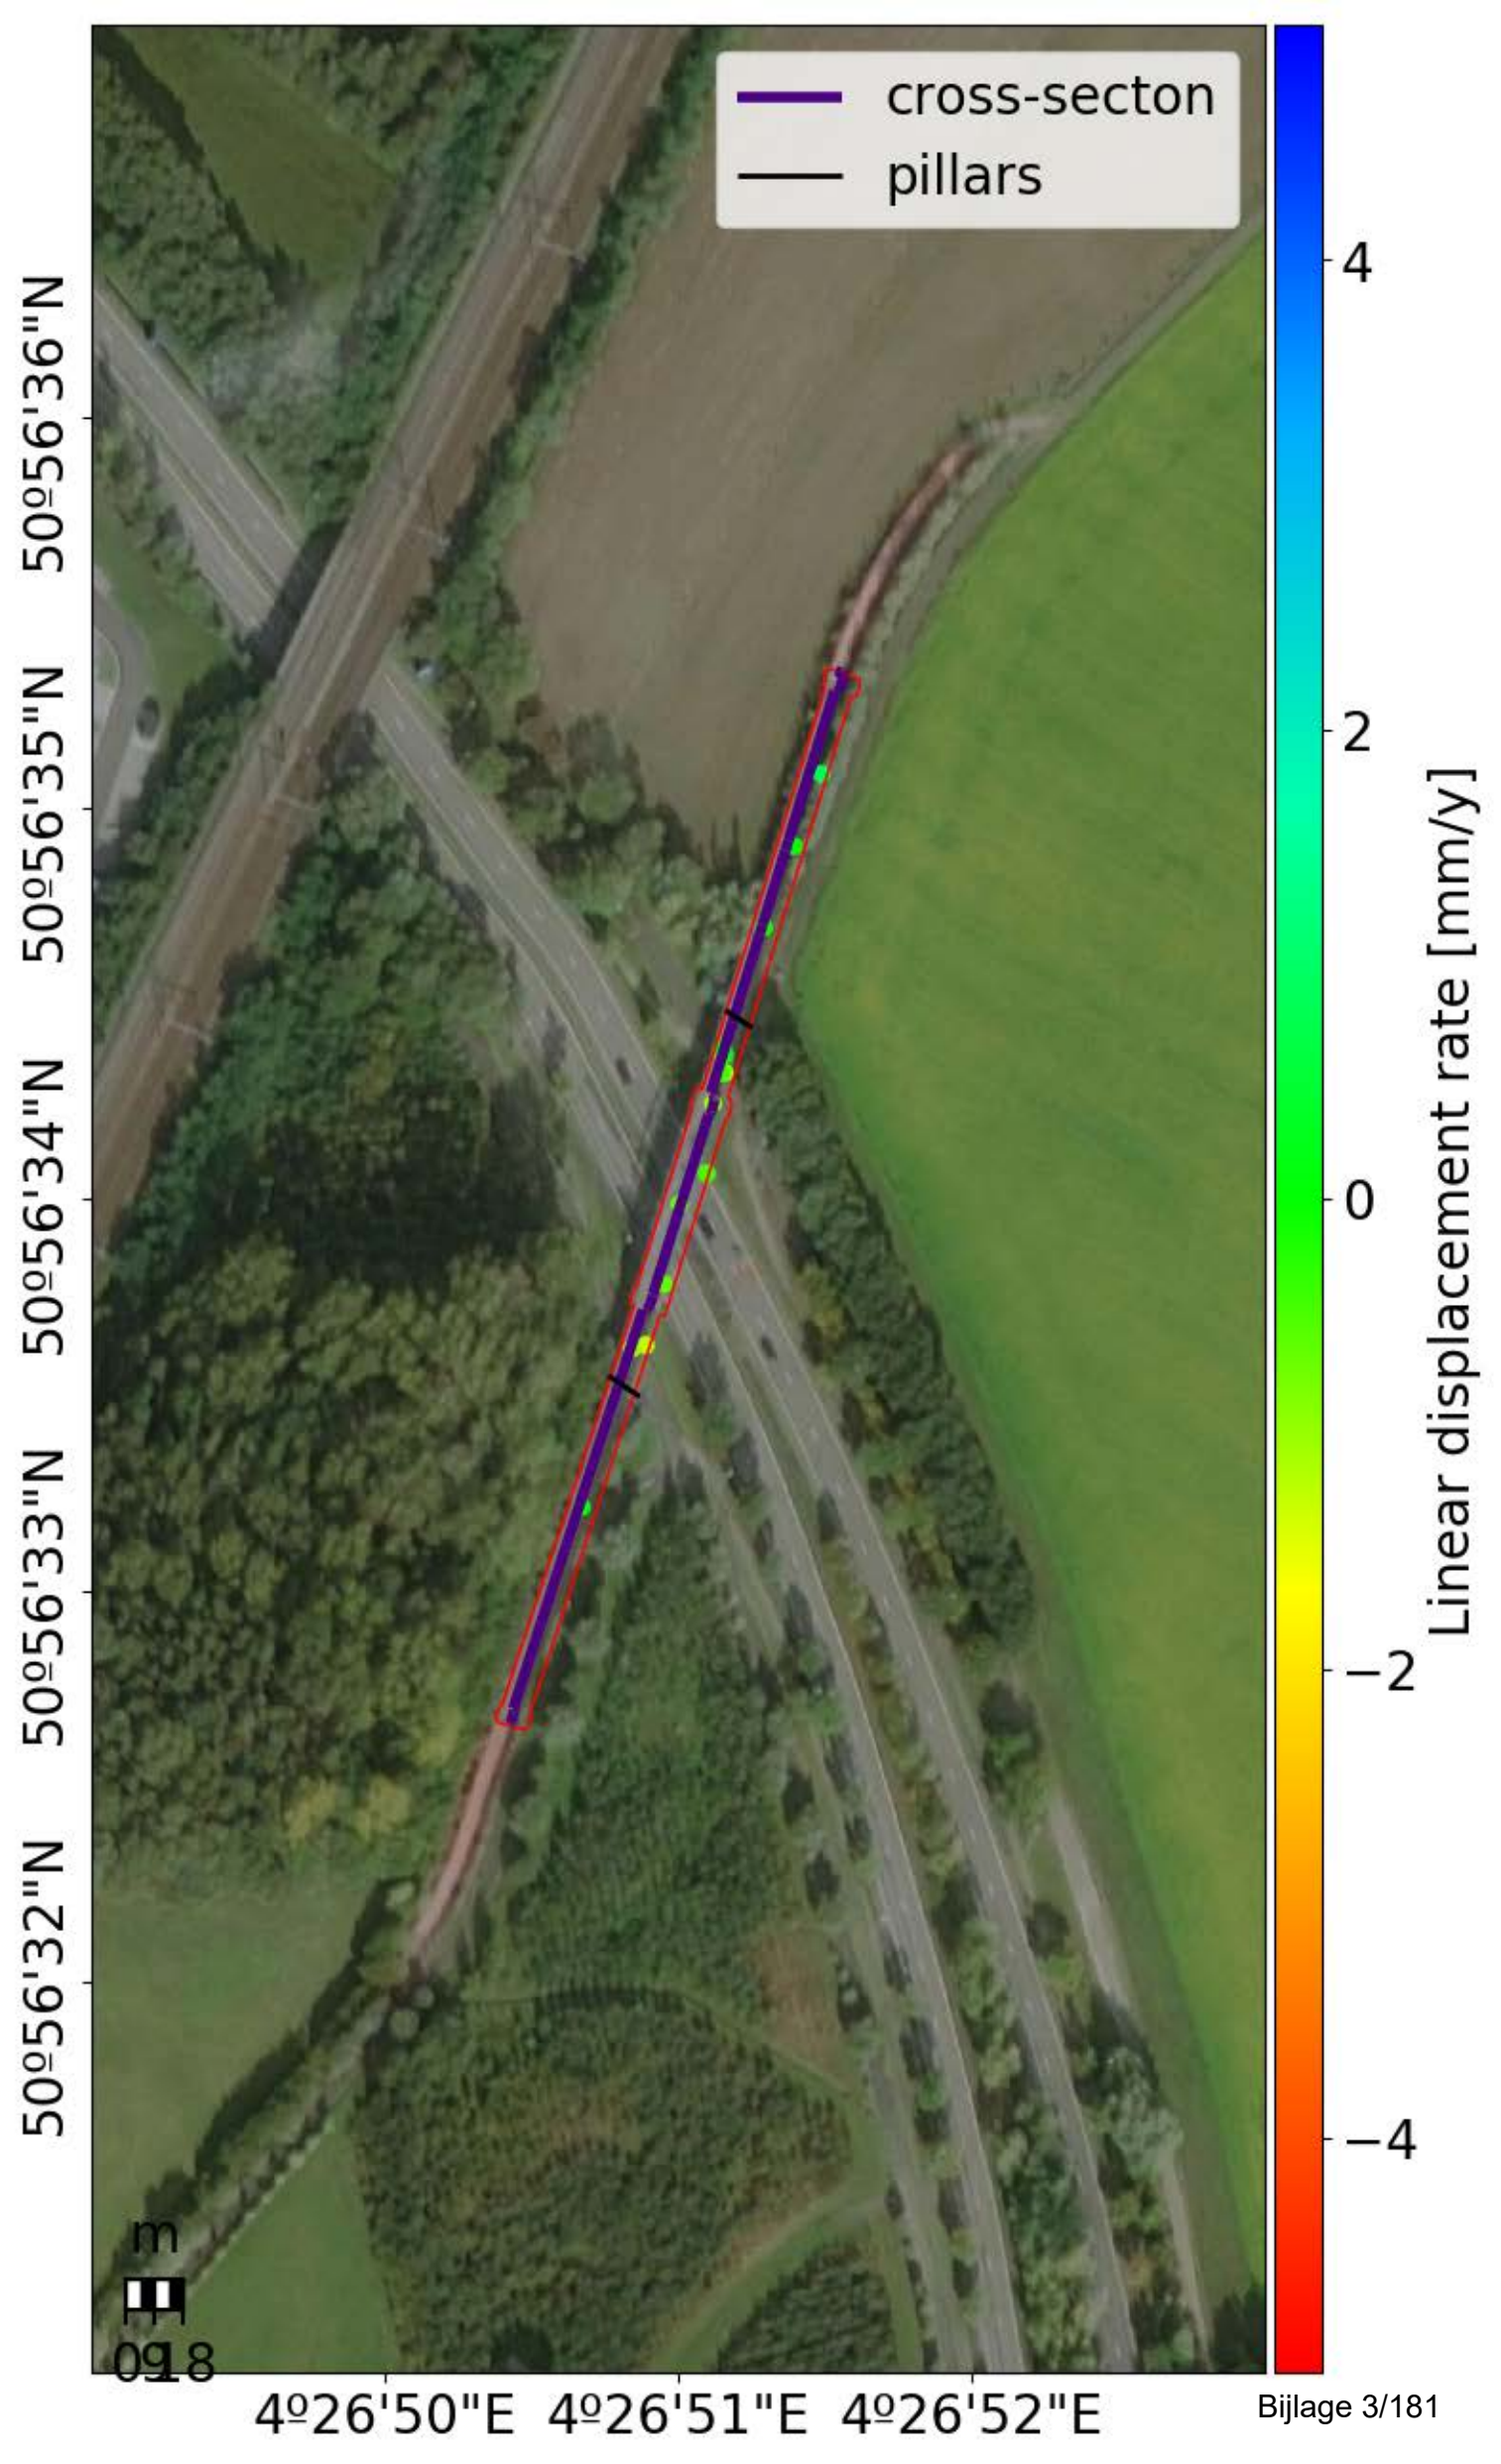
8639 Fiets- en voetbrug Schoeweever Woluwelaan

The southern end of the bridge has a lack of points in all three datasets (TSX, S1 asc and S1 dsc). This is mostly likely because it is a narrow bridge (4 m) with trees either side that S1 and TSX cannot penetrate, resulting in a loss of coherence.

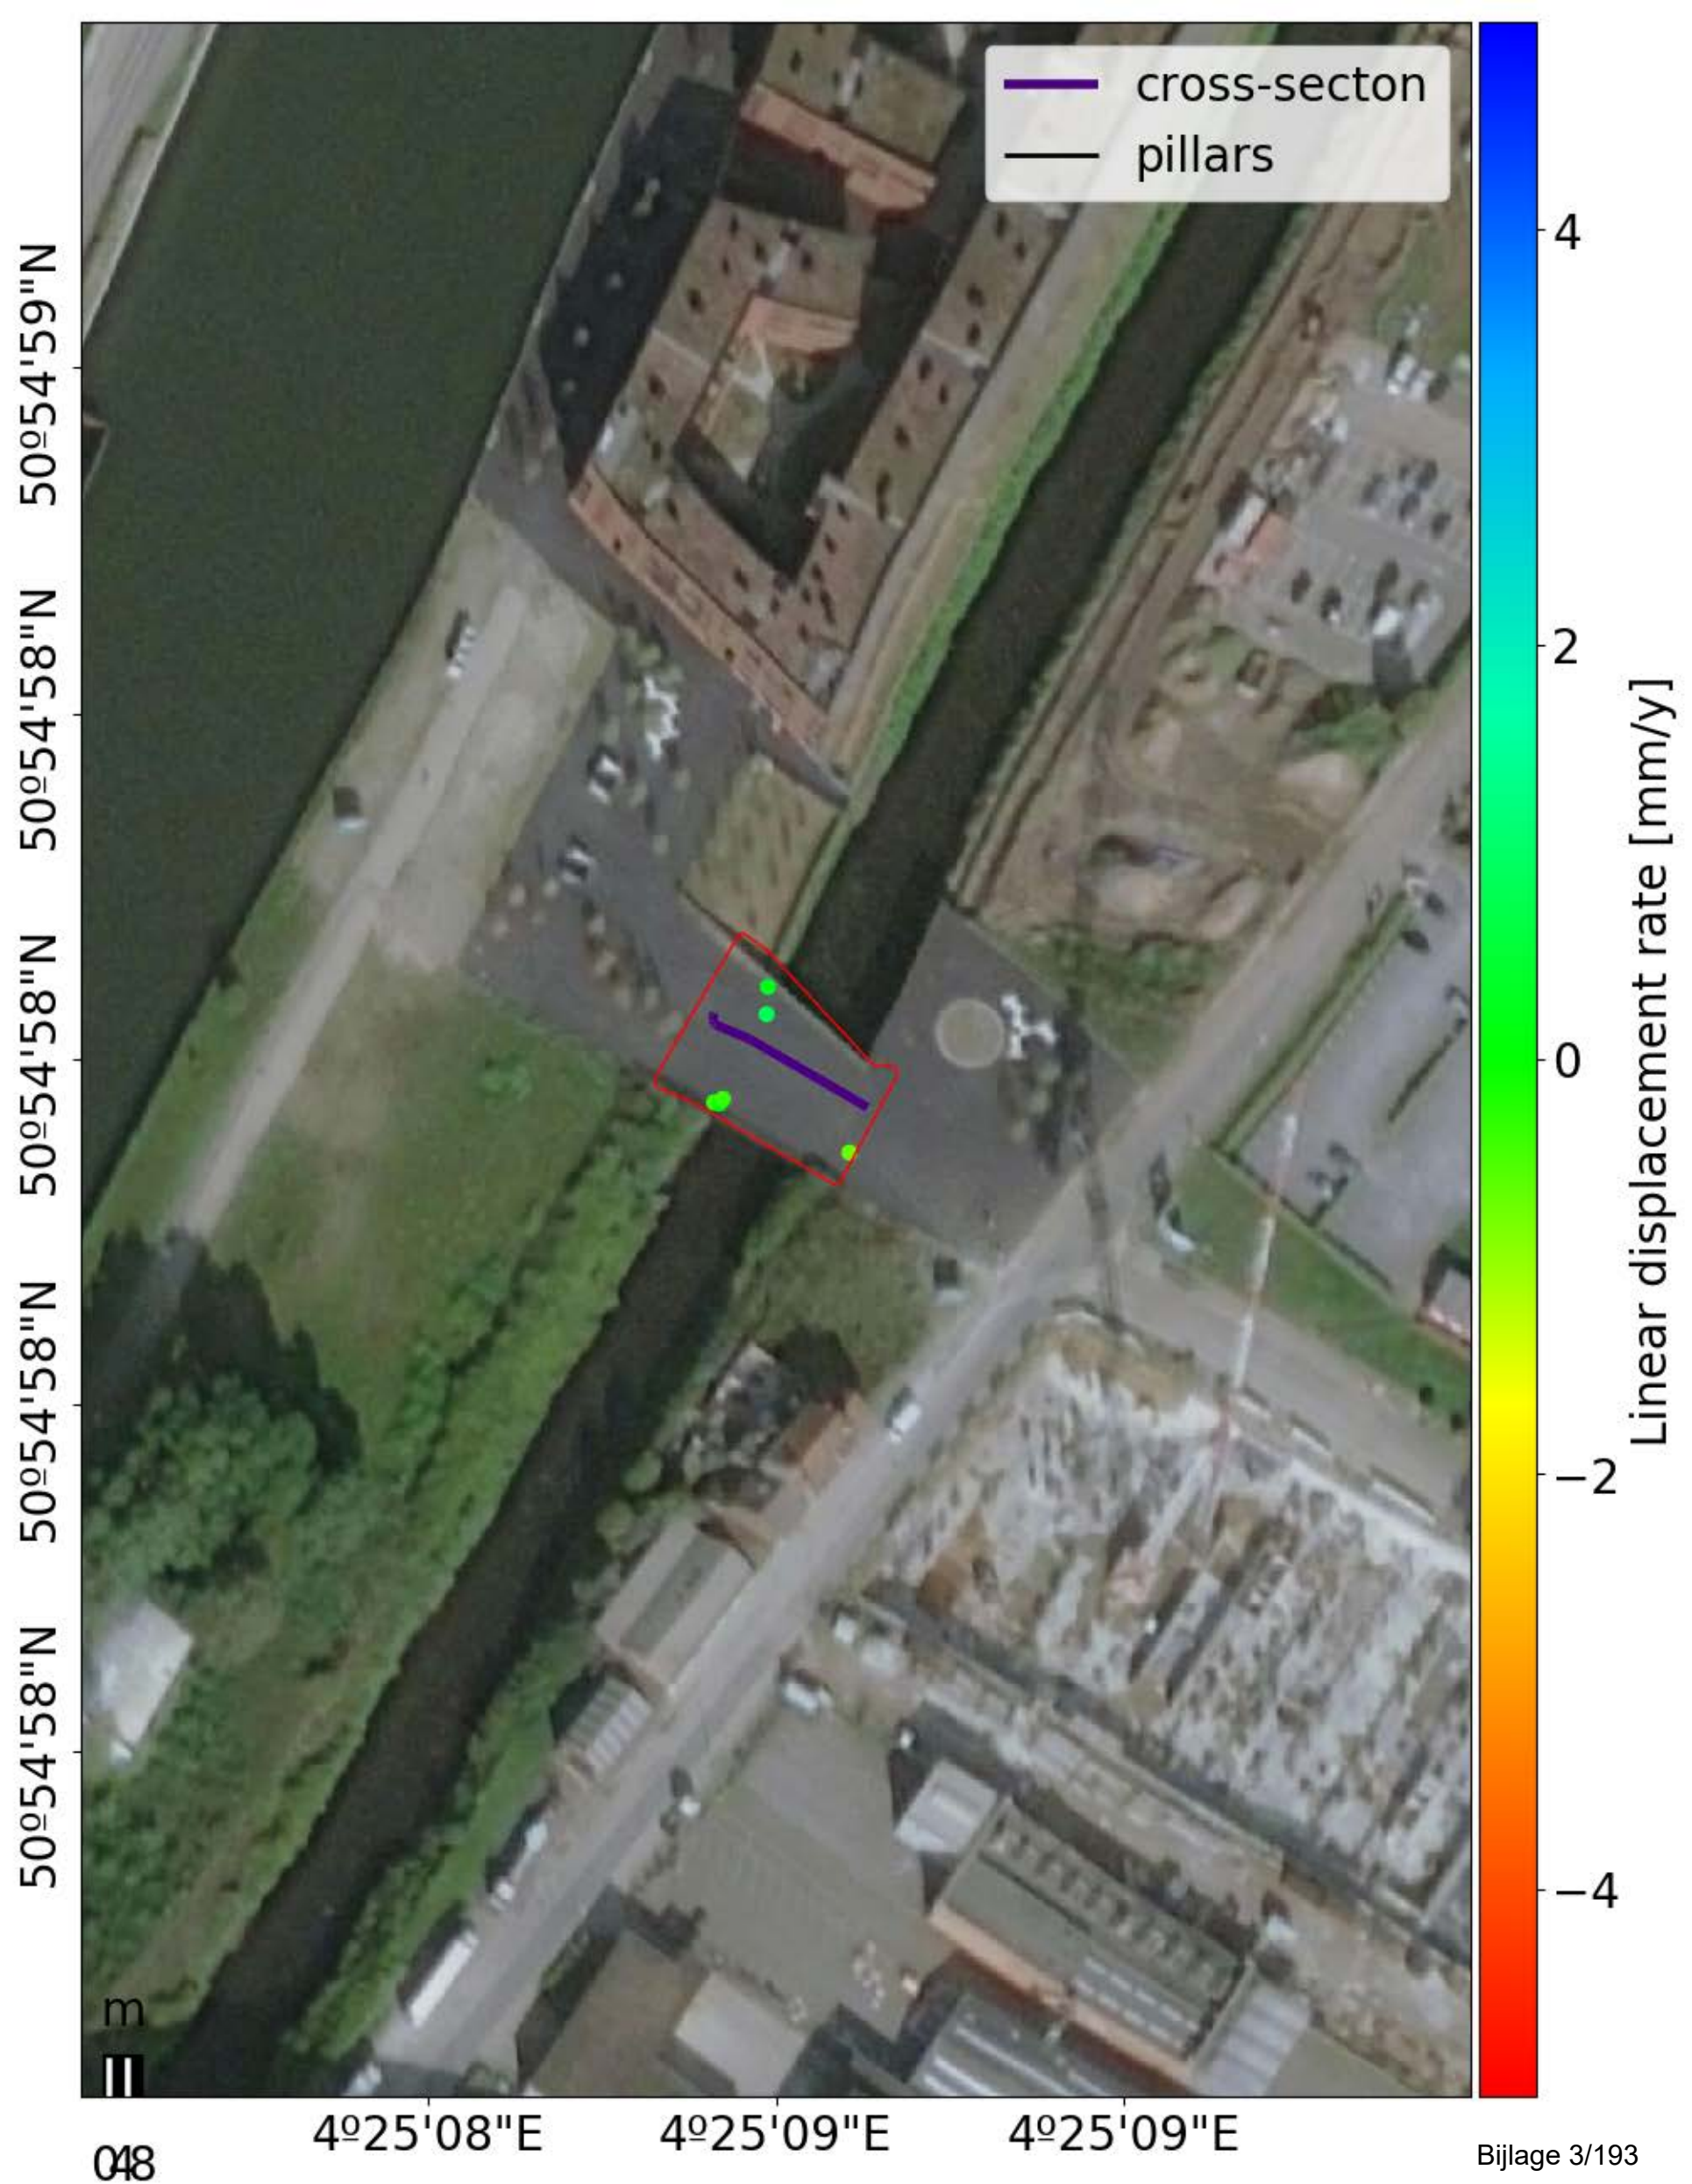
8677 Brug over de Zenne met verbindingsweg naar sluis

Change detection	Approx. period	Description
Change (all bridge)	2014 -2015	Change in amplitude during construction work (2014-2015)

Change (all bridge)	August 2018	Change in displacement rate from August 2018
---------------------	-------------	--

All three datasets have points on the abutments but not in the centre of the bridge. The bridge was built/finalised in 2014/2015 which explains the lack of data on the bridge itself, the points that are there are on the abutments/banks.

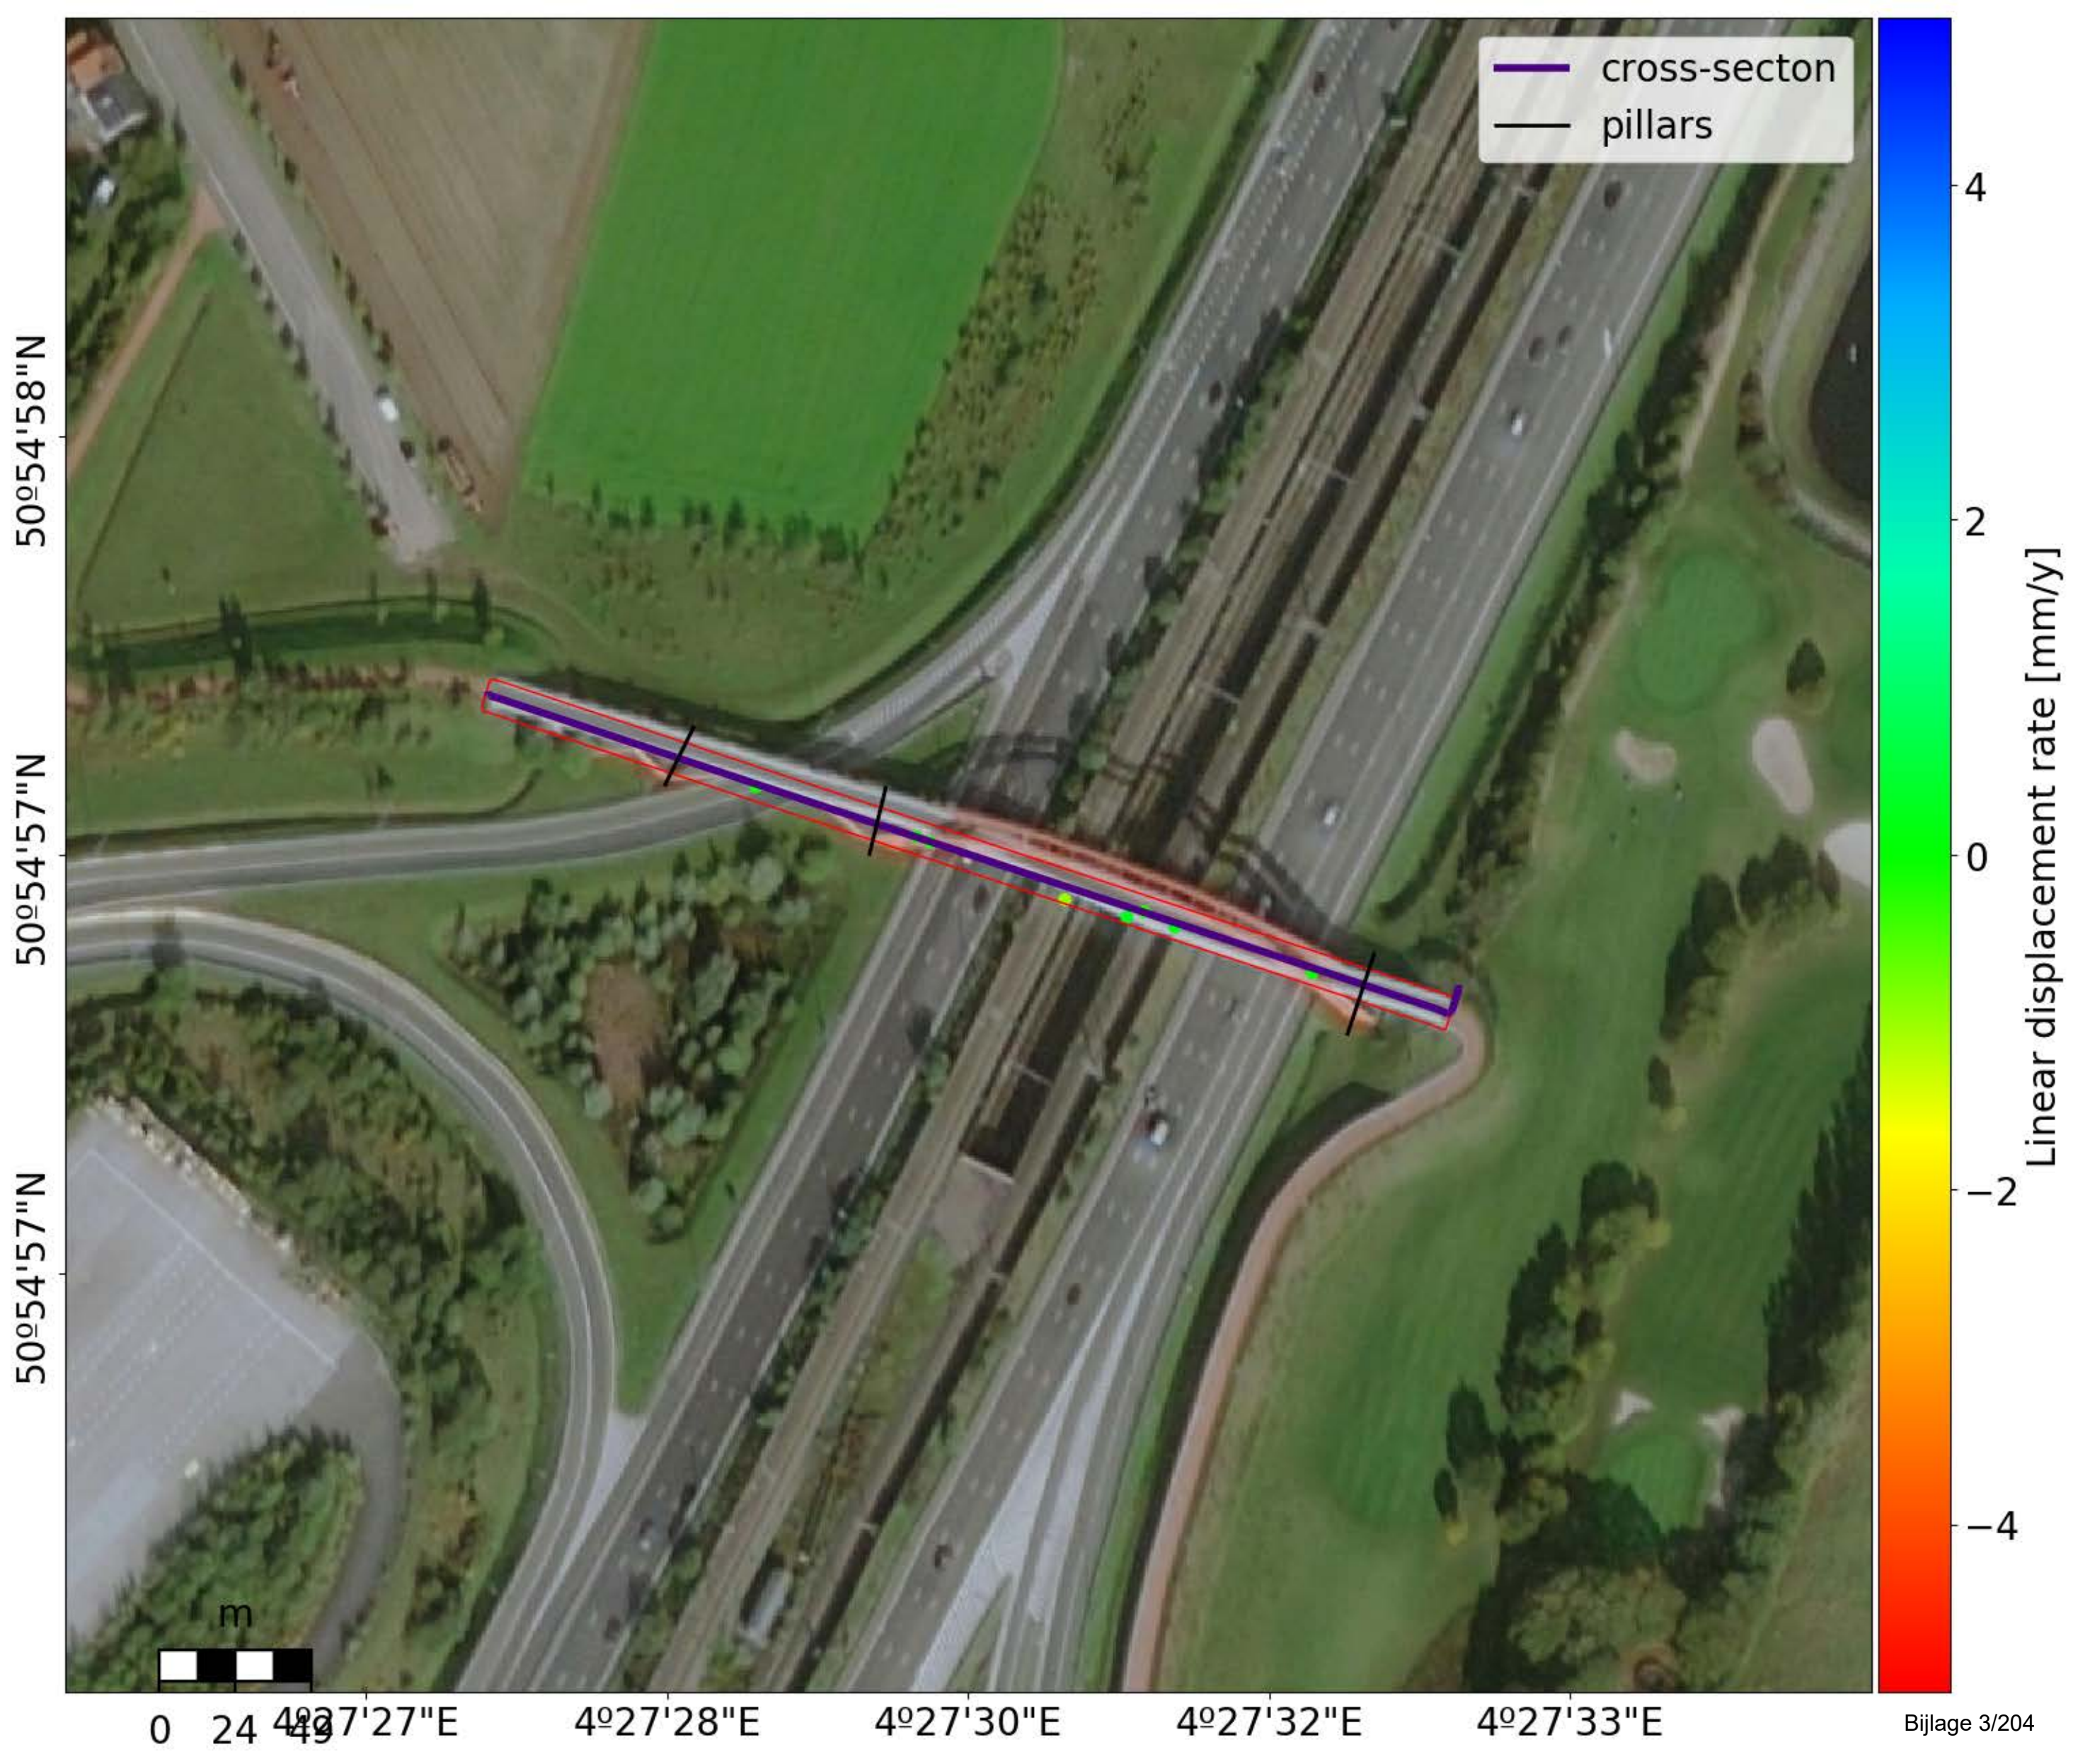
8763 Fietsbrug over E19 + Noordelijke spoorontsluiting luchthaven

Both TSX and S1 dsc have InSAR points along the length of the bridge. S1 asc has a lack of points to the western end. No changes were detected and no maintenance works recorded, so the reason for the lack of points is uncertain.

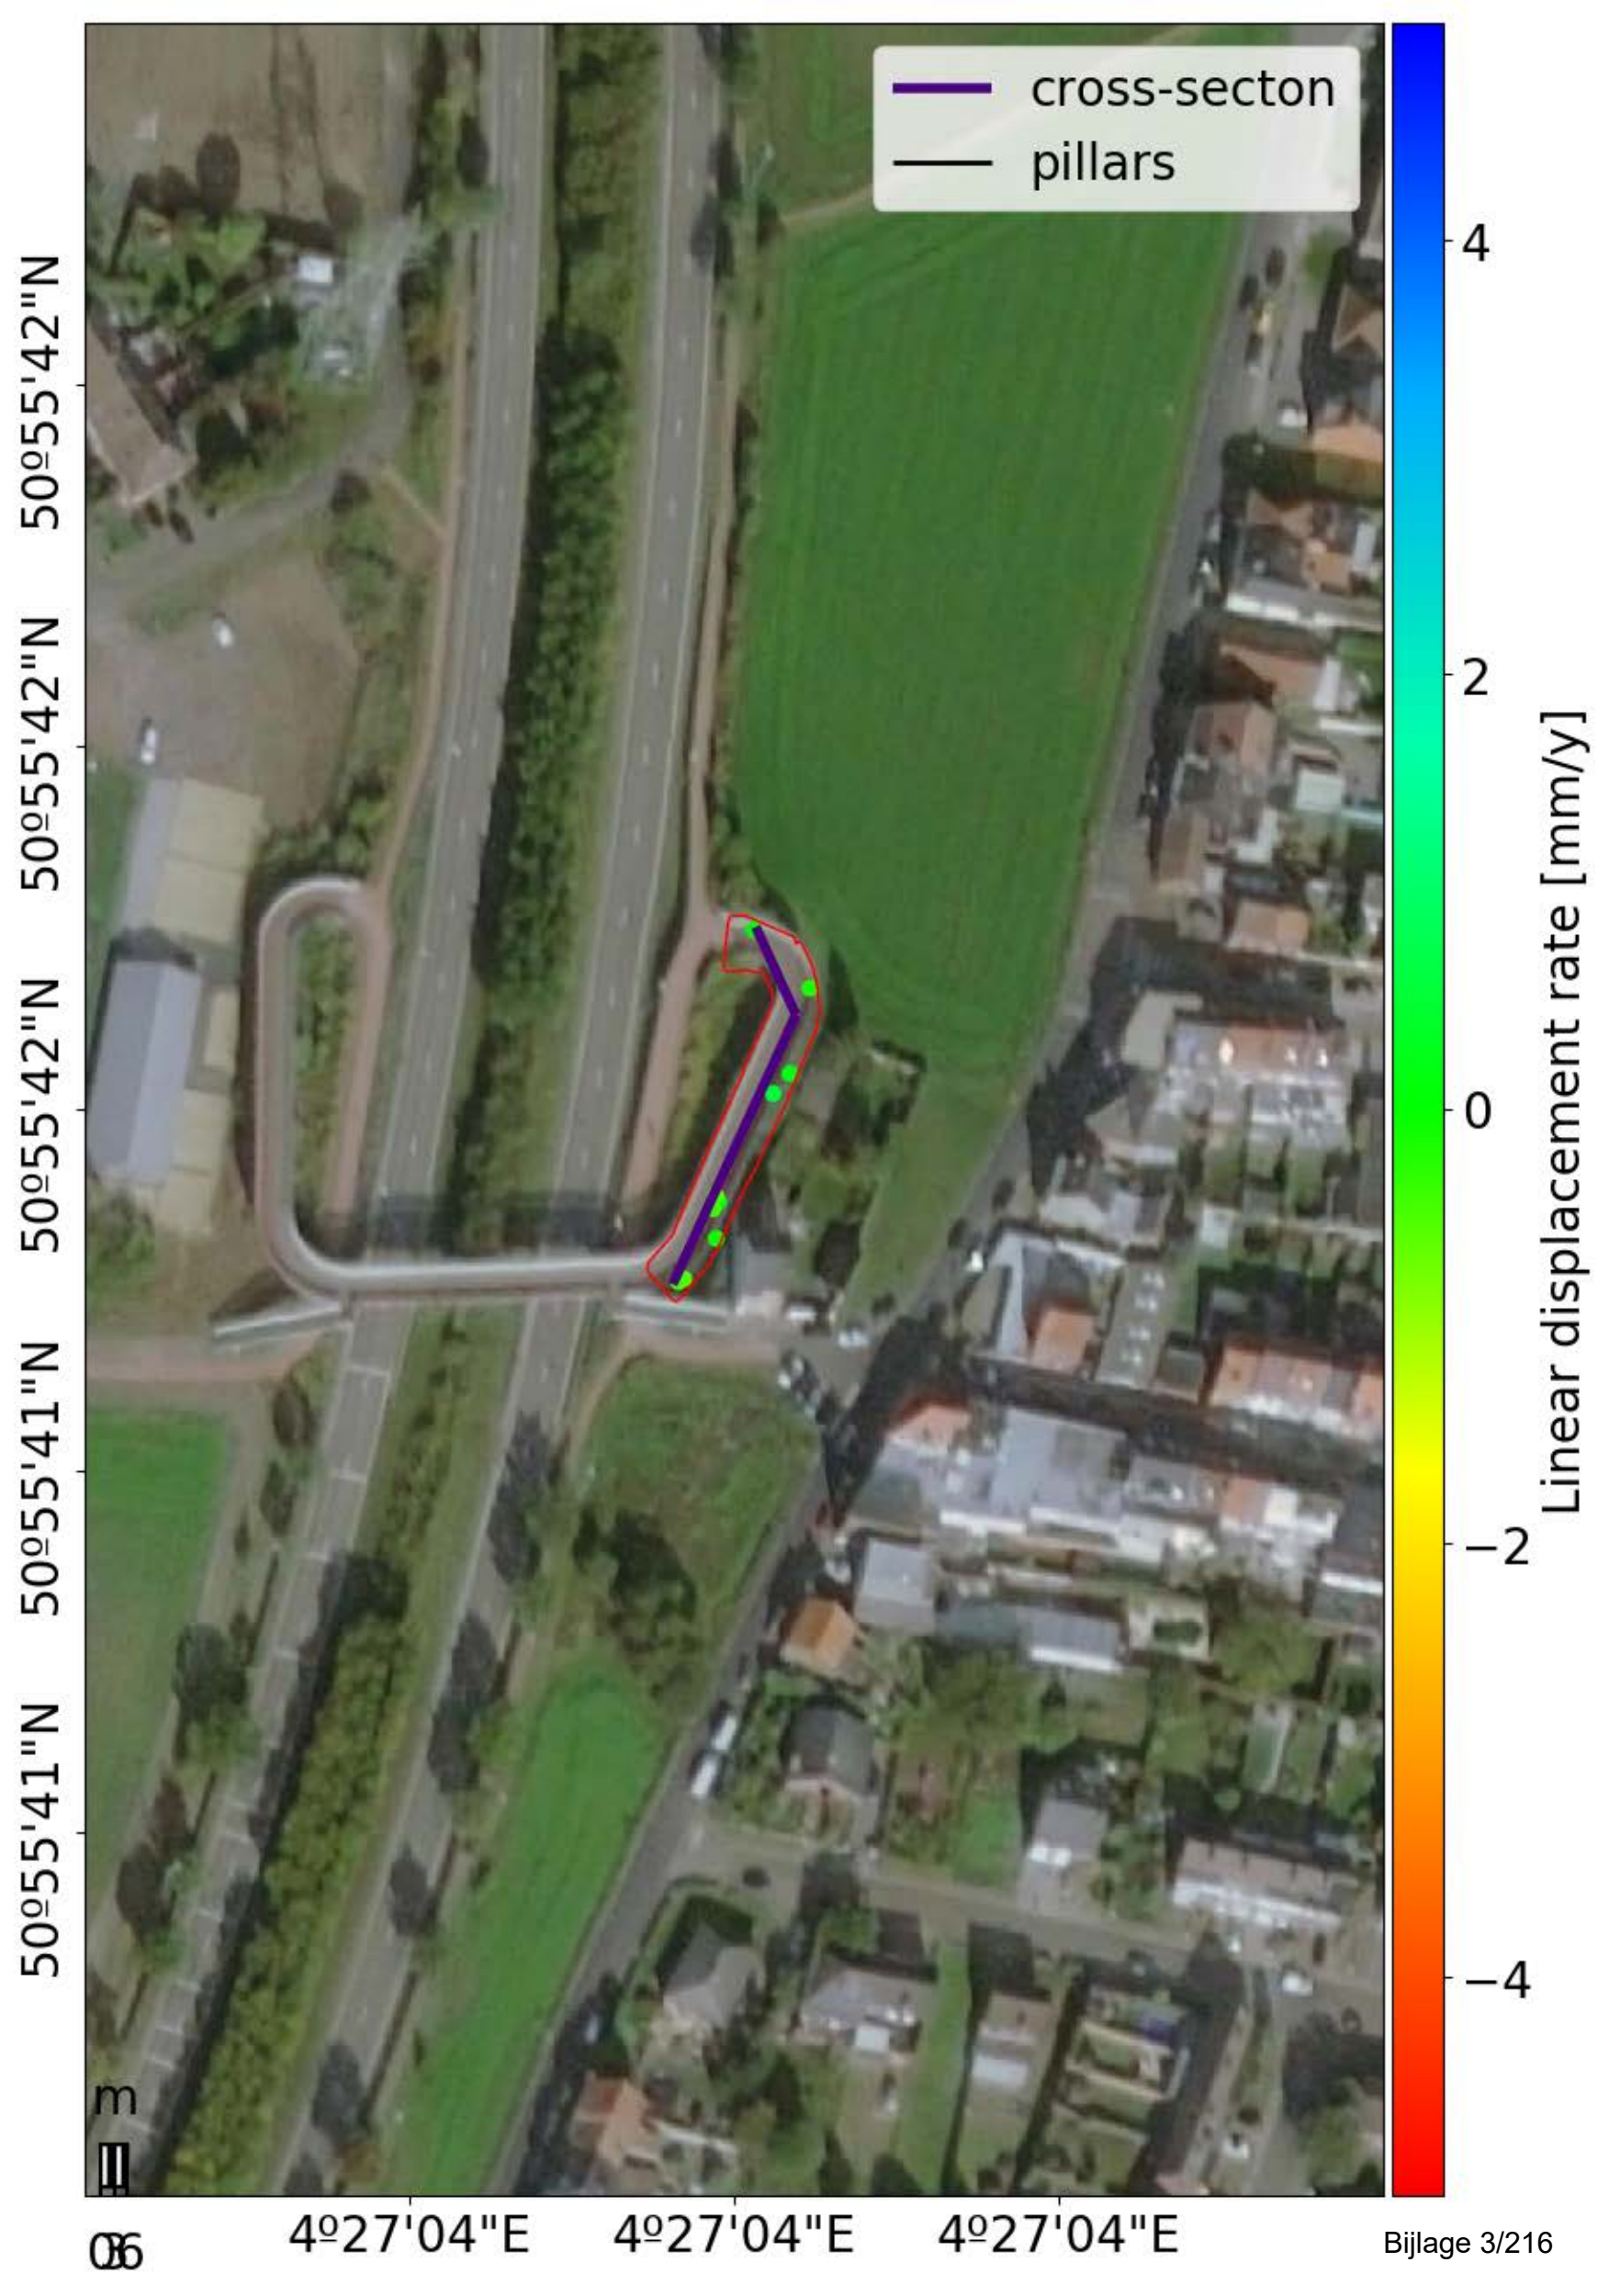
9084 Voet- en fietsbrug Kleine Steenstraat

Change detection	Approx. period	Description
Change W ramp	January 2018	Change in amplitude after January 2018

Both the TSX and S1 data have InSAR points along the full length of the bridge, no significant gaps in the data.
