3186 Havendoklaanbrug

Change Detection

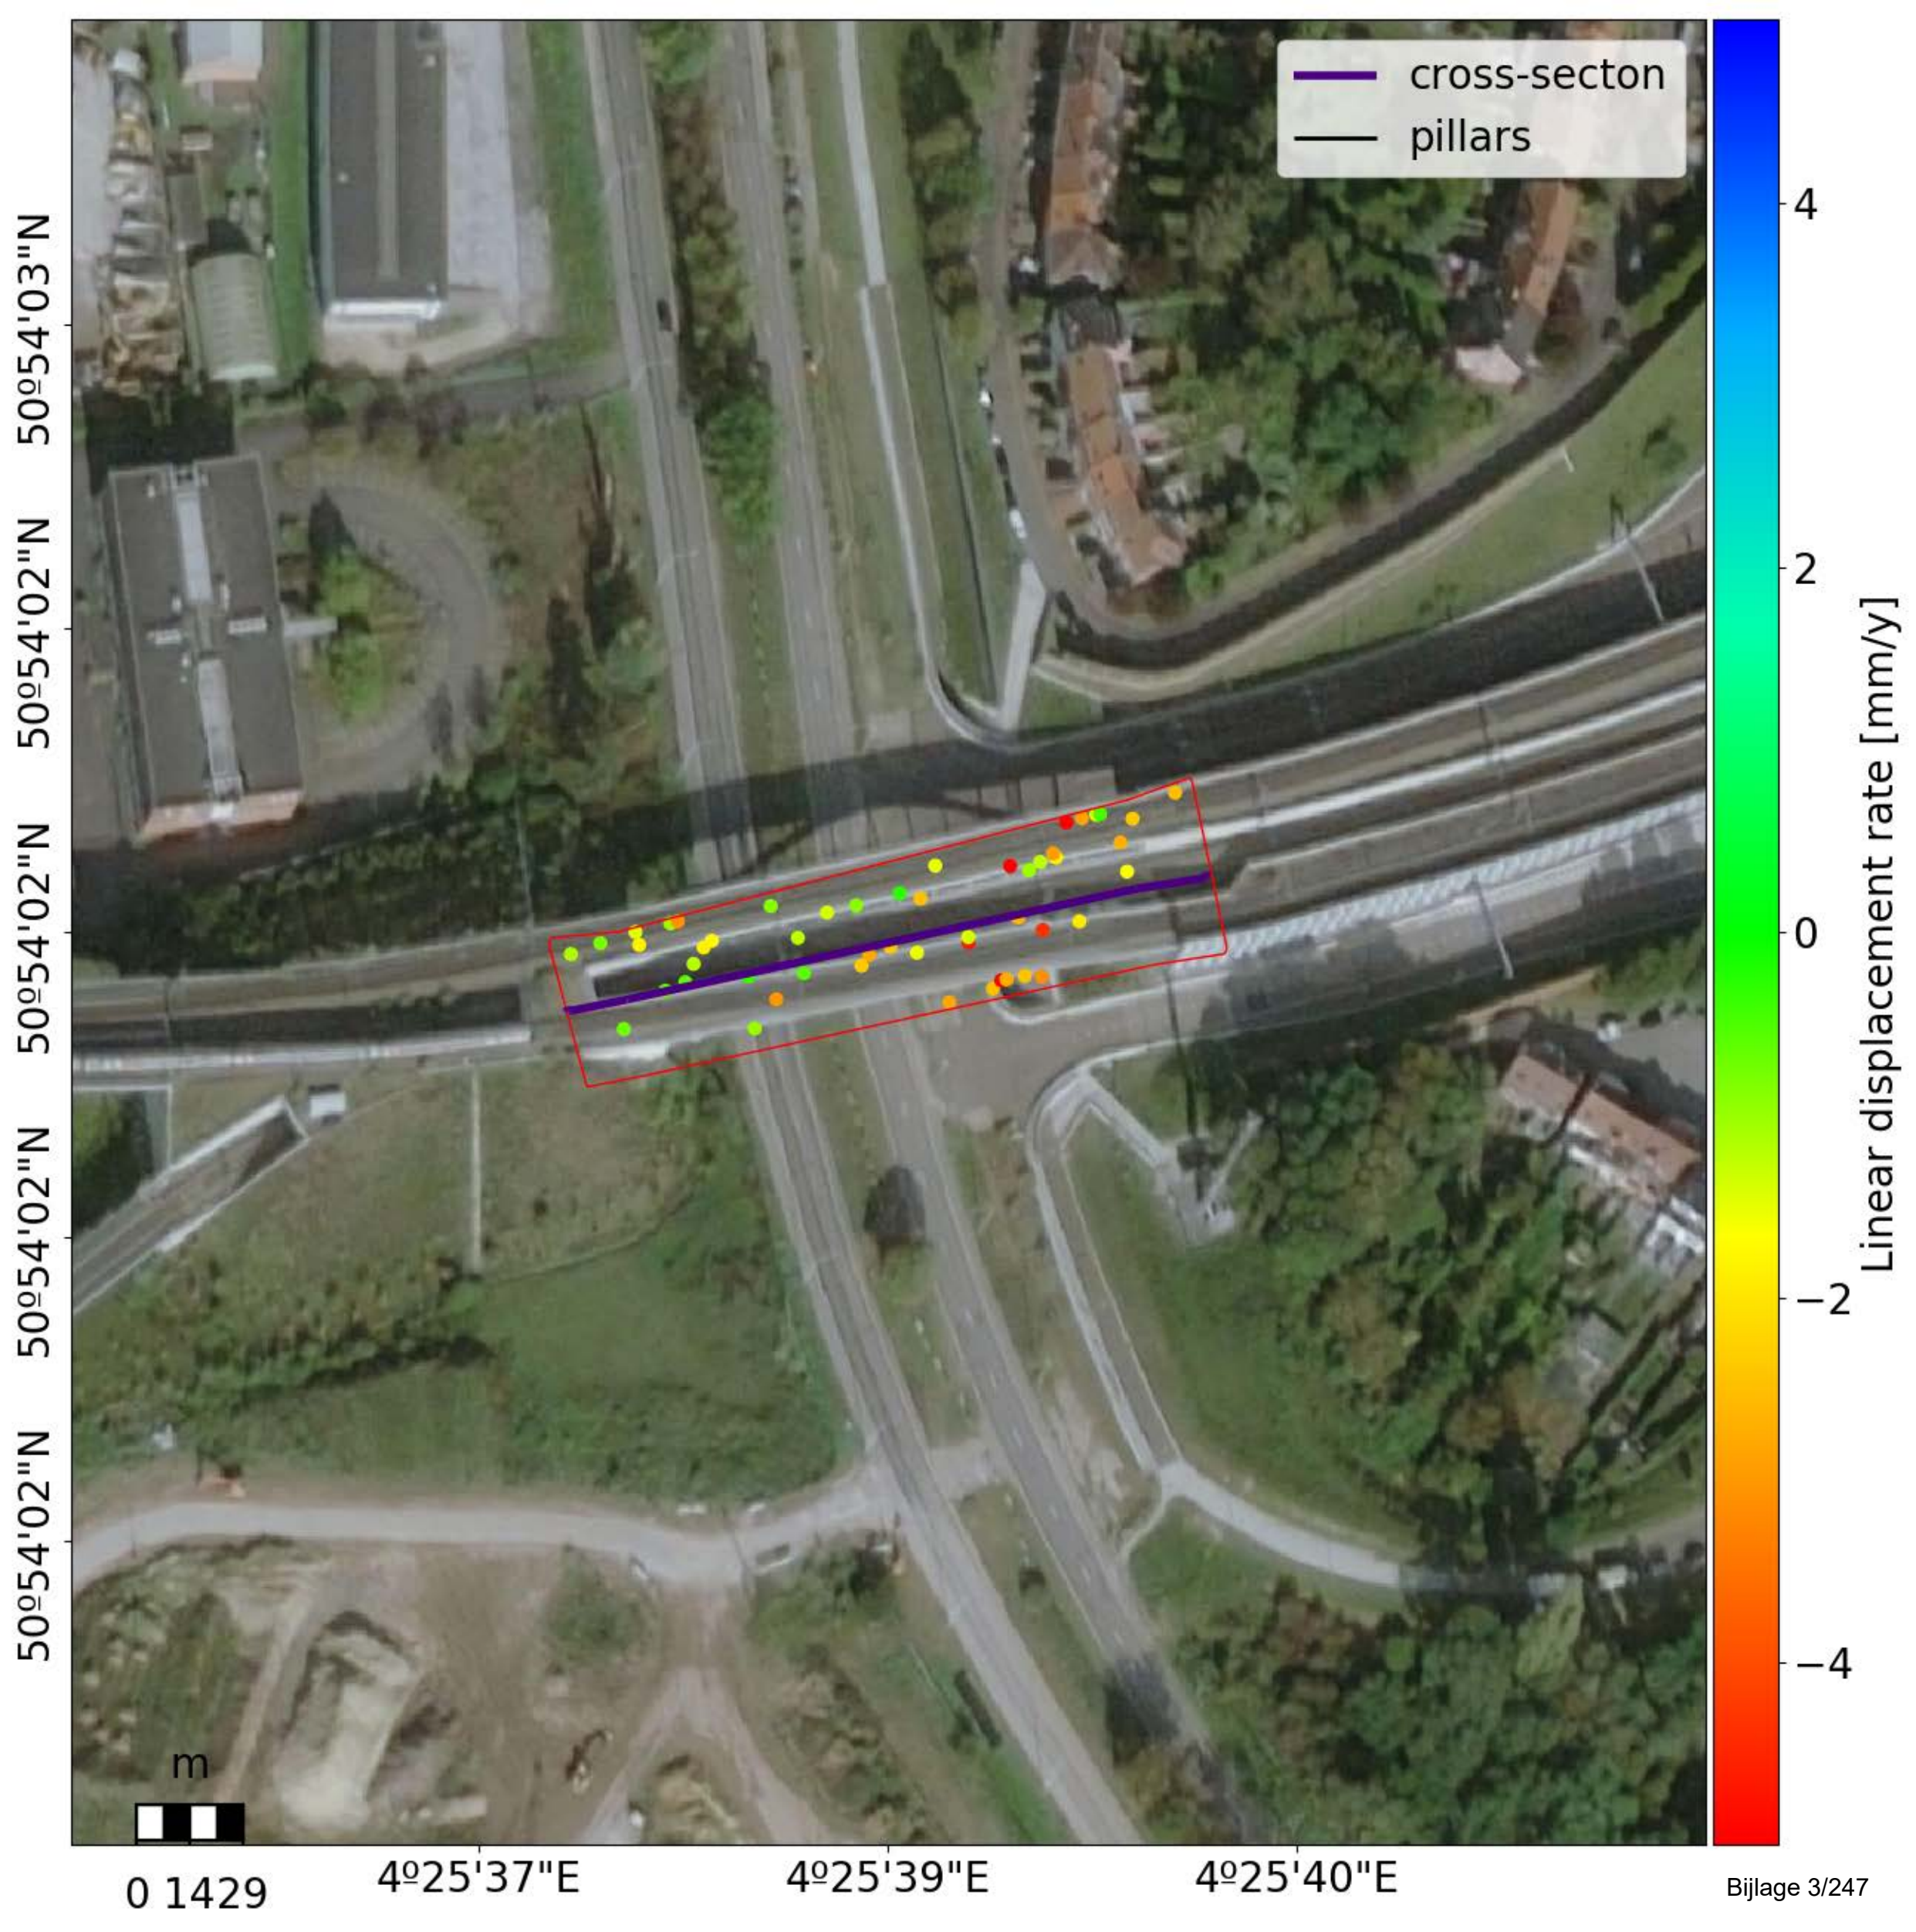
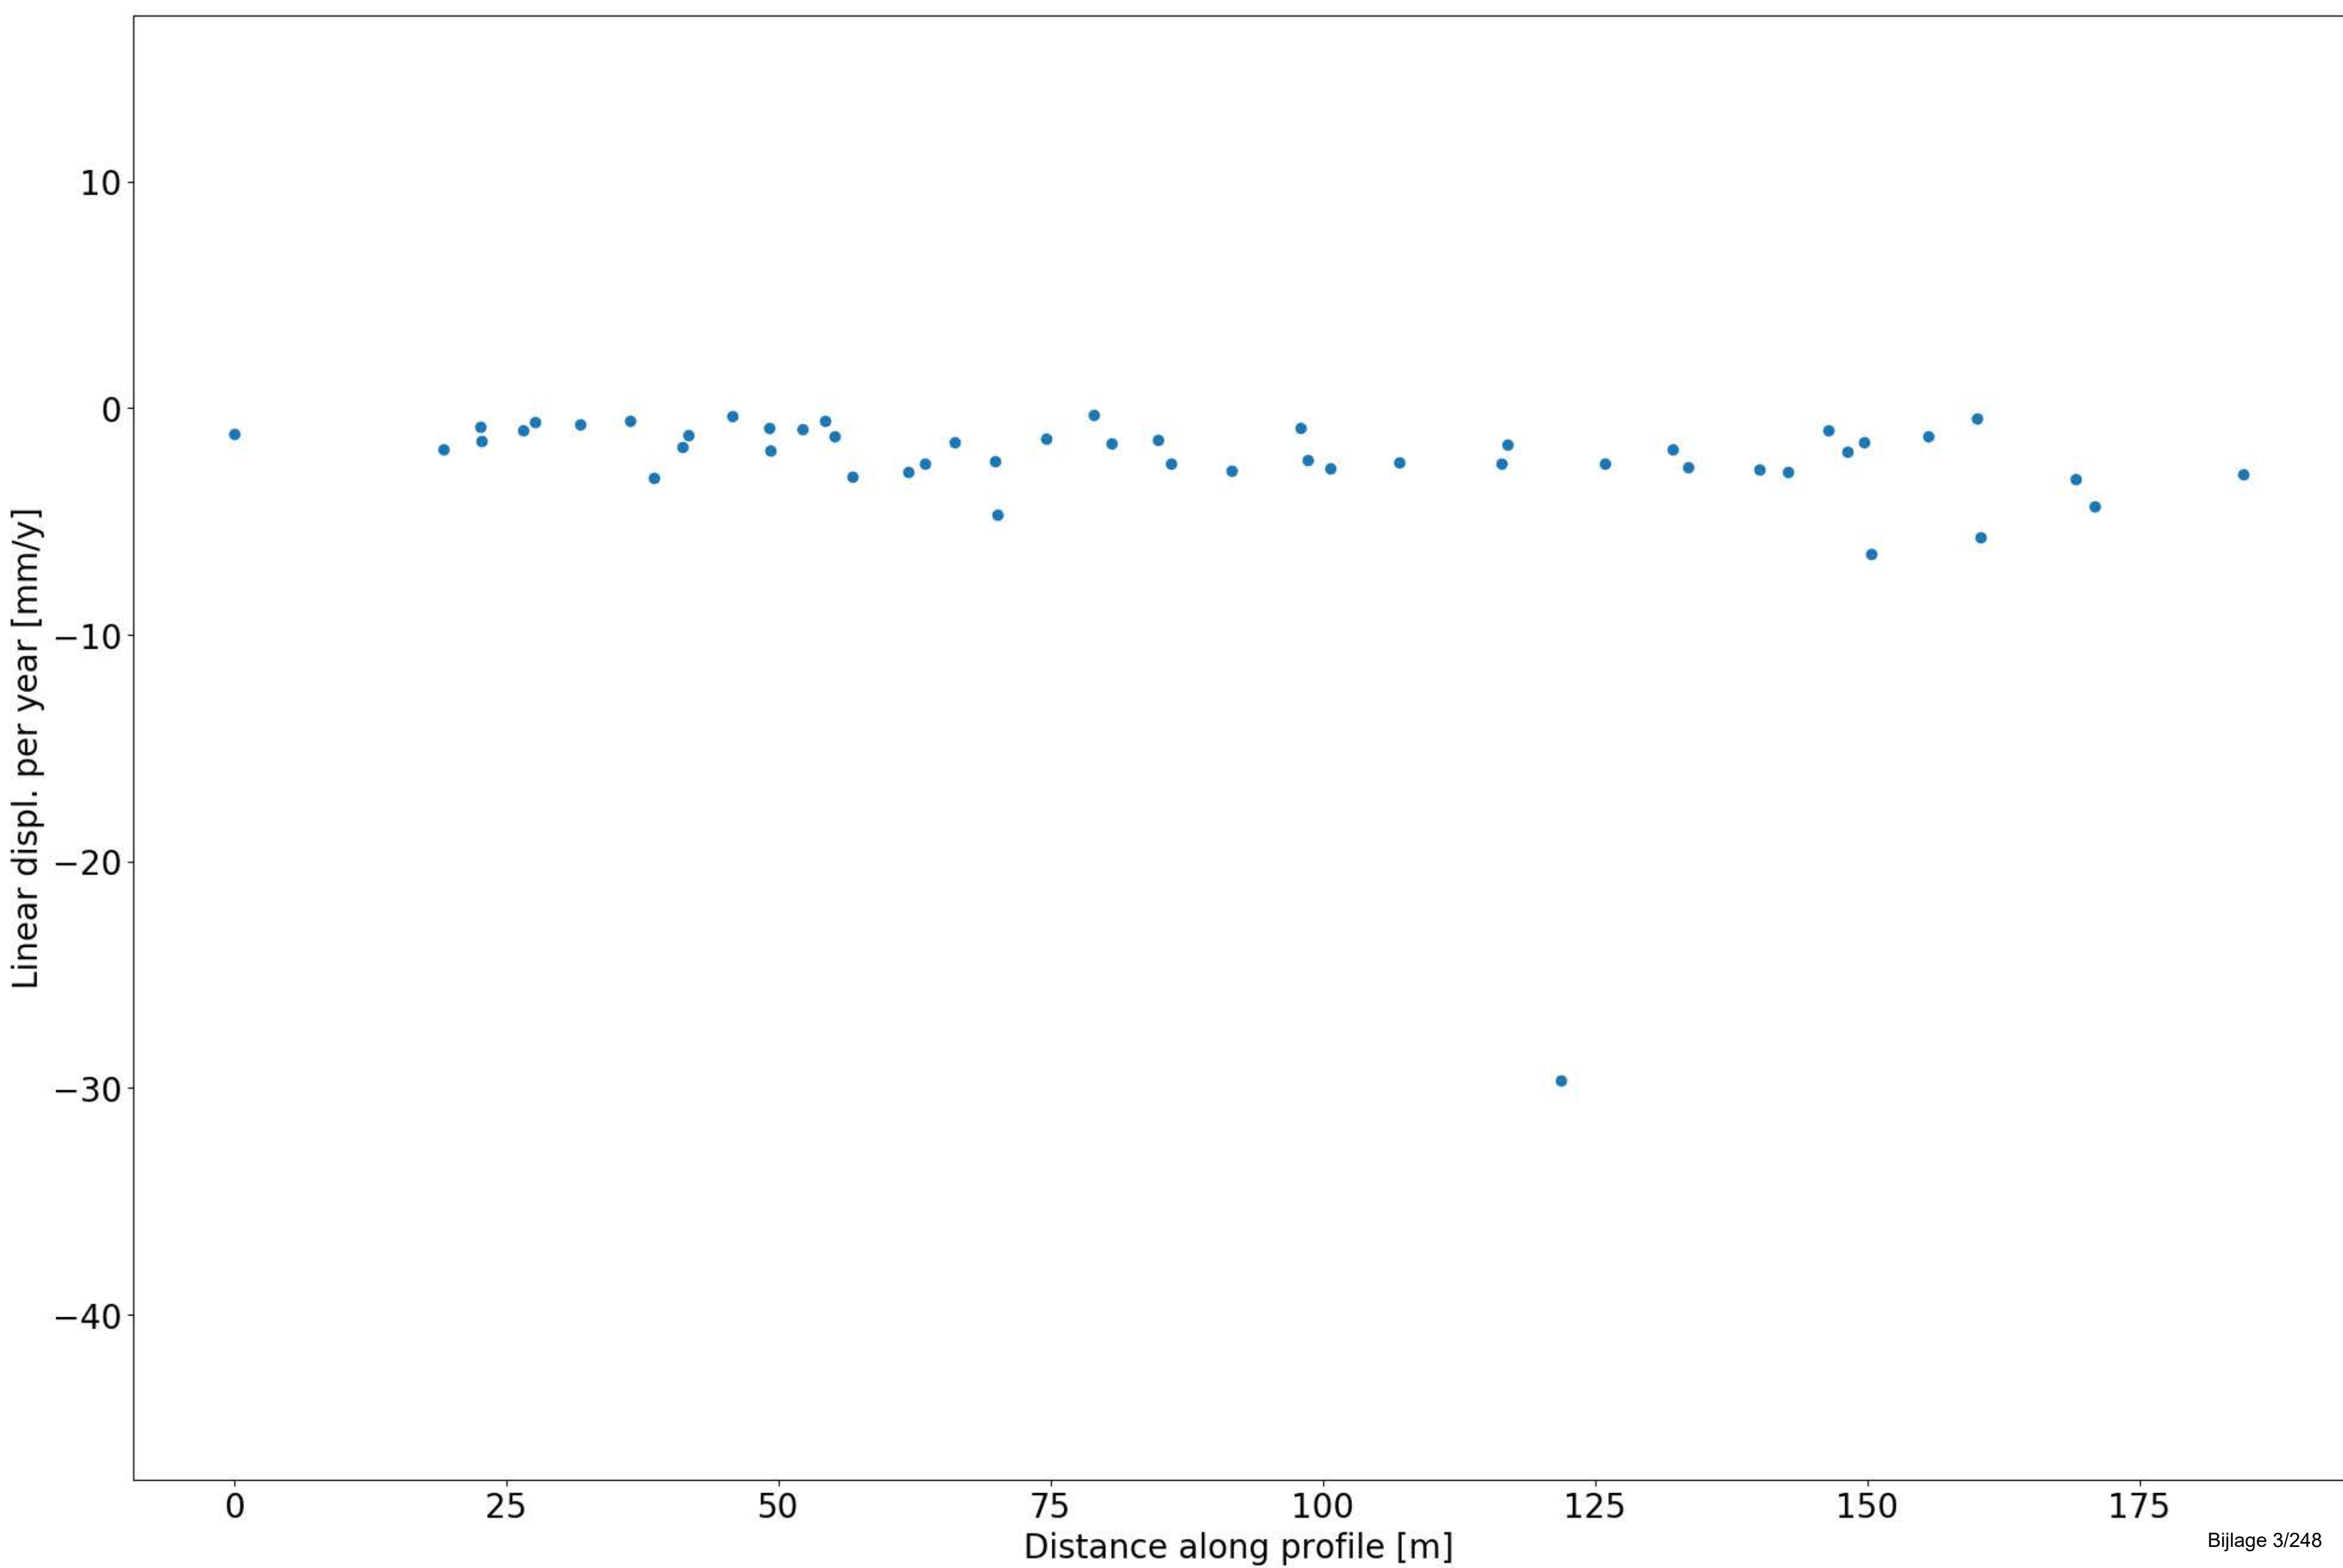
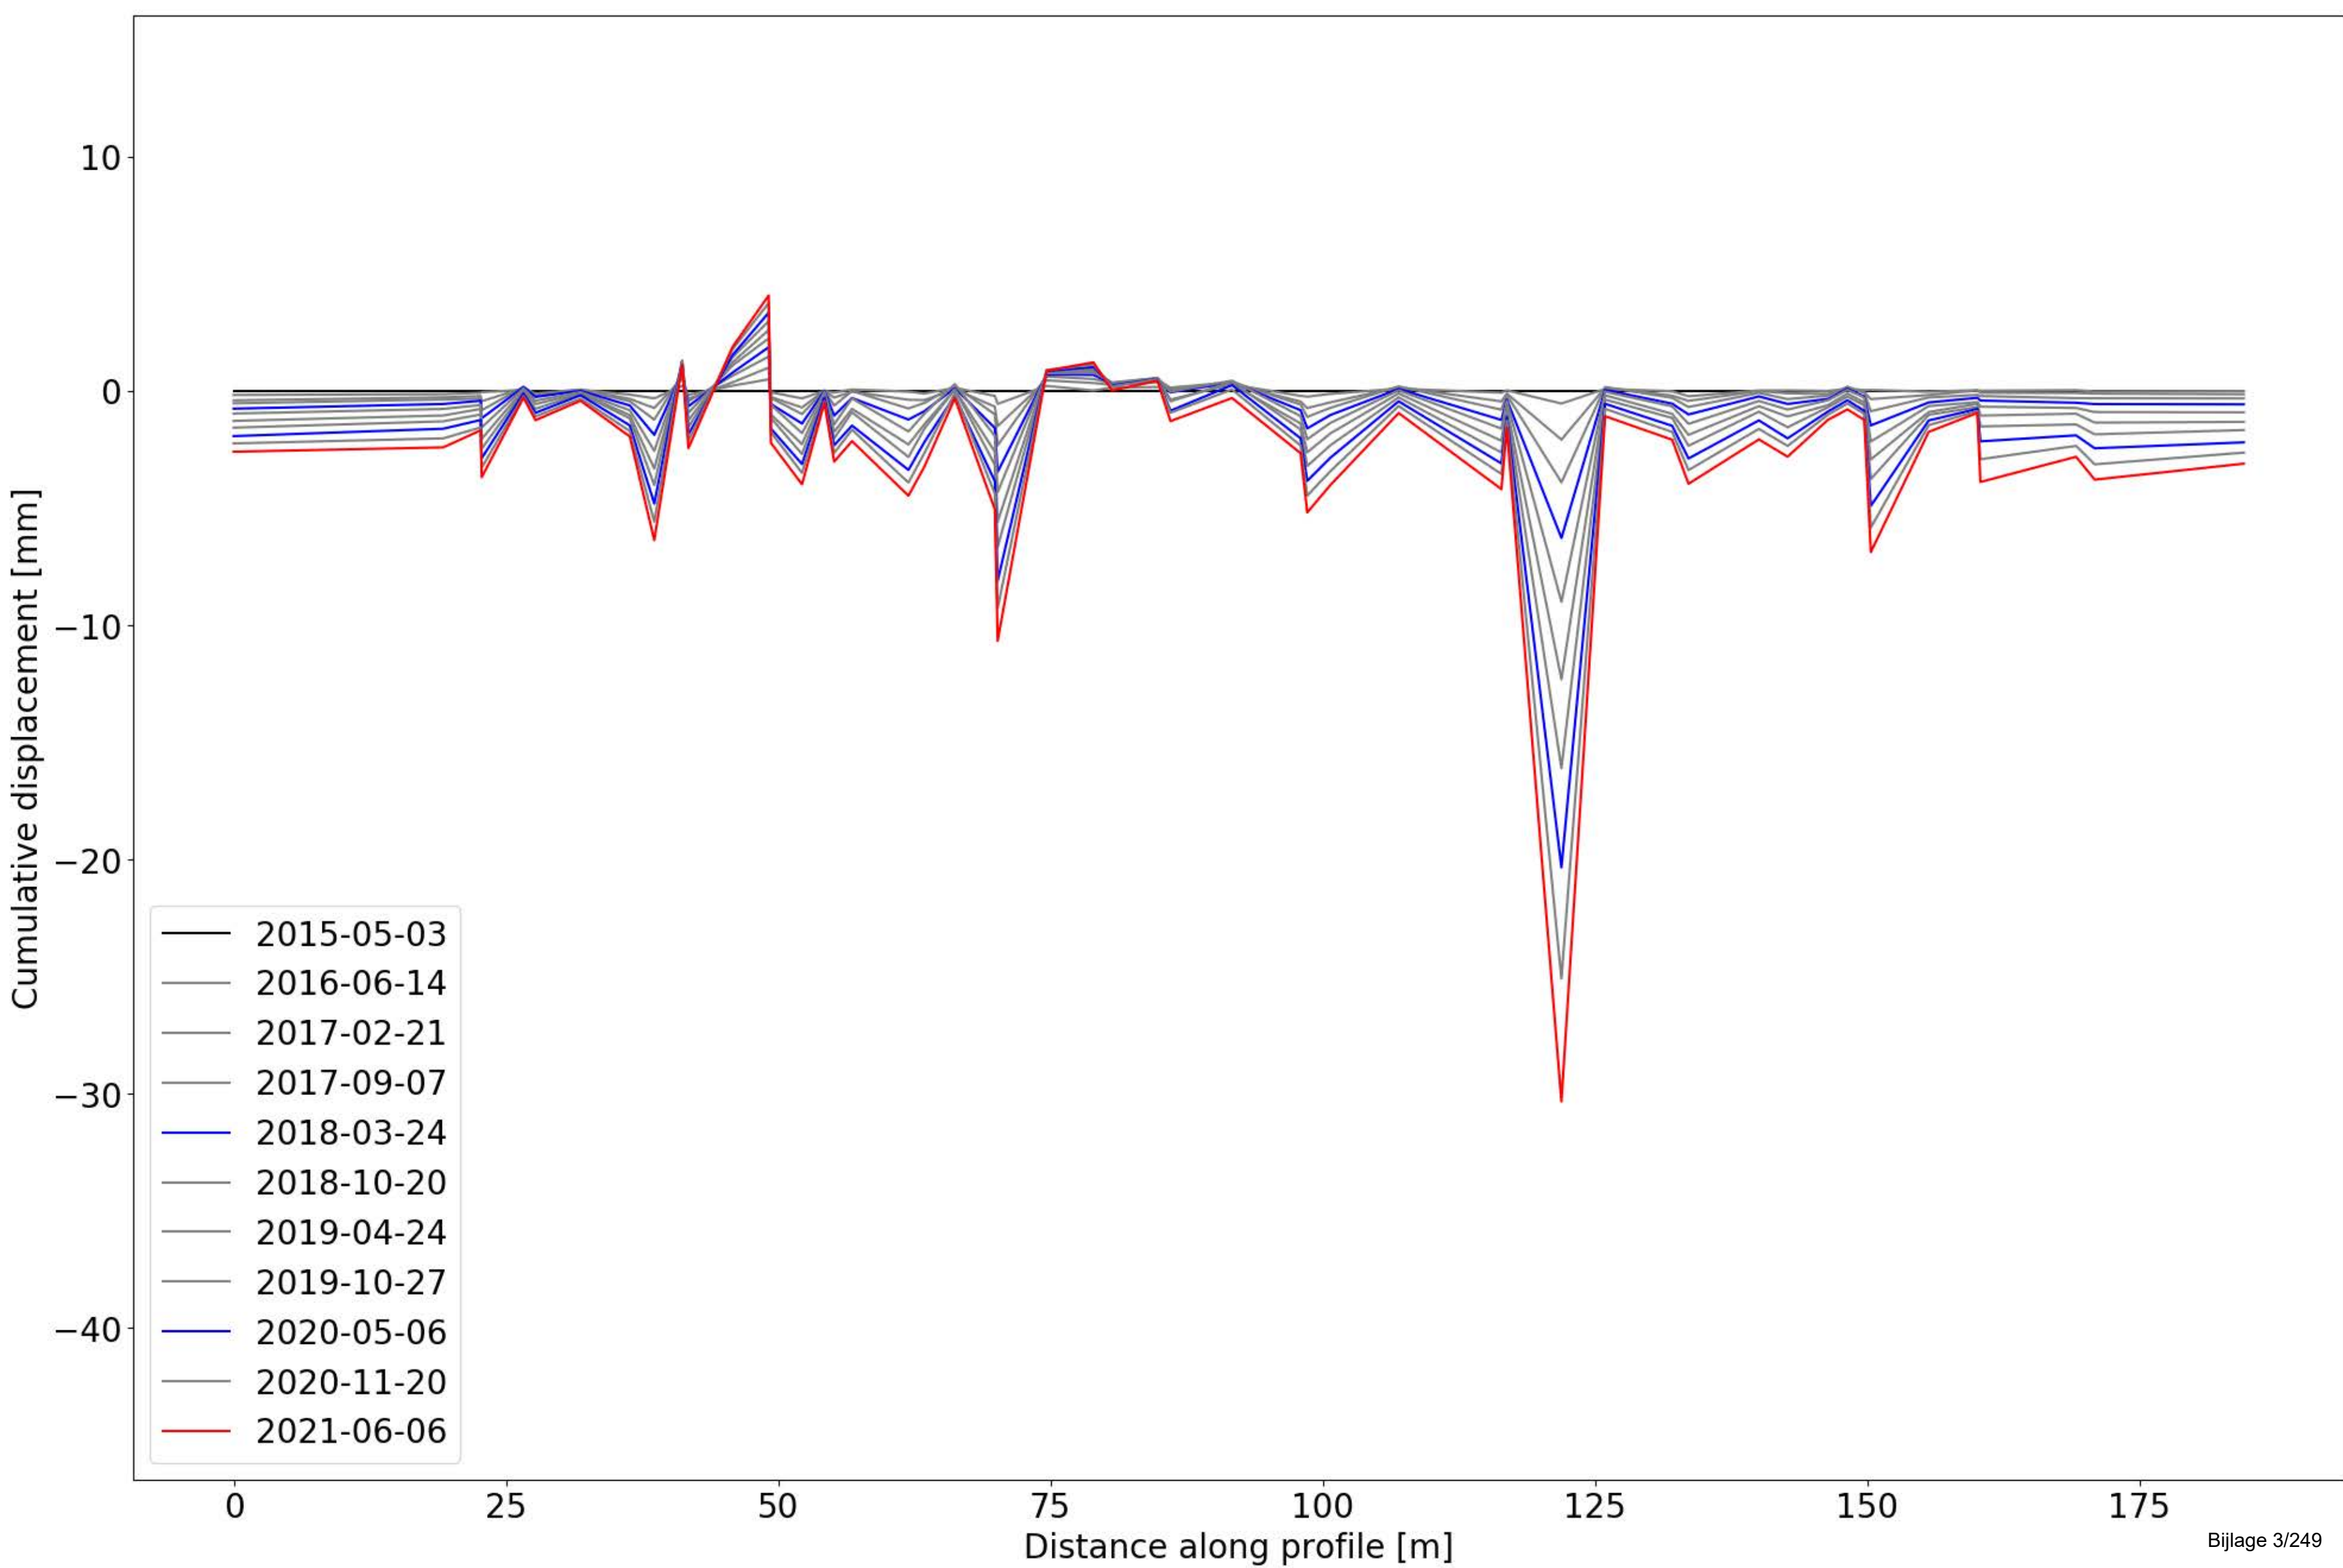
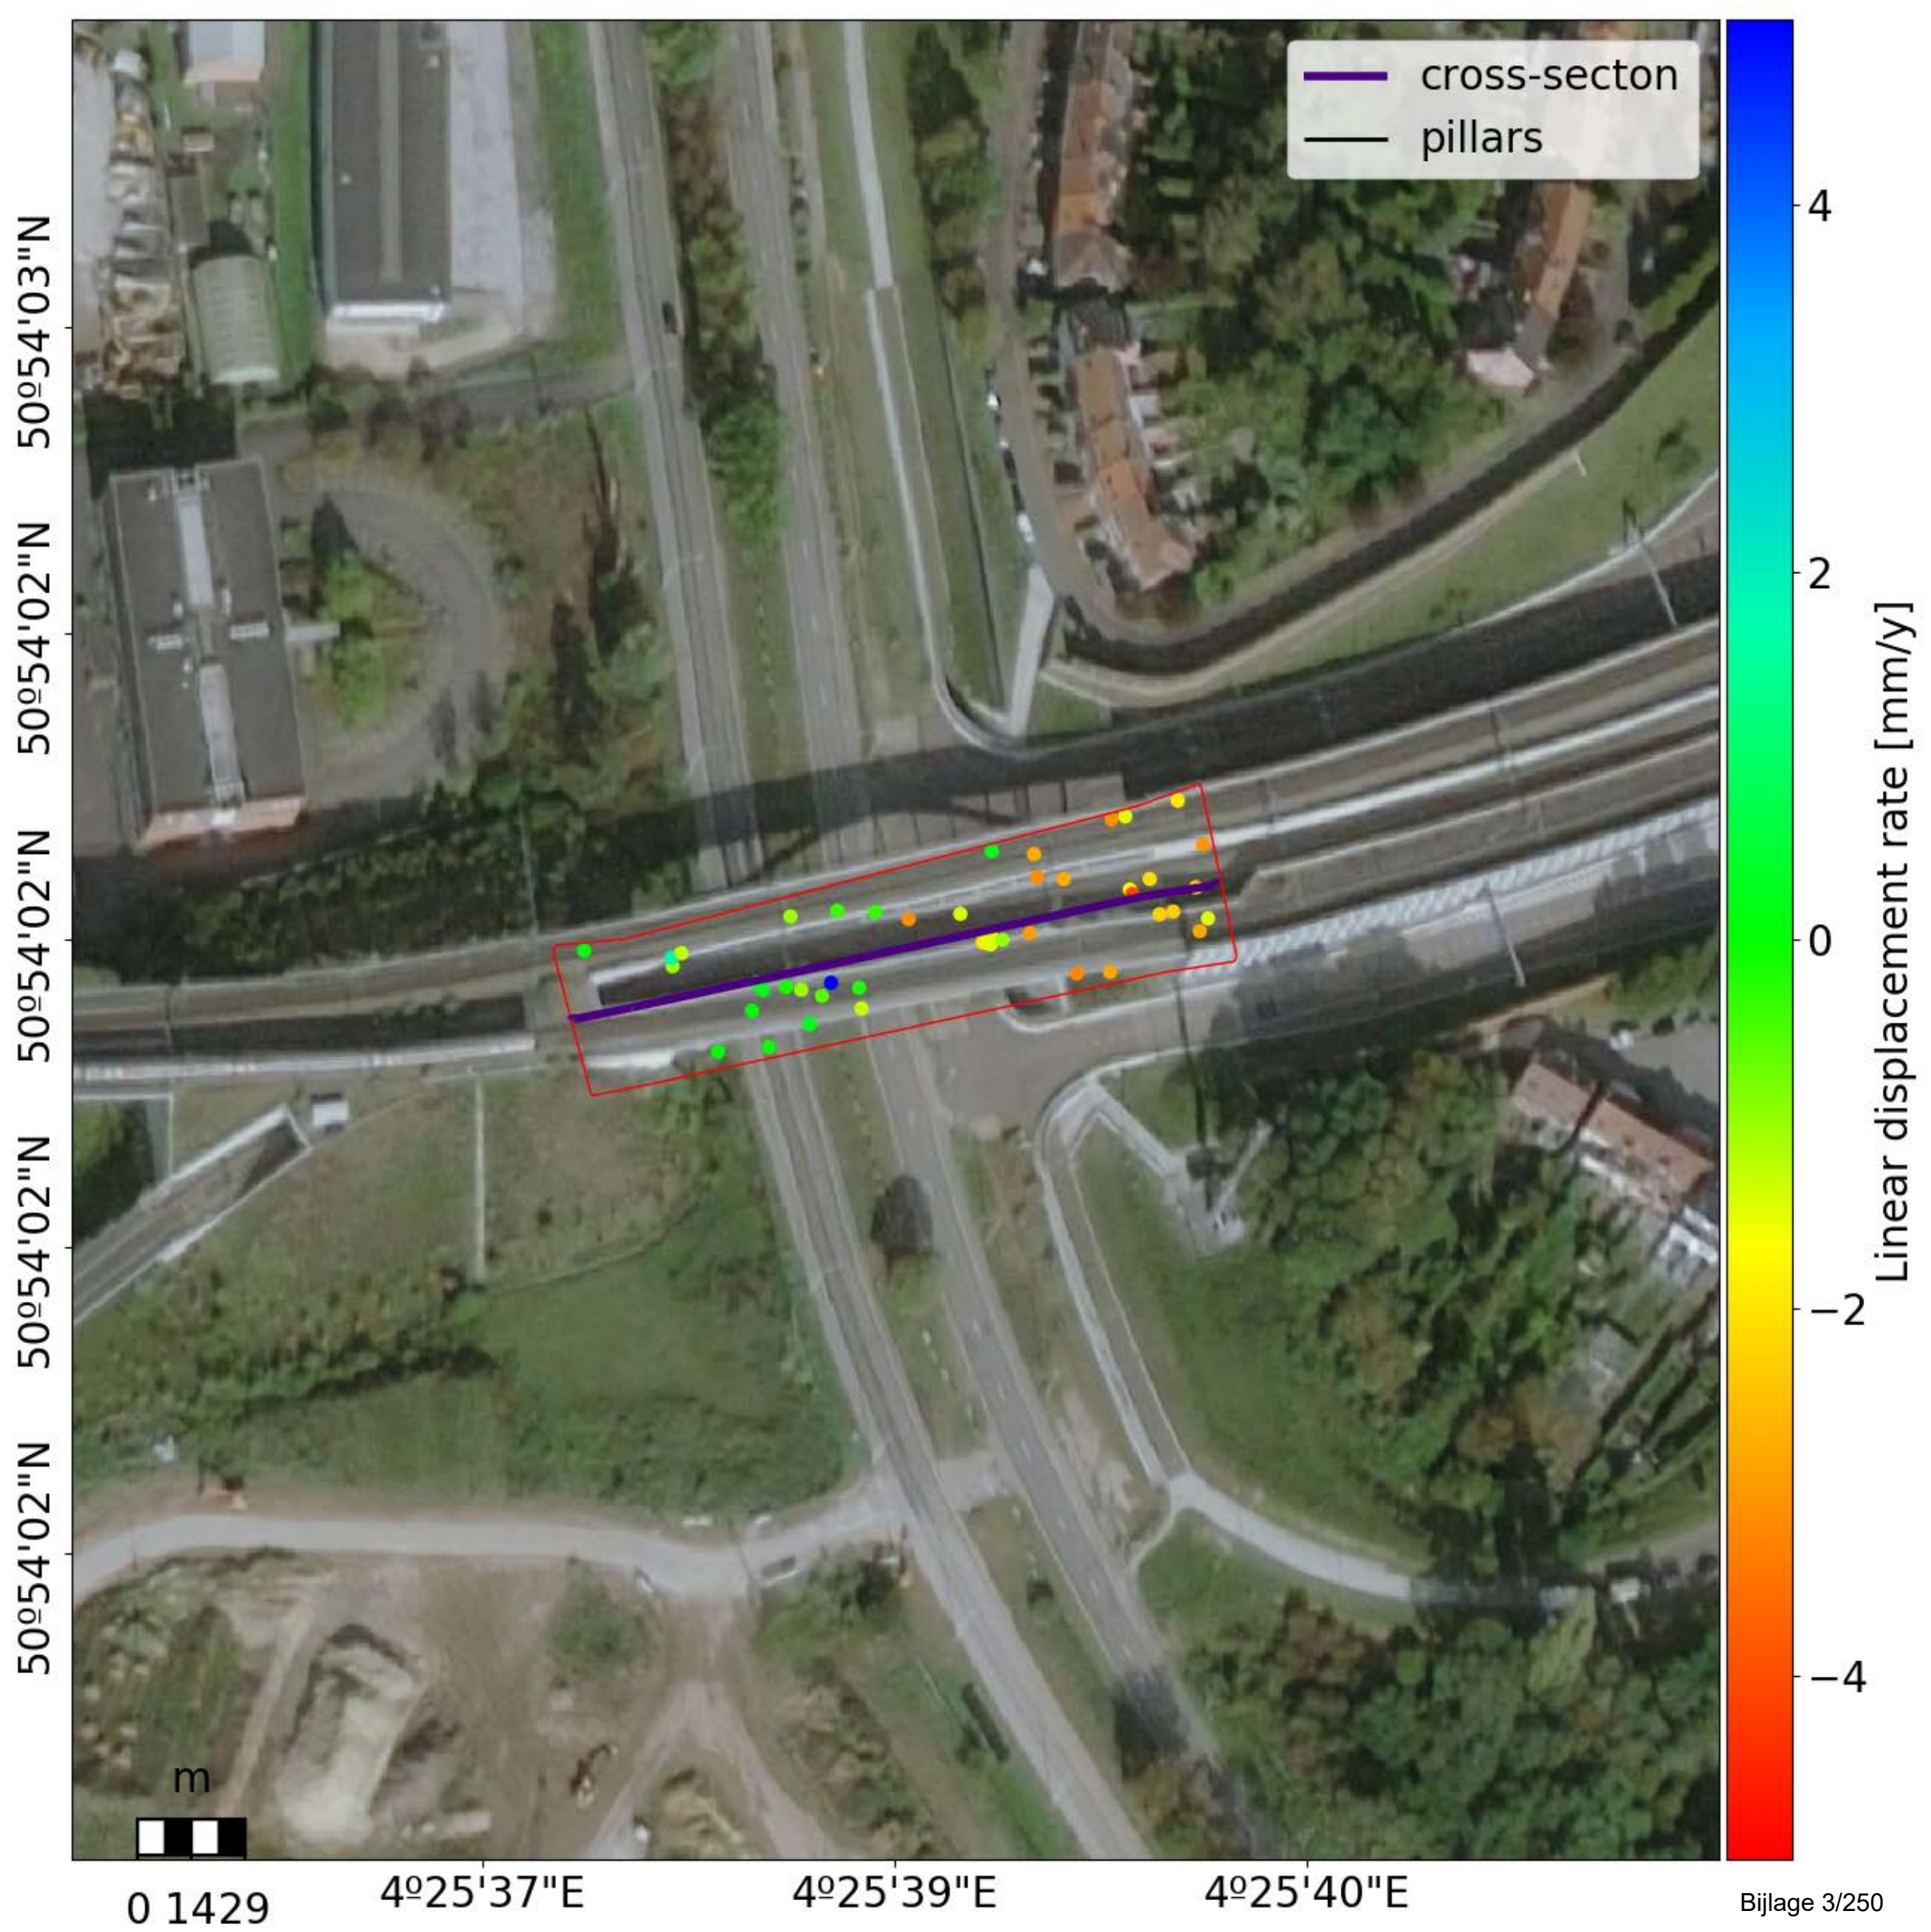
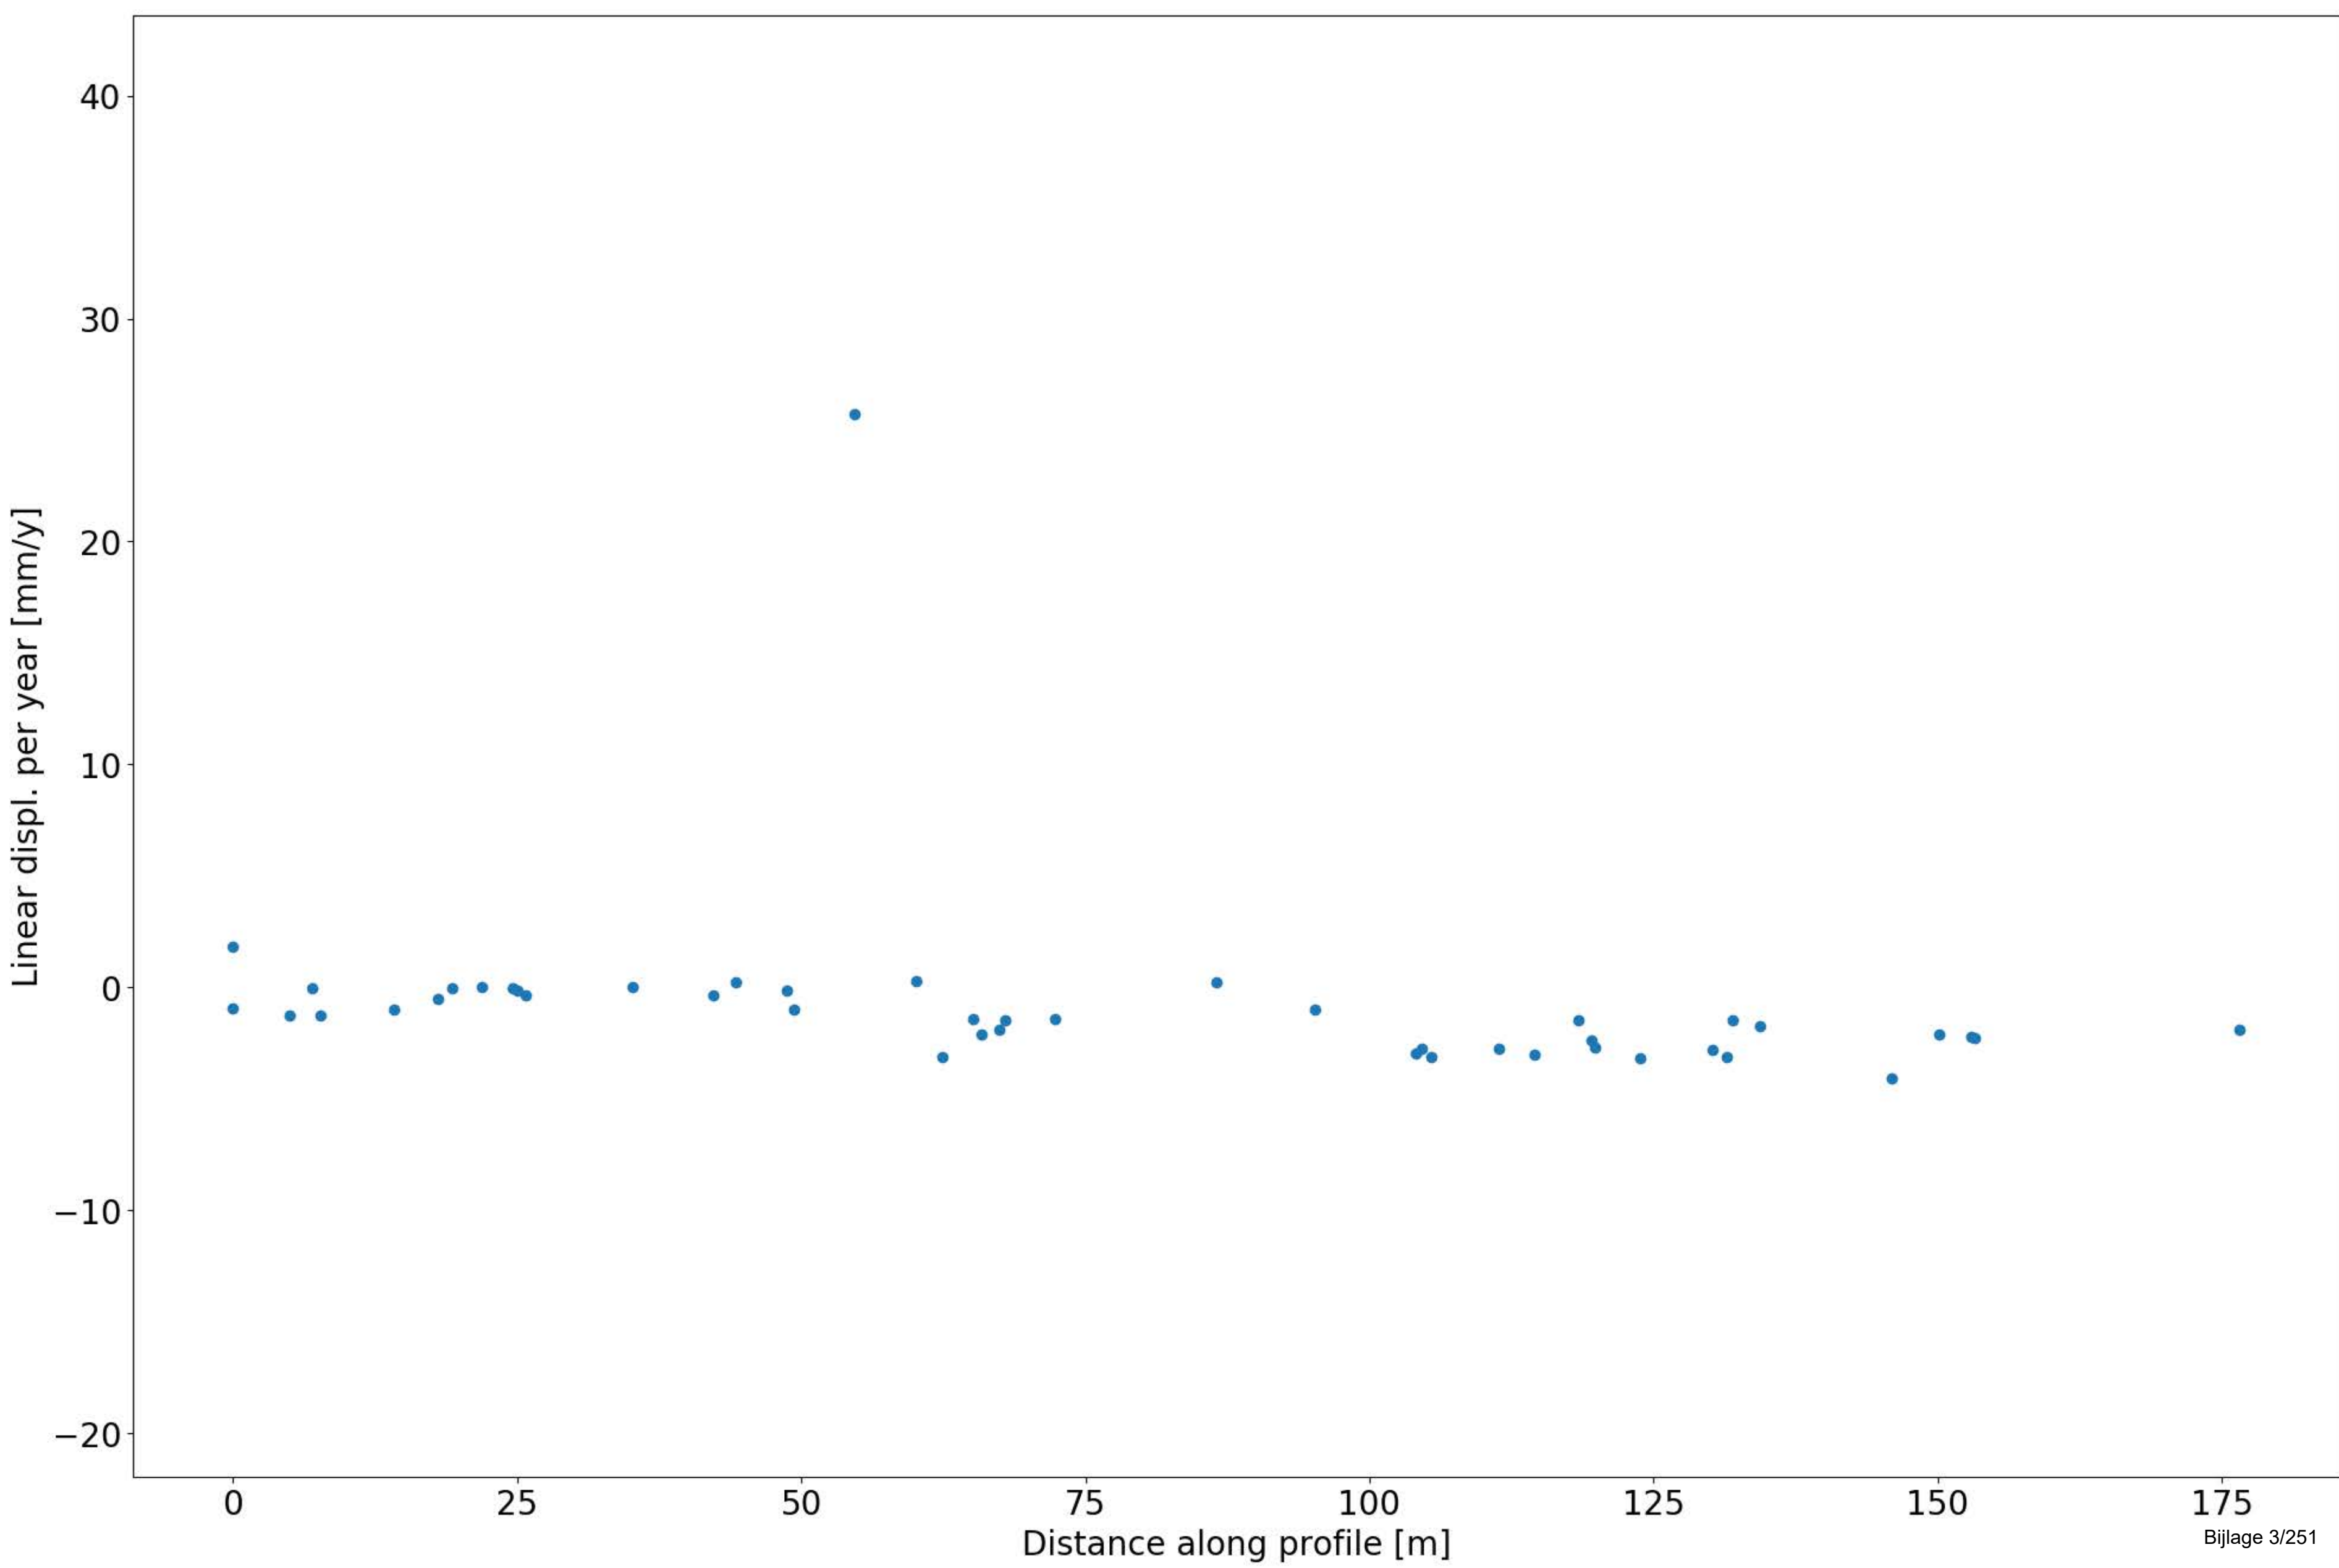
9105 Spoorwegbrug in Spoorlijn 25N over R22

Change detection	Approx. period	Description
Change	Since 2016	Differential movement in different bridge blocks

InSAR points along the length of the bridge for all three datasets (TSX, S1 asc and S1 dsc), no significant gaps in the data.
